**CASE # DRCA-25-06-143**

**1. REQUEST**

*This case was continued from the March 10, 2026 BCC Public Hearing at the request of the appellant.* This public hearing is to consider an appeal of the Development Review Committee's (DRC) decision of December 3, 2025, to uphold the Zoning Manager's decision regarding the Tree Removal Permit (TRP) TRP-25-04-068 and the Notice of Violation (NOV) issued under FIR-25-05-0295.

## Arborist Report- Single Family Home Property Tree Inspection(s) and Consulting Arborist Recommendations

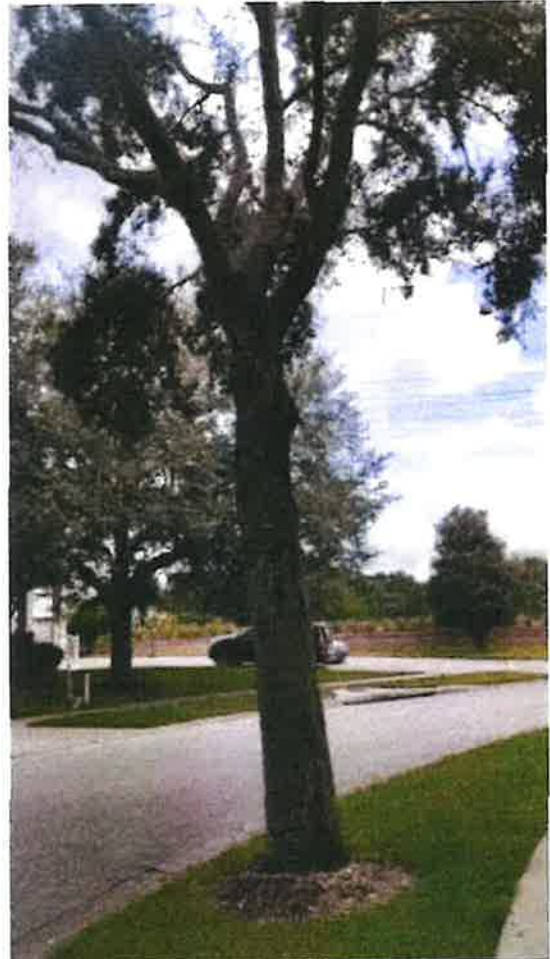
**Results and Recommendations:** Tree 335 was inspected as part of Street Tree inspections for this community in 2023. This tree was observed with very poor health condition, 40%, and visible signs of severe decline and structure damages in secondary and primary branches (dead branch sections, lack of live foliage, sloughing bark in sections), and damages along the lower trunk from disease and old wounds. Removal was recommended for this tree, due to expectation for continued health decline and increasing risks from dead branches and leaders that could break off at any time (imminent risks for targets on street and/or sidewalk within canopy width).

Disease damaging plant, Hatracked (stub cuts severe on most leaders), Included bark in junctures of leaders and branches, Leaning trunk/stem, Trunk damage- Wound/Cut over 4 inches, Damage-Curb (by tree), Damage-Sidewalk (by tree)

Oak tree in swale, has severe dieback of canopy showing in secondary and primary branches, sloughing bark along trunk, very poor overall health, leaning toward street, Removal recommended.

**Tree 335 has severe health and structure damages visible. This tree was assessed as High Risk, with removal the reasonable action to reduce risk level below moderate per FS163.045 terms. A permit may not be required by Orange County for removal of this tree, but we recommend to review this Report with County staff for their approval.**

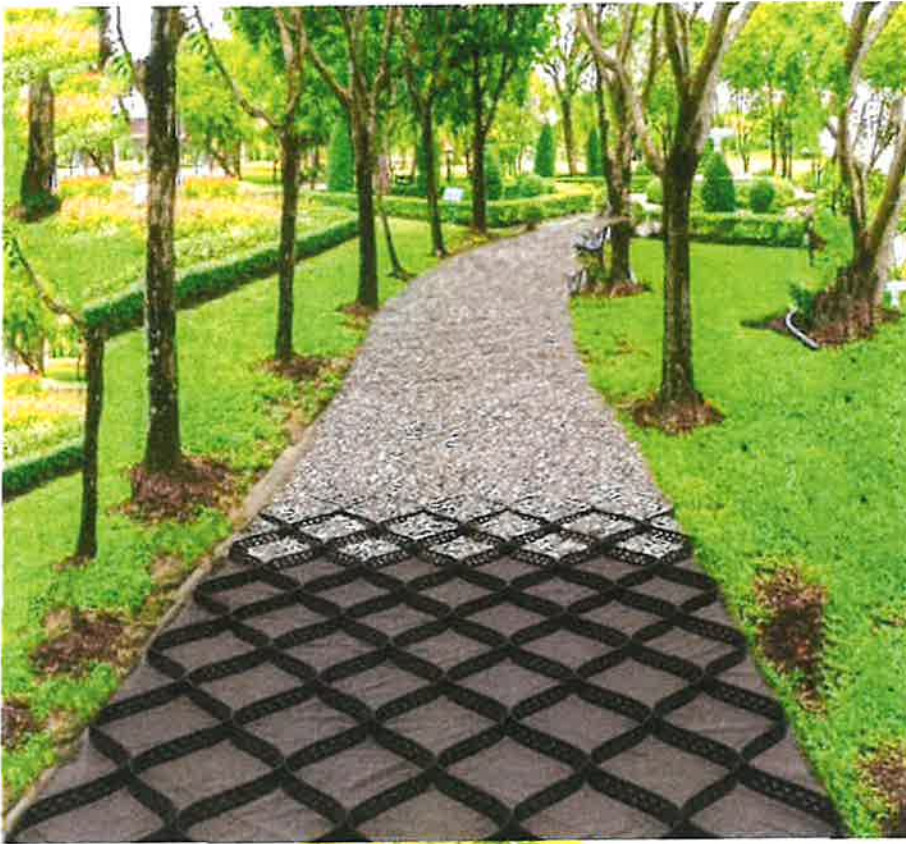
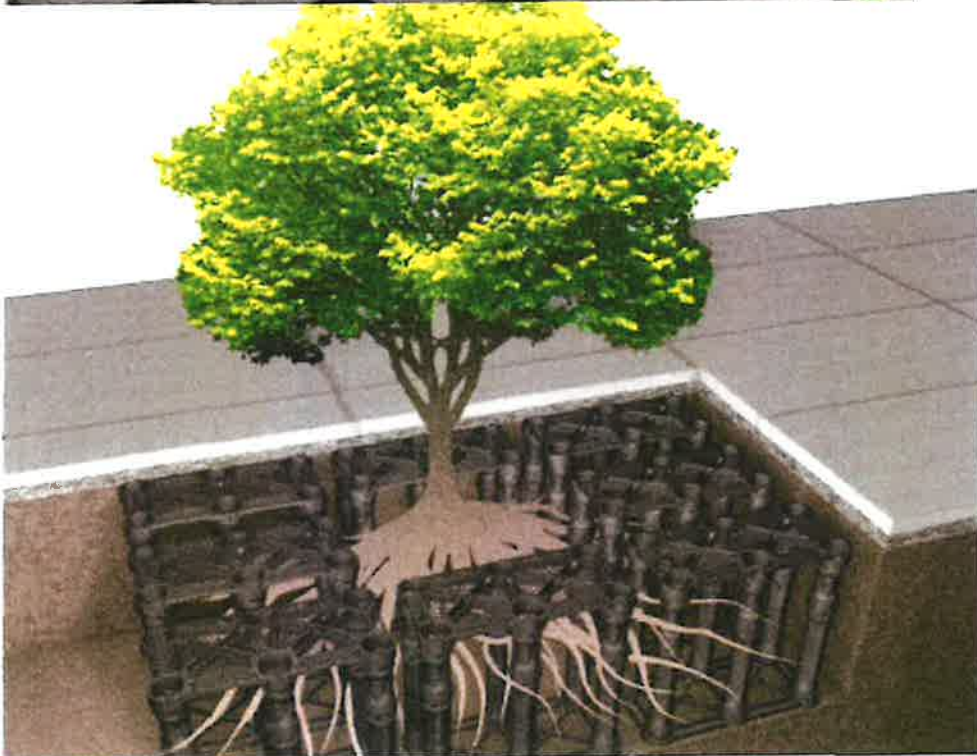
The geogrid with gravel base they mentioned looks something like this. I remember during our initial kickoff for this project, I had mentioned that if we want to properly do this, geogrids or Silva cells would be the way to go, but it does add A LOT of additional costs.

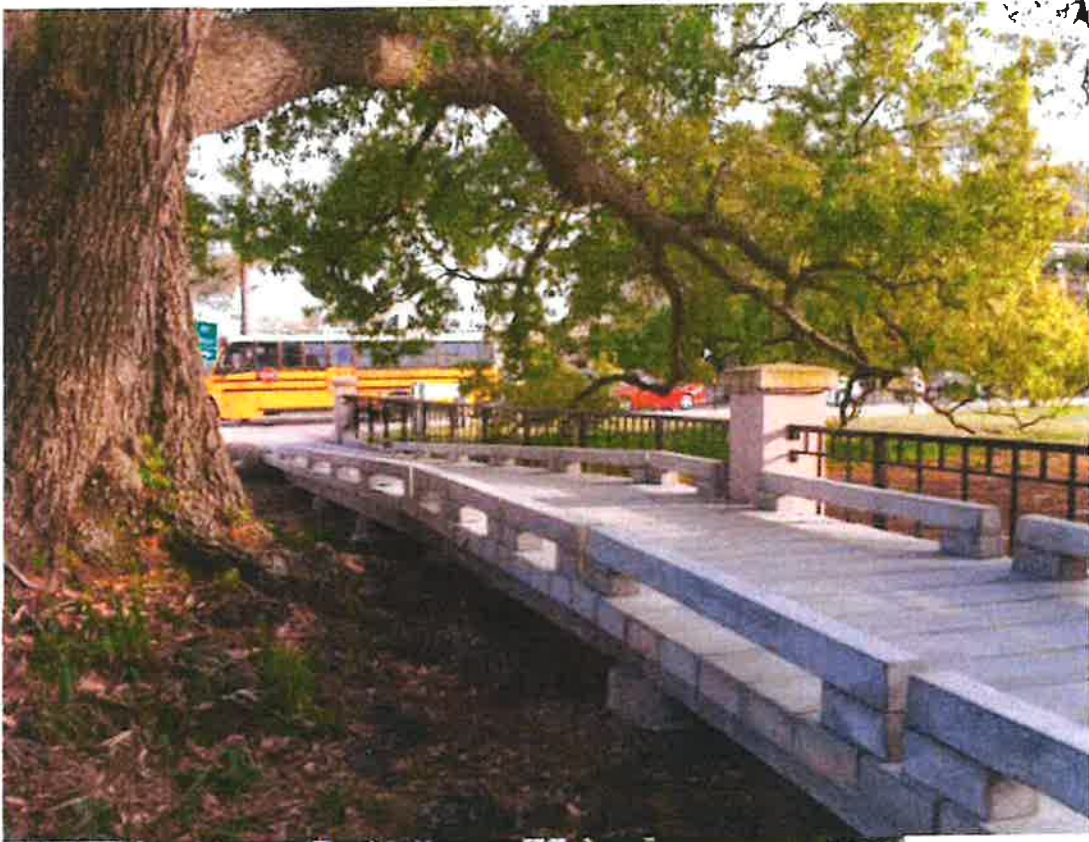
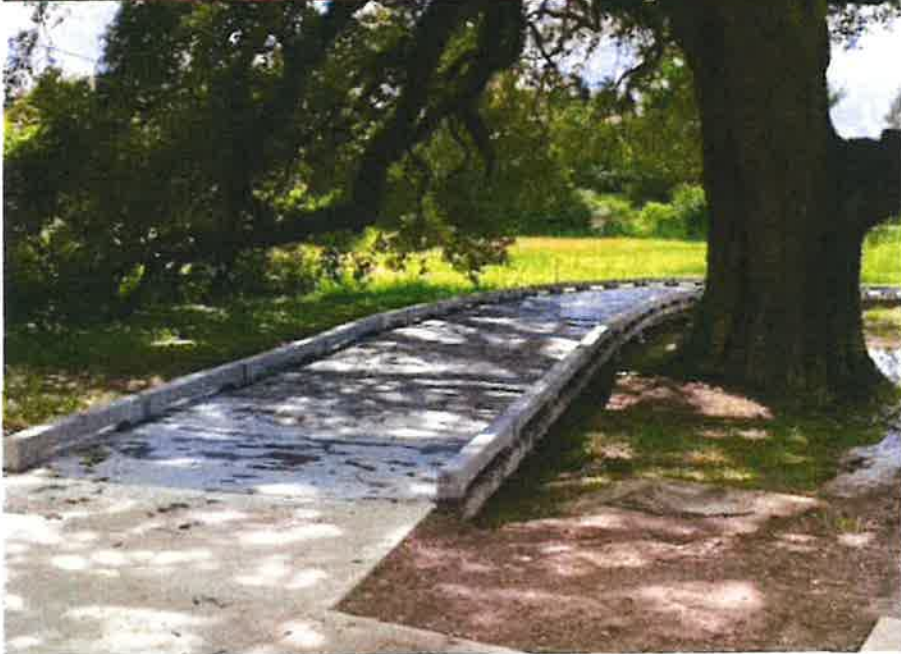
The ramping option is the only one that I think would work, but again, that's a lot of added cost if we are doing this to every tree with root issues.
