CASE # DRCA-25-06-143

1. REQUEST

This public hearing is to consider an appeal of the Development Review Committee's (DRC) decision of December 3, 2025, to uphold the Zoning Manager's decision regarding the Tree Removal Permit (TRP) TRP-25-04-068 and the Notice of Violation (NOV) issued under FIR-25-05-0295.

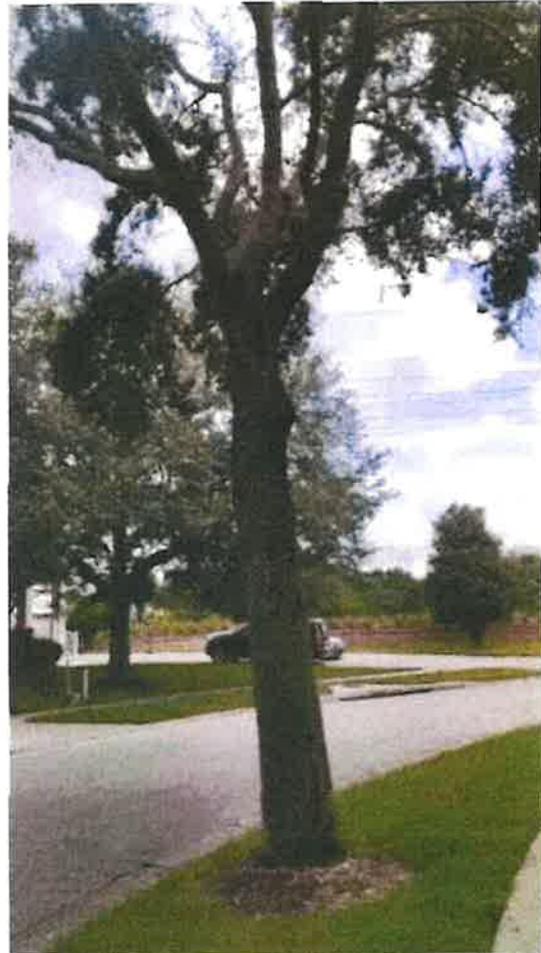
Photos

Tree Id: 335
 Survey ID Number-IF NEEDED:
 Address Number: 5844
 Address Street Caymus Loop
 Common Name: Oak mixed species
 Latin Name: Quercus species
 Cultivar:
 Height (Estimated) [ft]: 50
 DBH: 16
 Canopy/TPZ RADIUS (ft): 45
 Trunks/Stems: 1
 Condition %: 40
 Condition:

Observation Items: Disease damaging plant, Hatracked (stub cuts severe on most leaders), Included bark in junctures of leaders and branches, Leaning trunk/stem, Trunk damage- Wound/Cut over 4 inches, Damage-Curb (by tree), Damage-Sidewalk (by tree)

Oak tree in swale, has severe dieback of canopy showing in secondary and primary branches, sloughing bark along trunk, very poor overall health, leaning toward street, Removal recommended.

Tree 335 has severe health and structure damages visible. This tree was assessed as High Risk, with removal the reasonable action to reduce risk level below moderate per FS163.045 terms. A permit may not be required by Orange County for removal of this tree, but we recommend to review this Report with County staff for their approval.

Mtc 1 Priority: Risk Removal
 Tree Prtcn Zone (TPZ): 16
 Critical Root Zone (CRZ): 8

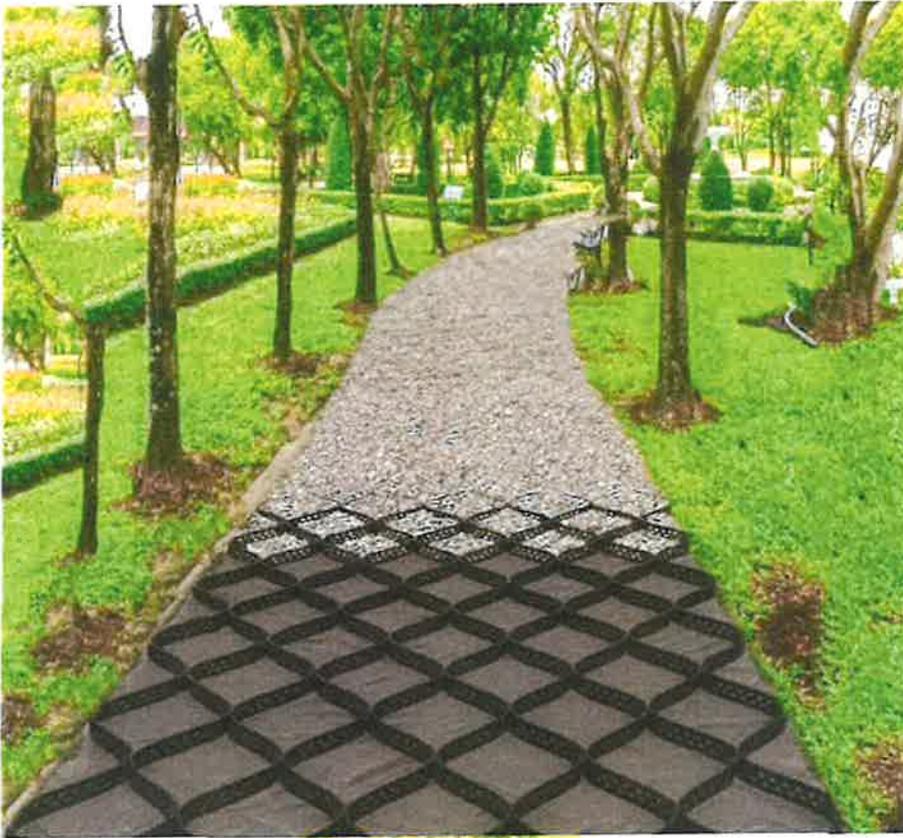
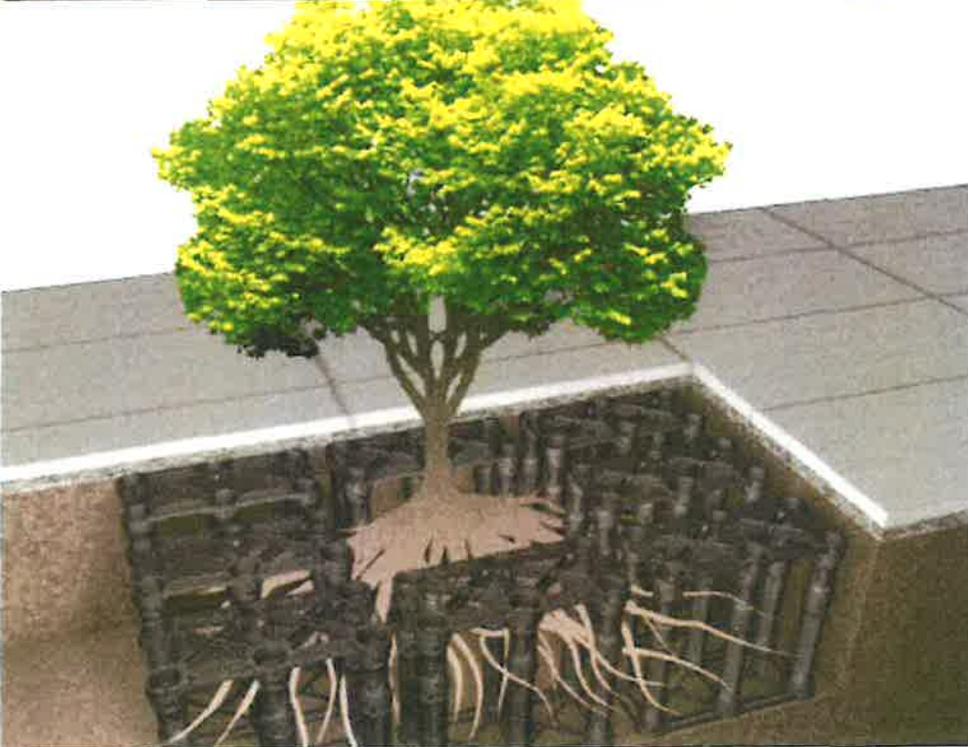
The geogrid with gravel base they mentioned looks something like this. I remember during our initial kickoff for this project, I had mentioned that if we want to properly do this, geogrids or Silva cells would be the way to go, but it does add A LOT of additional costs.

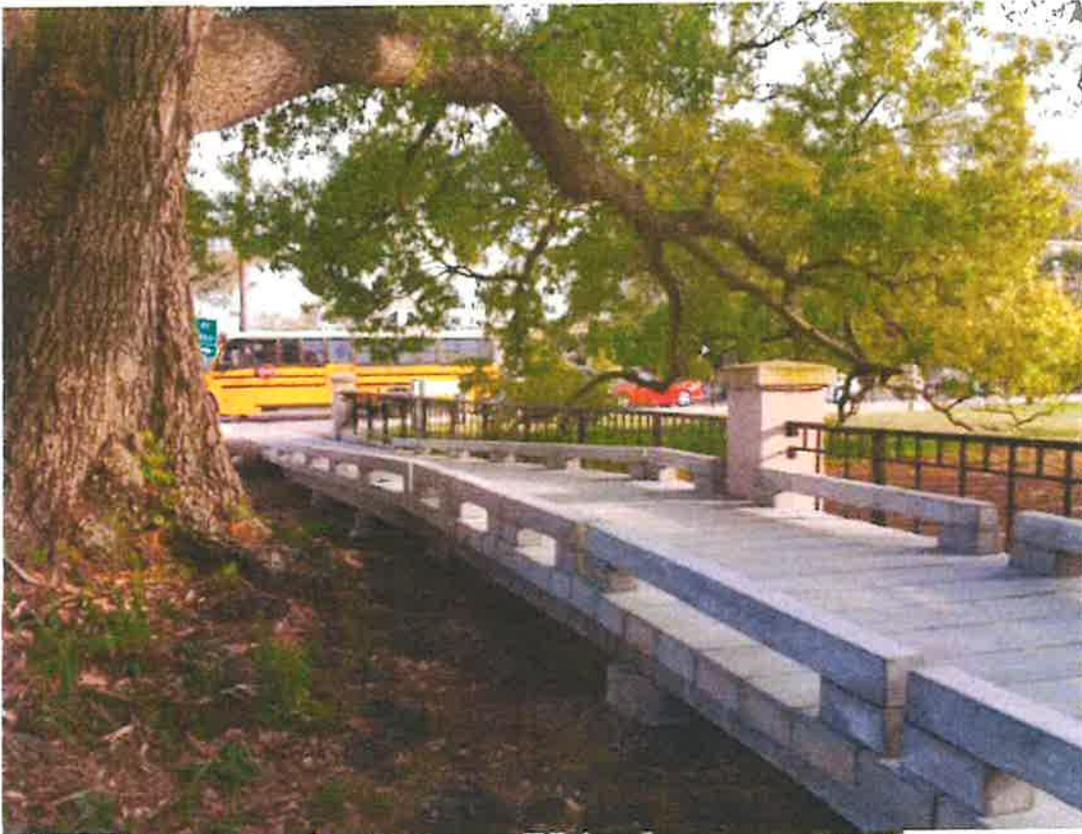
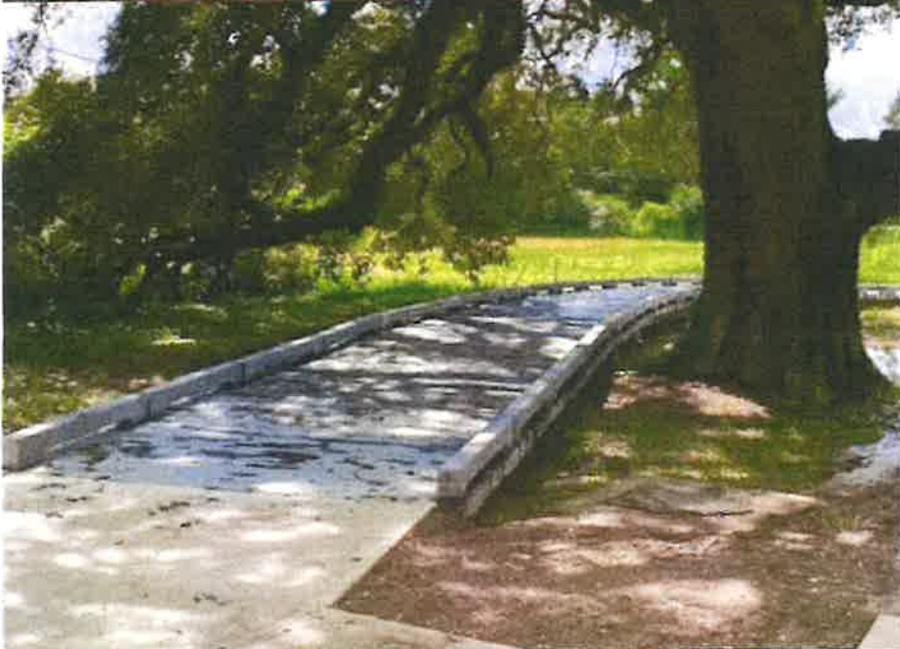
The ramping option is the only one that I think would work, but again, that's a lot of added cost if we are doing this to every tree with root issues.
