Roadway Conceptual Analysis for Chuluota Road (CR 419) From SR 50 to Lake Pickett Road

ROADWAY CONCEPTUAL ANALYSIS

Chuluota Road (CR 419)

FROM SR 50 TO LAKE PICKETT ROAD

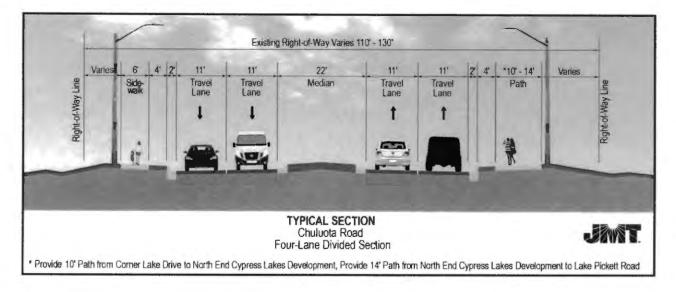
Figure ES 1-2 - Chuluota Road Proposed Typical Section

To satisfy the forecasted traffic demands and provide multimodal accommodations for Chuluota Road, the proposed typical section is recommended to include the full reconstruction of Chuluota Road and replaced with an urban section consisting of two 11-foot travel lanes in each direction separated by a 22-foot raised median. Type E curb and gutter will be used along the median and Type F curb and gutter is proposed along the outside lanes.

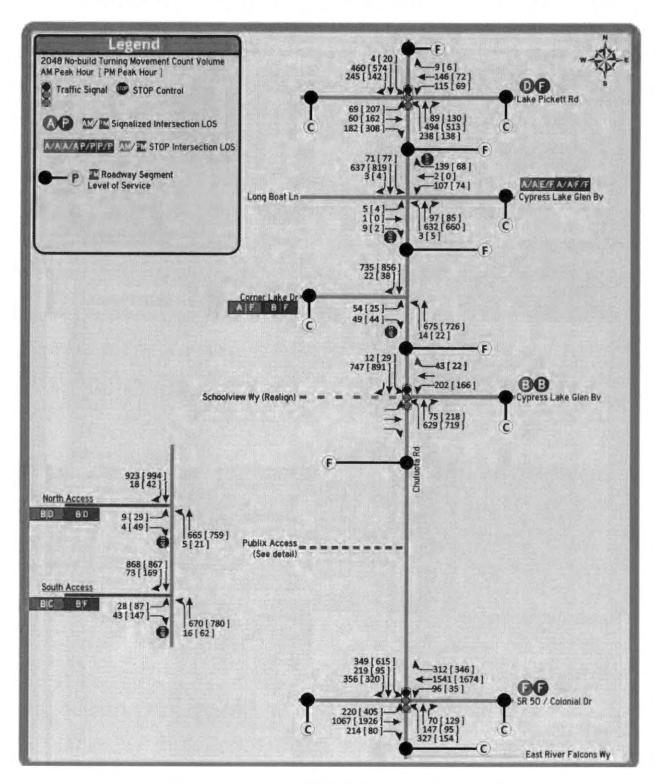
Figure 2-1 Year 2048 No Build Segment and Intersection Analysis

Without improvements, Chuluota Road will operate at an unacceptable LOS F by the design year 2048 (see Figure 2-1, next page). The roadway segments were analyzed using the procedures of the Highway Capacity Manual for signalized and unsignalized intersections. The No Build analysis used forecasted traffic volumes applied against the existing travel lane conditions.

In the design year 2048 and without capacity improvements, only the Cypress Lake Glen Boulevard (South) intersection is projected to operate at an acceptable level of service (LOS B). Therefore, capacity improvements are needed to achieve an acceptable level of service along Chuluota Road.

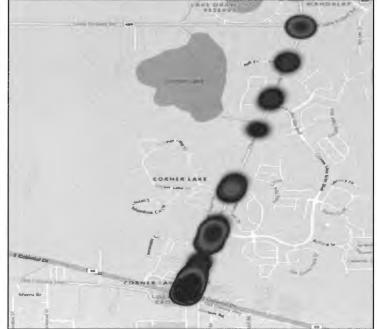
Figure 2-5 Concentration of Crashes Along Chuluota Road

- Chuluota Road at SR 50/Colonial Drive – 60 crashes
- Chuluota Road at Cypress Lake Glen Boulevard (South)/Schoolview Way Intersections – 24 crashes
- Chuluota Road at CR 420/Lake Pickett Road – 13 crashes

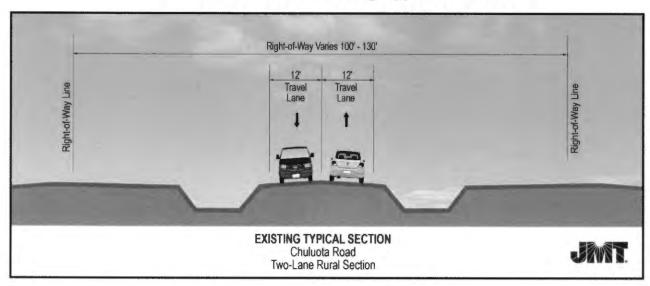
Figure 3-1 Chuluota Road Existing Typical Section

Chuluota Road is generally a two-lane, undivided rural roadway with roadside swales that collect stormwater, though to the south of Cypress Lake Glen Boulevard (South), the roadway has been widened to four lanes to provide for turn lanes. Figure 3-1 depicts the existing, nominal typical section.

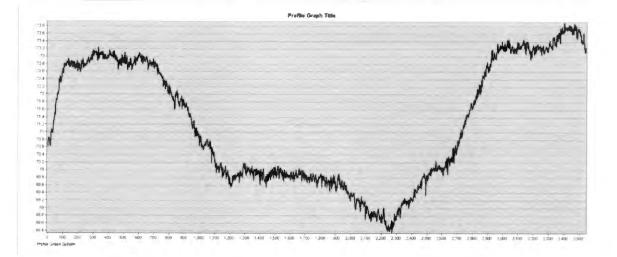
Figure 3-2 Existing Roadway Profile from LiDAR SR 50 to Lake Pickett Road

The existing ground profile of Chuluota Road is reflected below on Figure 2-2 which indicates a starting elevation of approximately 70 feet at SR 50. The existing profile then rises to an elevation of approximately 73 feet just south of Schoolview Way. The roadway then steadily drops between Cypress Lake Glen Boulevard to the north of Corner Lake Drive before reaching an elevation of approximately 69 feet. The Chuluota Road grade then rises to an elevation of approximately 73.5 feet at Lake Pickett Road. It is noted that the information presented in the section is based on Orange County LiDAR information which utilizes the NAVD88 datum.

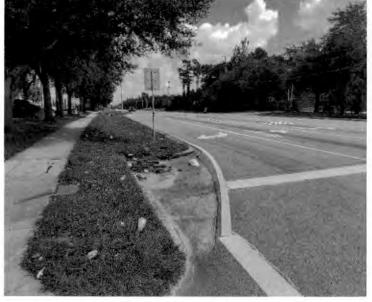
Stormwater runoff is conveyed by a ditch into an existing FDOT storm drain system draining west along SR 50. There is no existing stormwater attenuation or water quality treatment.

Existing inlet drains west into FDOT SR 50 ROW

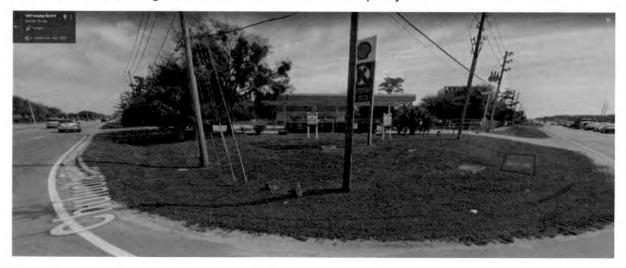
Stormwater runoff sheet flows into the existing FDOT storm drain system draining east along Colonial Blvd. There is no existing stormwater attenuation or water guality treatment.

Existing inlet on east side of Chuluota Road drains into FDOT SR 50 ROW

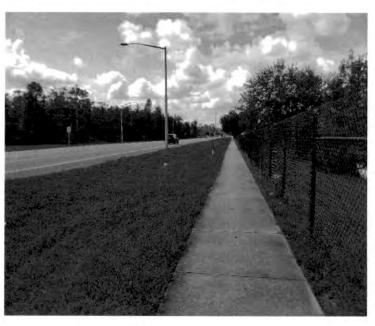
Roadside ditch facing south

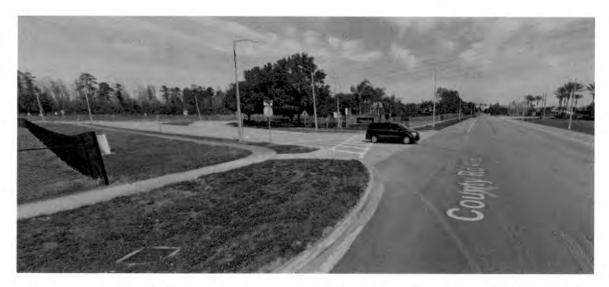
County LiDAR indicates that Basin 2A ranges in elevation from 70 feet to 73 feet (mean 72.0 feet). Stormwater runoff sheet flows into a ditch which is conveyed via a ditch bottom inlet and storm drain into the existing pond north of intersection of Schoolview Way and Chuluota Road (ERP#27857).

Chuluota Road and Schoolview Way showing ditch bottom inlet which drains to existing pond

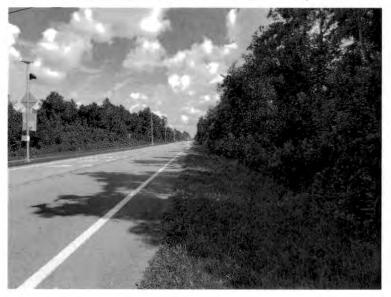
County LiDAR indicates that Basin 2B ranges in elevation from 66.7 feet to 73.5 feet (mean 70.7 feet). Stormwater runoff sheet flows into adjacent roadside diches that flow towards an existing cross drain (CD-1). The existing cross drain flows toward the wetland system to the west of Chuluota Road. A side drain under Corner Lake Drive conveys this runoff to wetlands west of Chuluota Road in Basin 3.

Roadside ditch facing north

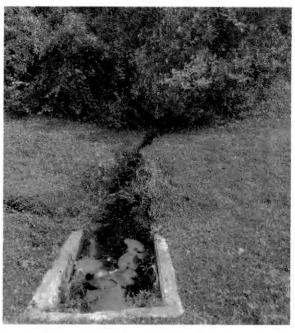
The existing cross drain drains to a relict wetland canal west of Chuluota Road which ultimately discharges to Corner Lake.

Existing side drain under Corner Lake Drive which conveys runoff from Basin 2B to Basin 3

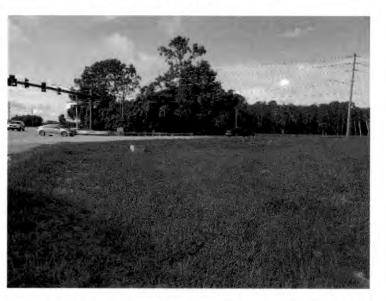
Existing dry pond northeast of Lake Pickett Road and Chuluota Road

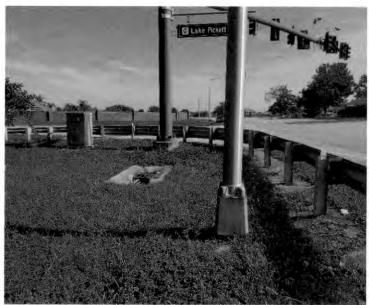
Ditch bottom inlet at southwest intersection of Lake Pickett Road and Chuluota Road, facing north

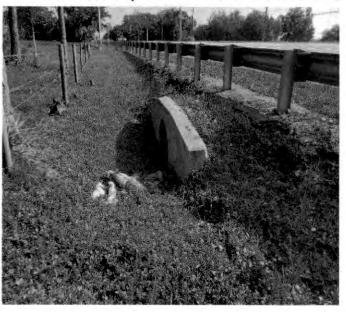
Cross drain which conveys runoff from basin 4-300 to storm drain on east side of Chuluota Road, facing north and east.

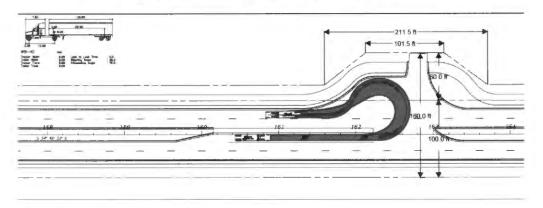
Figure 6-1: Typical U-turn Layout

The County has expressed a desire to provide for the ability of trucks (WB-40) to make U- turns along the corridor. As shown on Figure 6-1, the typical right-of-way width required at a median opening to accommodate this movement is approximately 160 feet.

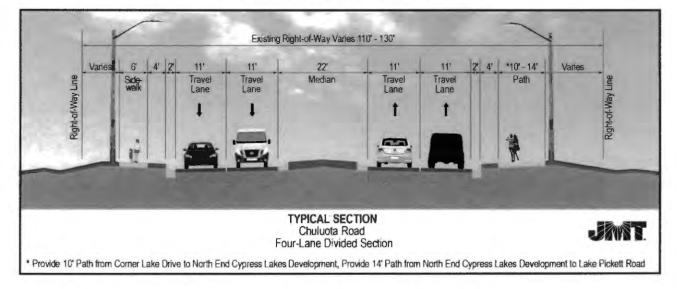
Figure 6-2 Proposed Typical Section

Other typical sections, such as a five-lane, undivided section, were considered, though discarded since these sections typically have a higher crash rate experience than roadways with median separations. The proposed typical section is shown on Figure 6-2.

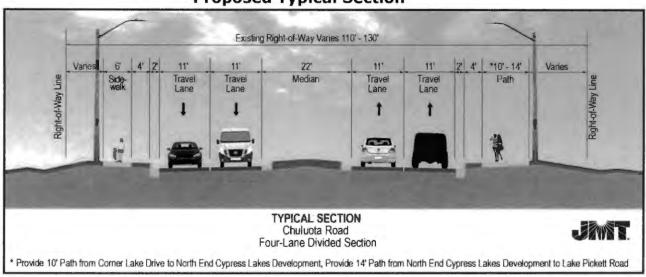
Figure 7-1 Proposed Typical Section

In general, the preferred alignment will generally bisect the existing right-of-way, though at the south end of the project, the proposed centerline has been shifted to the west to avoid impacts to the old Circle K property. The resulting intersection will have a significant deflection at SR 50 and East River Falcons Way (approximately 15 degrees).

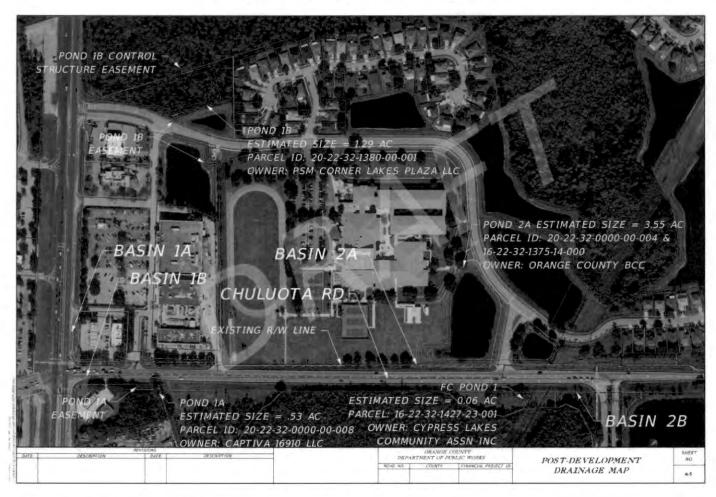
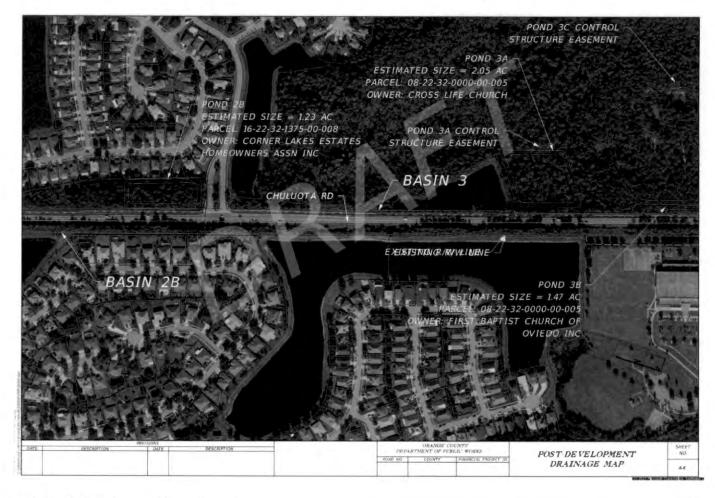
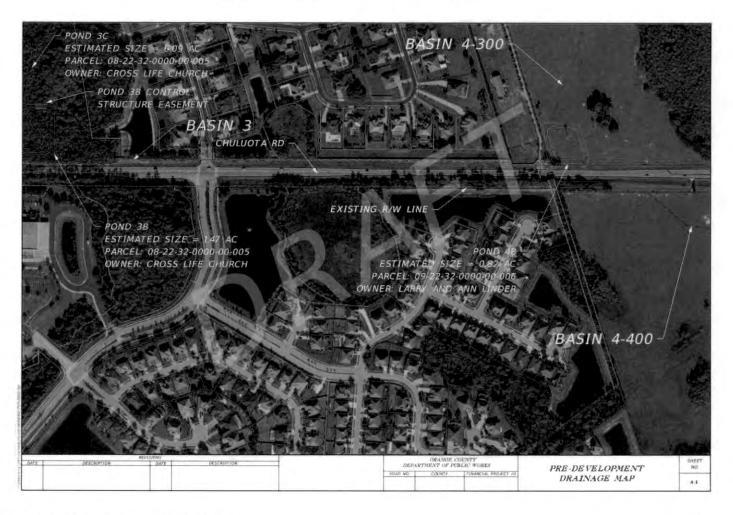
Figure 7-2 – Post Development Drainage Map

A floodplain compensatory pond (FC-1) is proposed across from Corner Lake Middle School, and a floodplain compensatory pond (FC-2) is proposed adjacent to wetlands south of Lake Pickett Road and east of Chuluota Road.
