**After-the-Fact Application for
Conservation Area Impact Permit
CAI-23-12-059
District #4**

Applicant: KP Home 1 Investment LLC

Address: 13450 E Lake Mary Jane Rd

RESTORATION PLAN APPROVAL LETTER

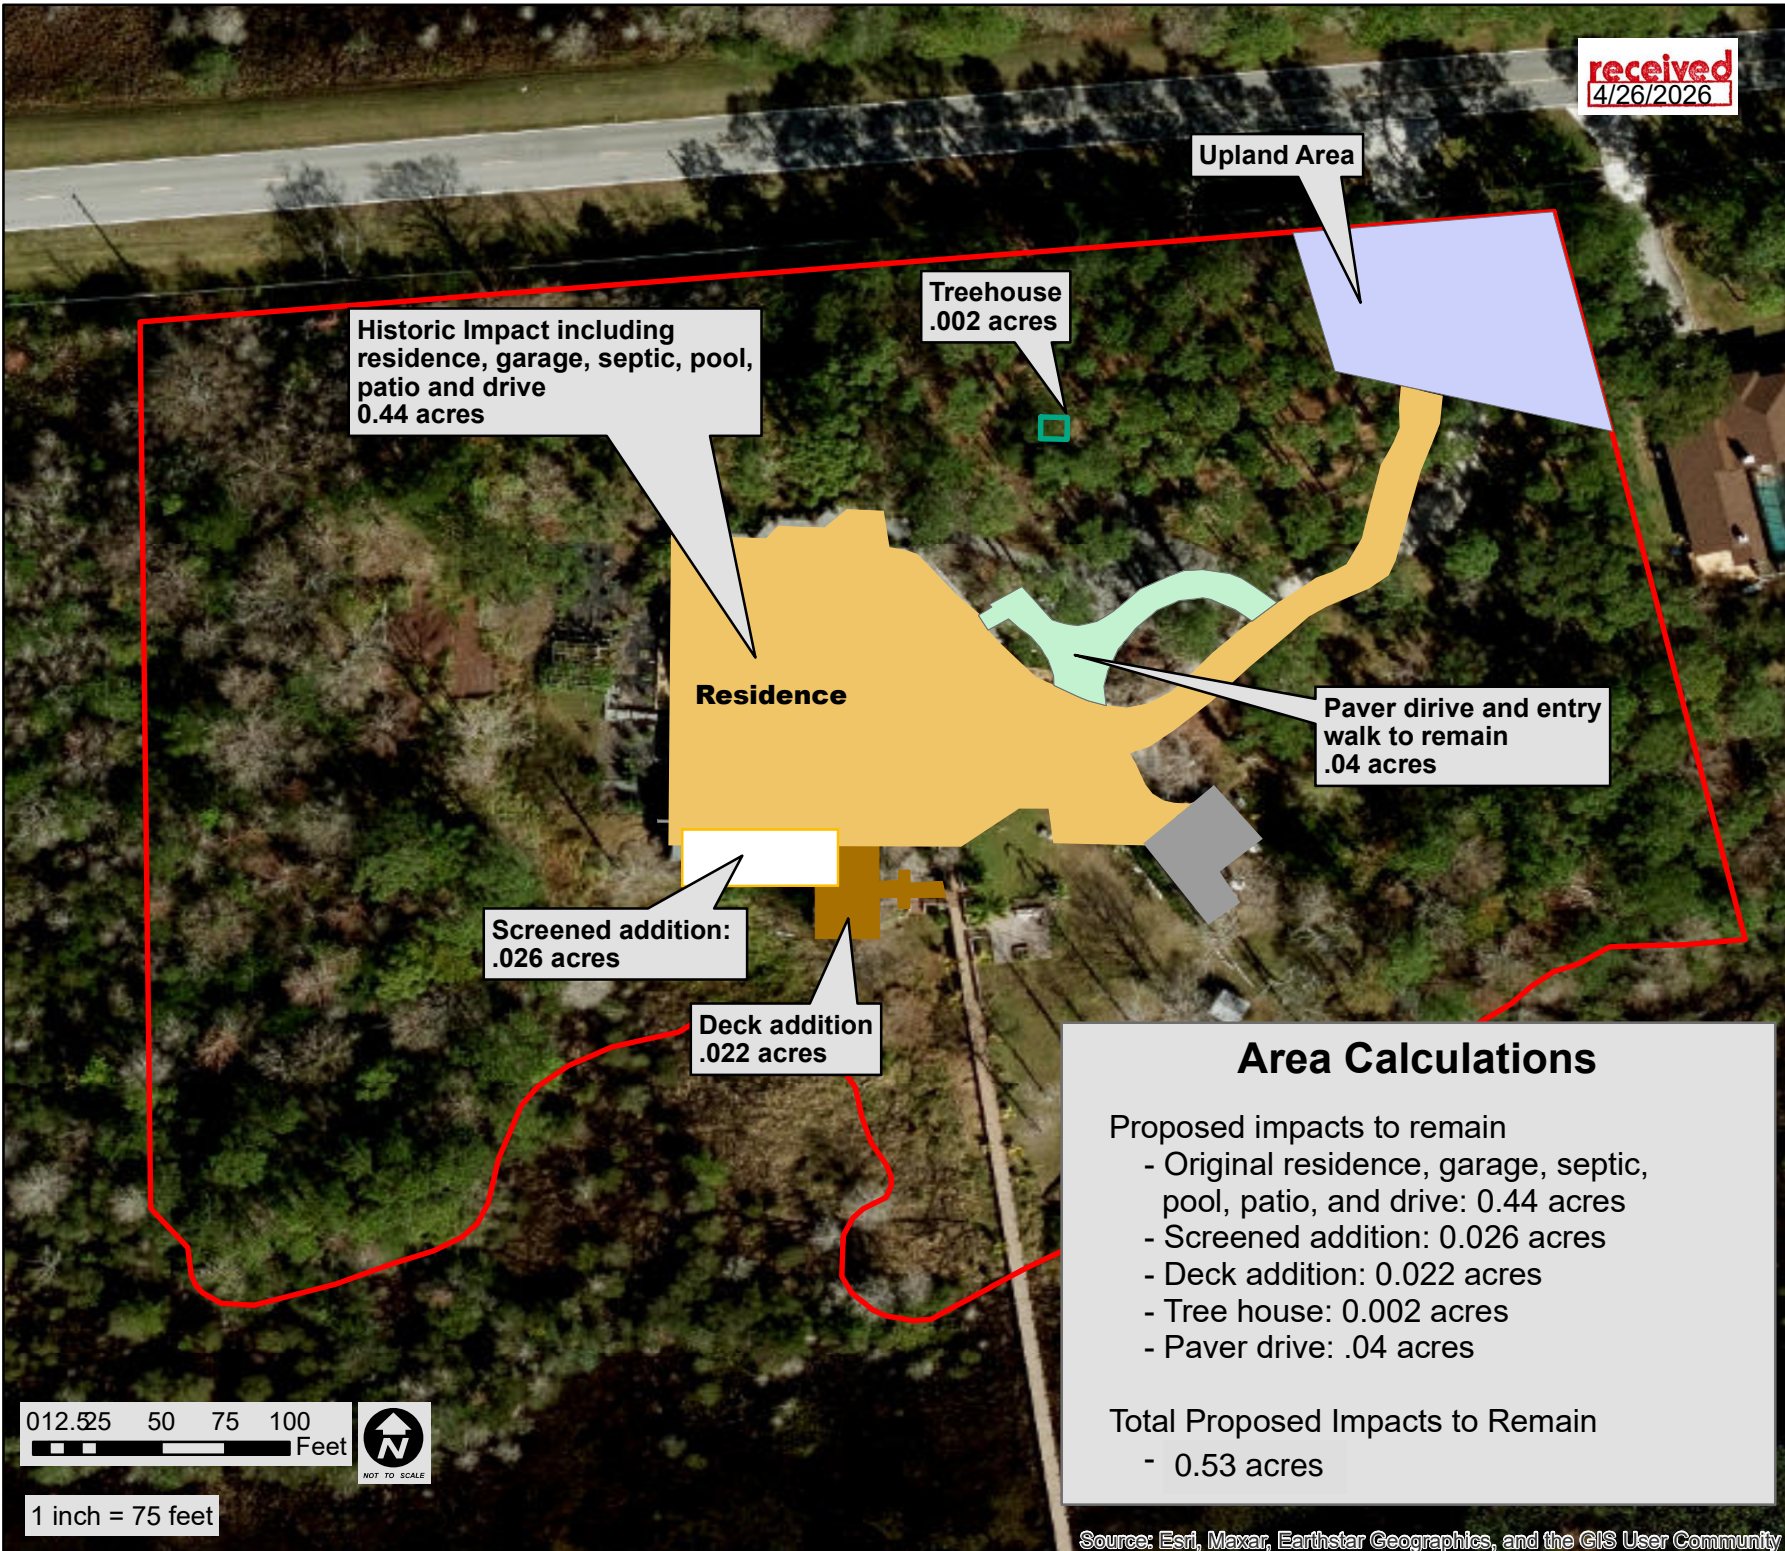
Wetland Impacts	
Rev Date: 4-27-26 Project No.: 220109 Fig 10 Revised Wetland Impacts	Figure 10
13450 E. Lake Mary Jane Road Orlando, FL 32832	
Parcel: 23-24-31-0000-00-003	
BOWMAN and BLAIR ECOLOGY and DESIGN, INC. 5080 Parkridge Ct. Oviedo, FL 32765 407-637-5883 www.bowmanandblair.com

Historic Impact including residence, garage, septic, pool, patio and drive 0.44 acres

Treehouse
.002 acres

Paver drive and entry walk to remain
.04 acres

Screened addition:
.026 acres

Deck addition
.022 acres

- Original residence, garage, septic, pool, patio, and drive: 0.44 acres
- Screened addition: 0.026 acres
- Deck addition: 0.022 acres
- Tree house: 0.002 acres
- Paver drive: .04 acres

- 0.53 acres

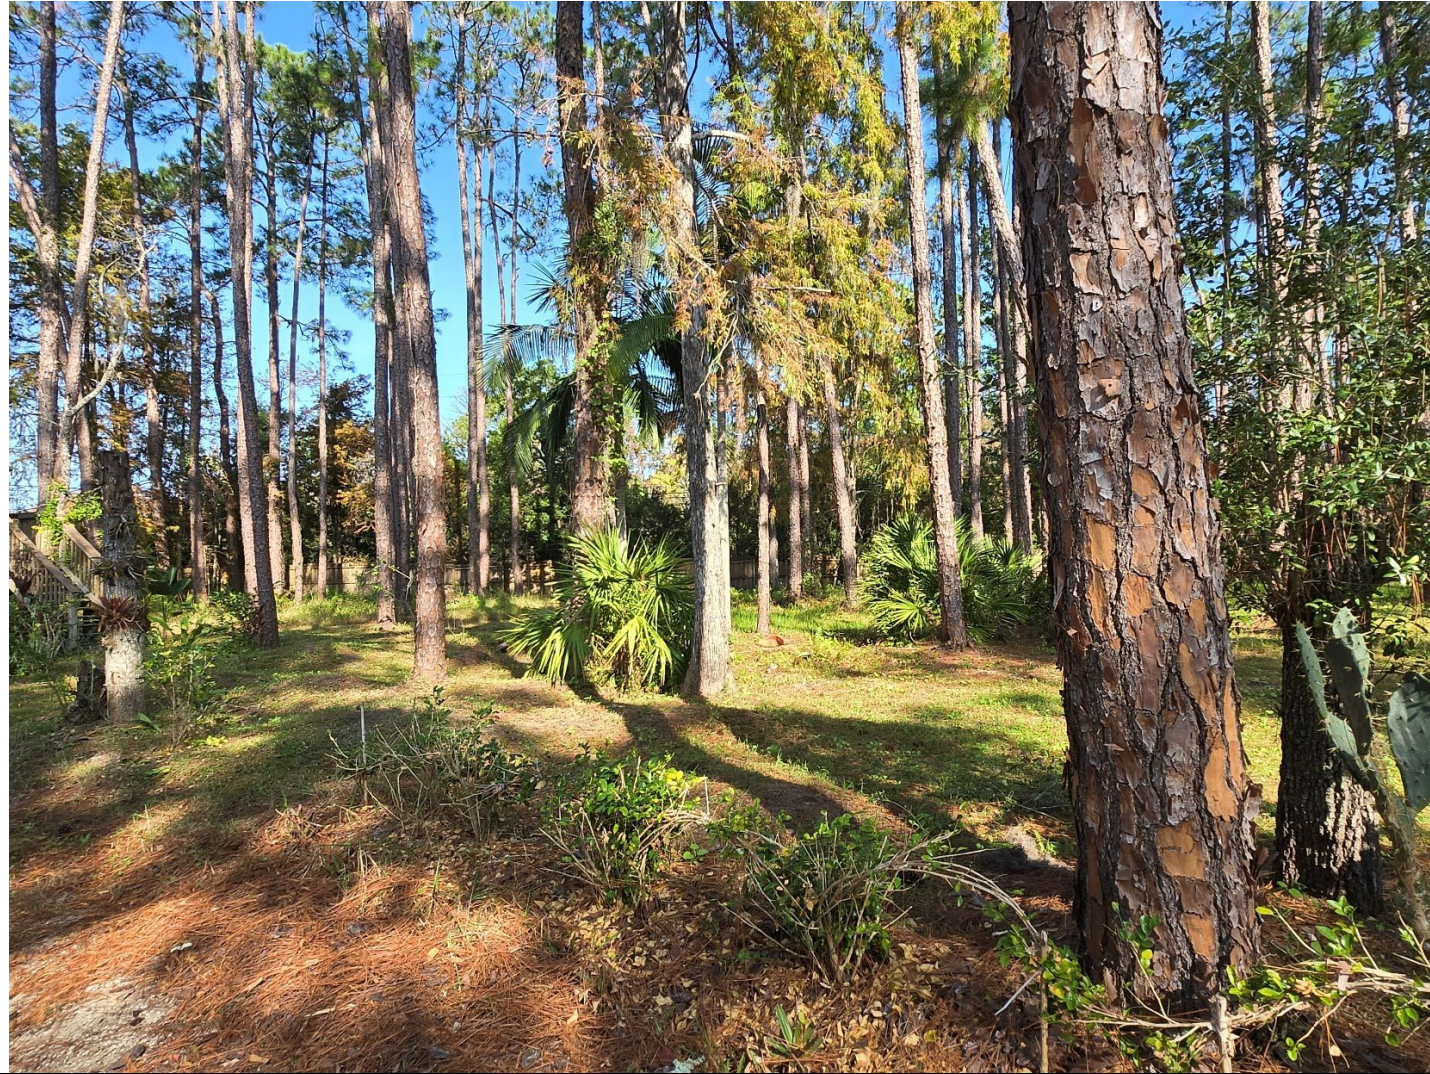
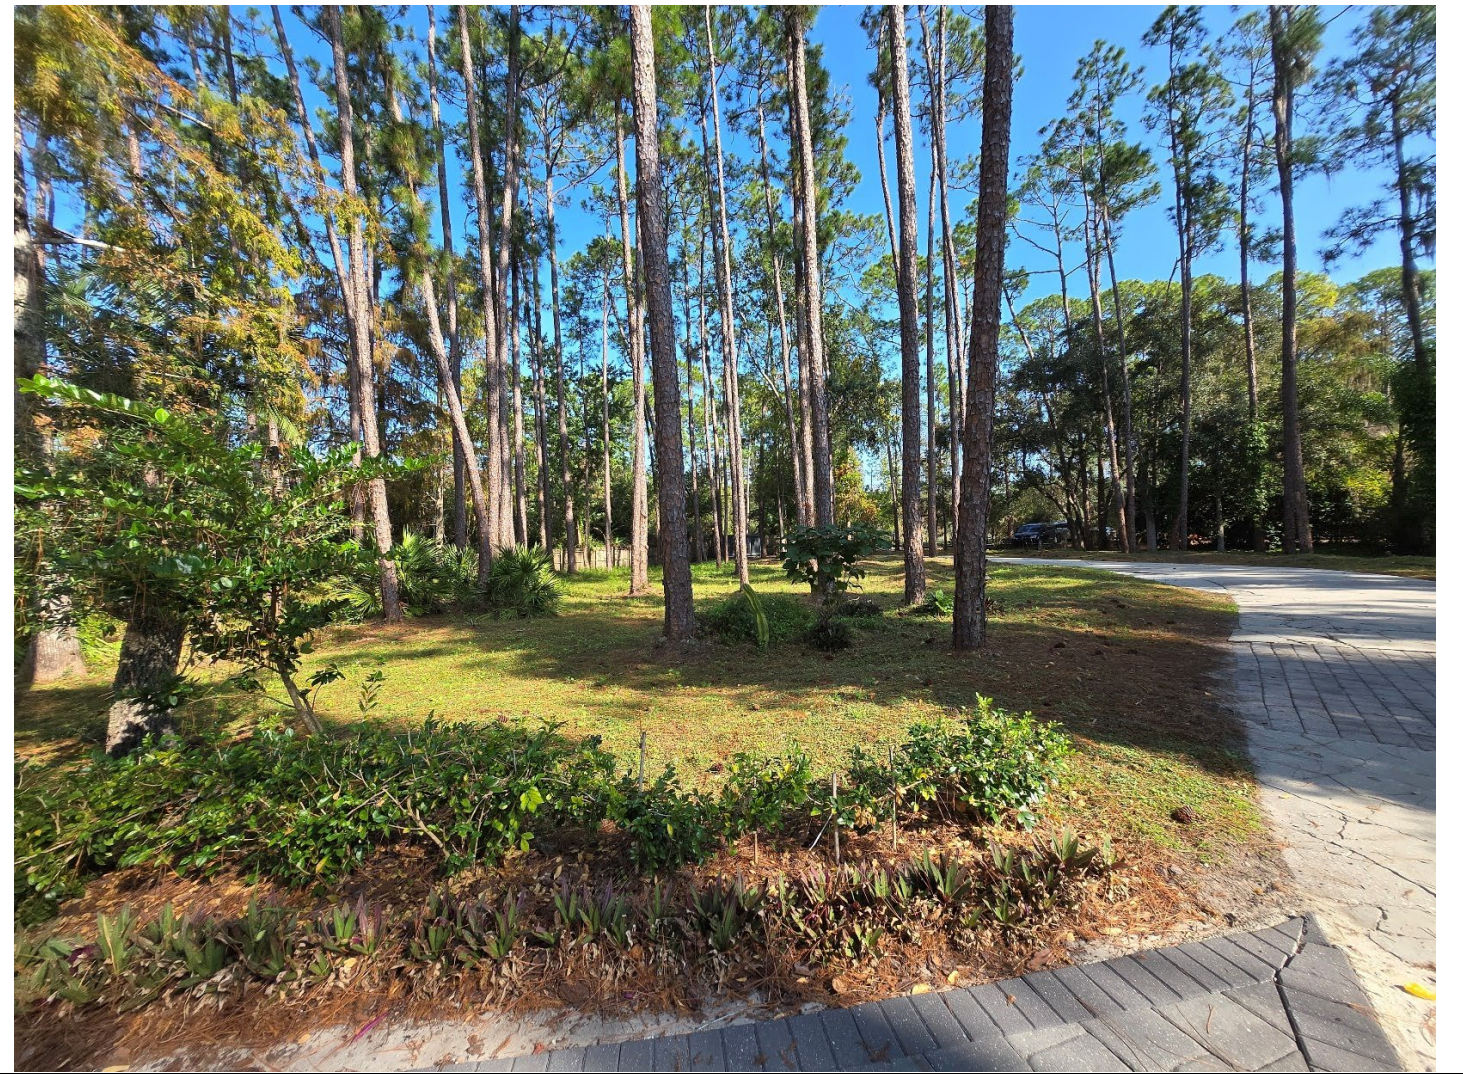
R1 – View looking northwest to northwest from driveway; area to have fill removed, non-native plants removed, and understory shrubs planted among existing.

R1 - 0.132 ac, W2a fill to be removed and supplemental planting of shrubs under slash pine canopy

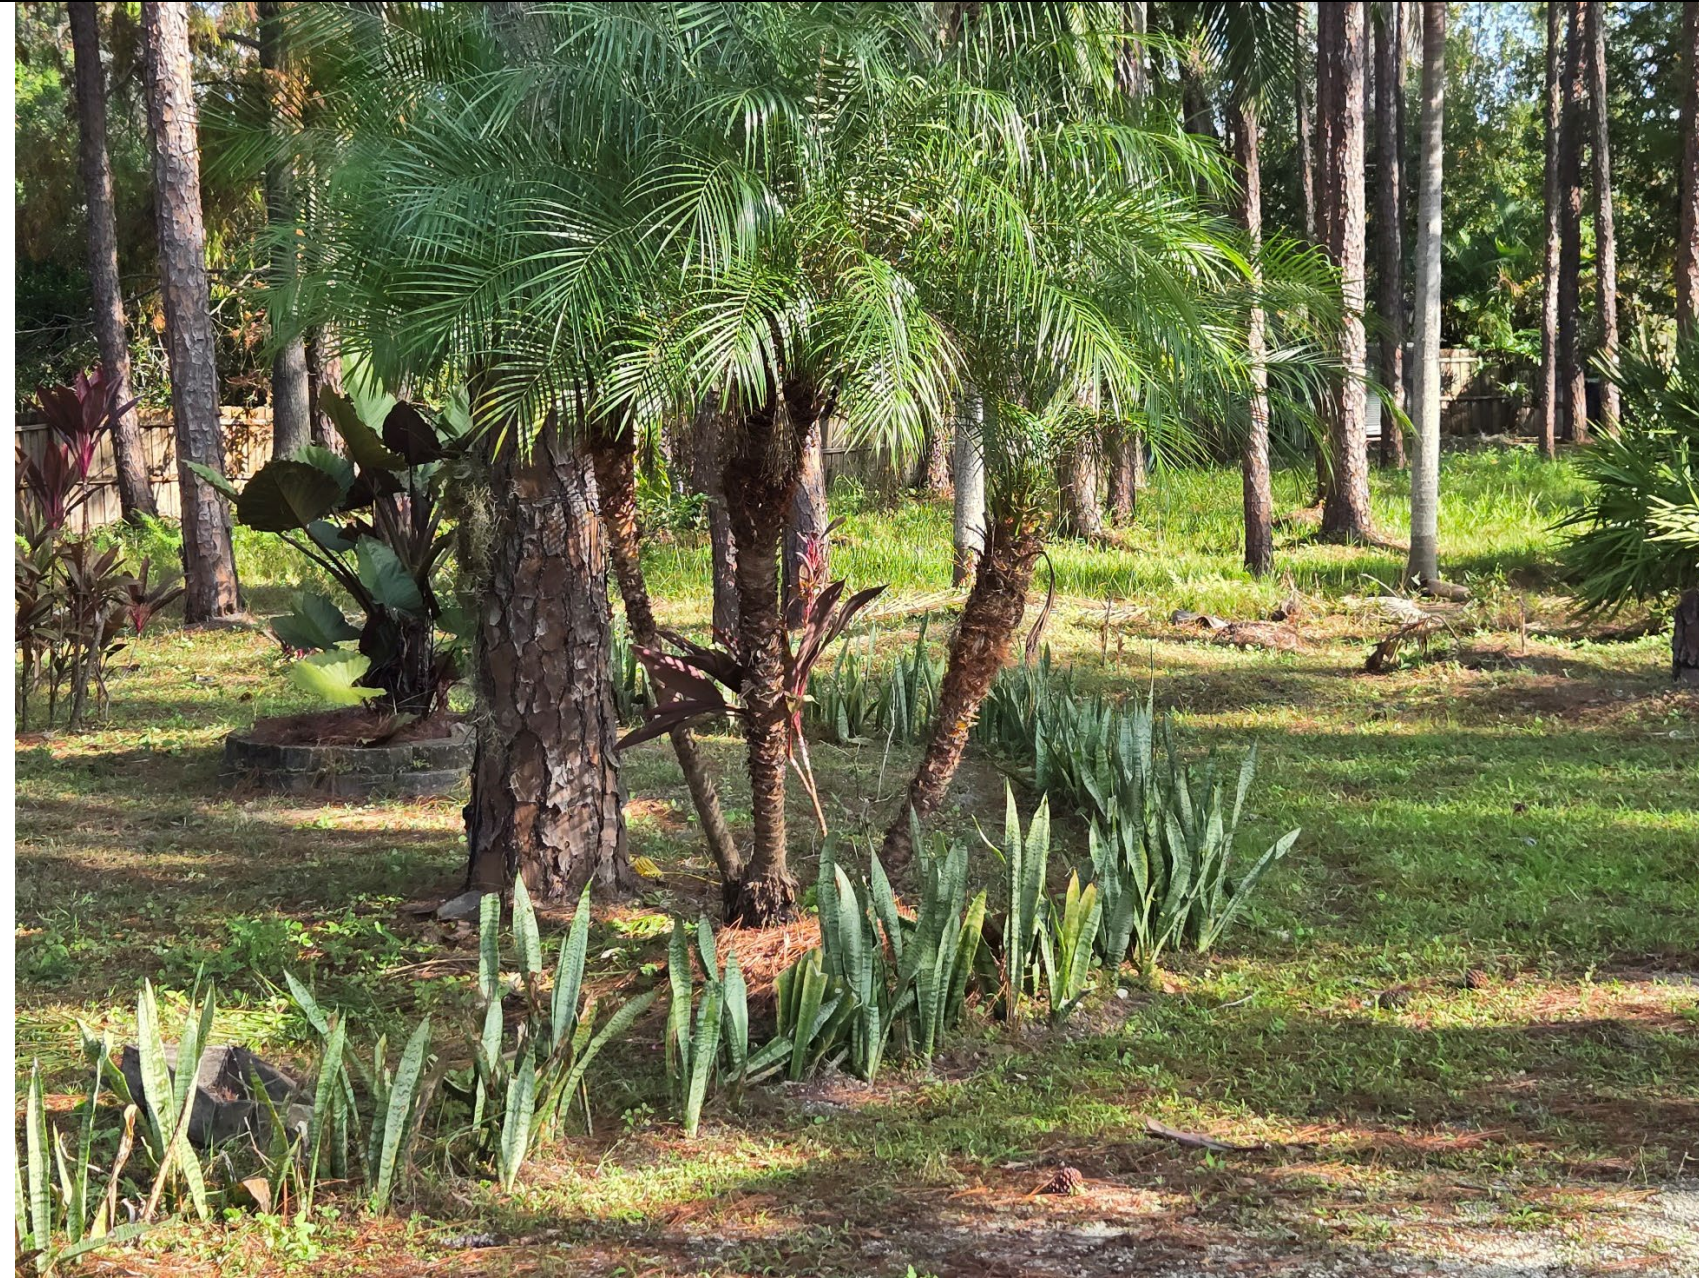
R1 View looking north/northeast from driveway; fill and non-native plants to be removed.

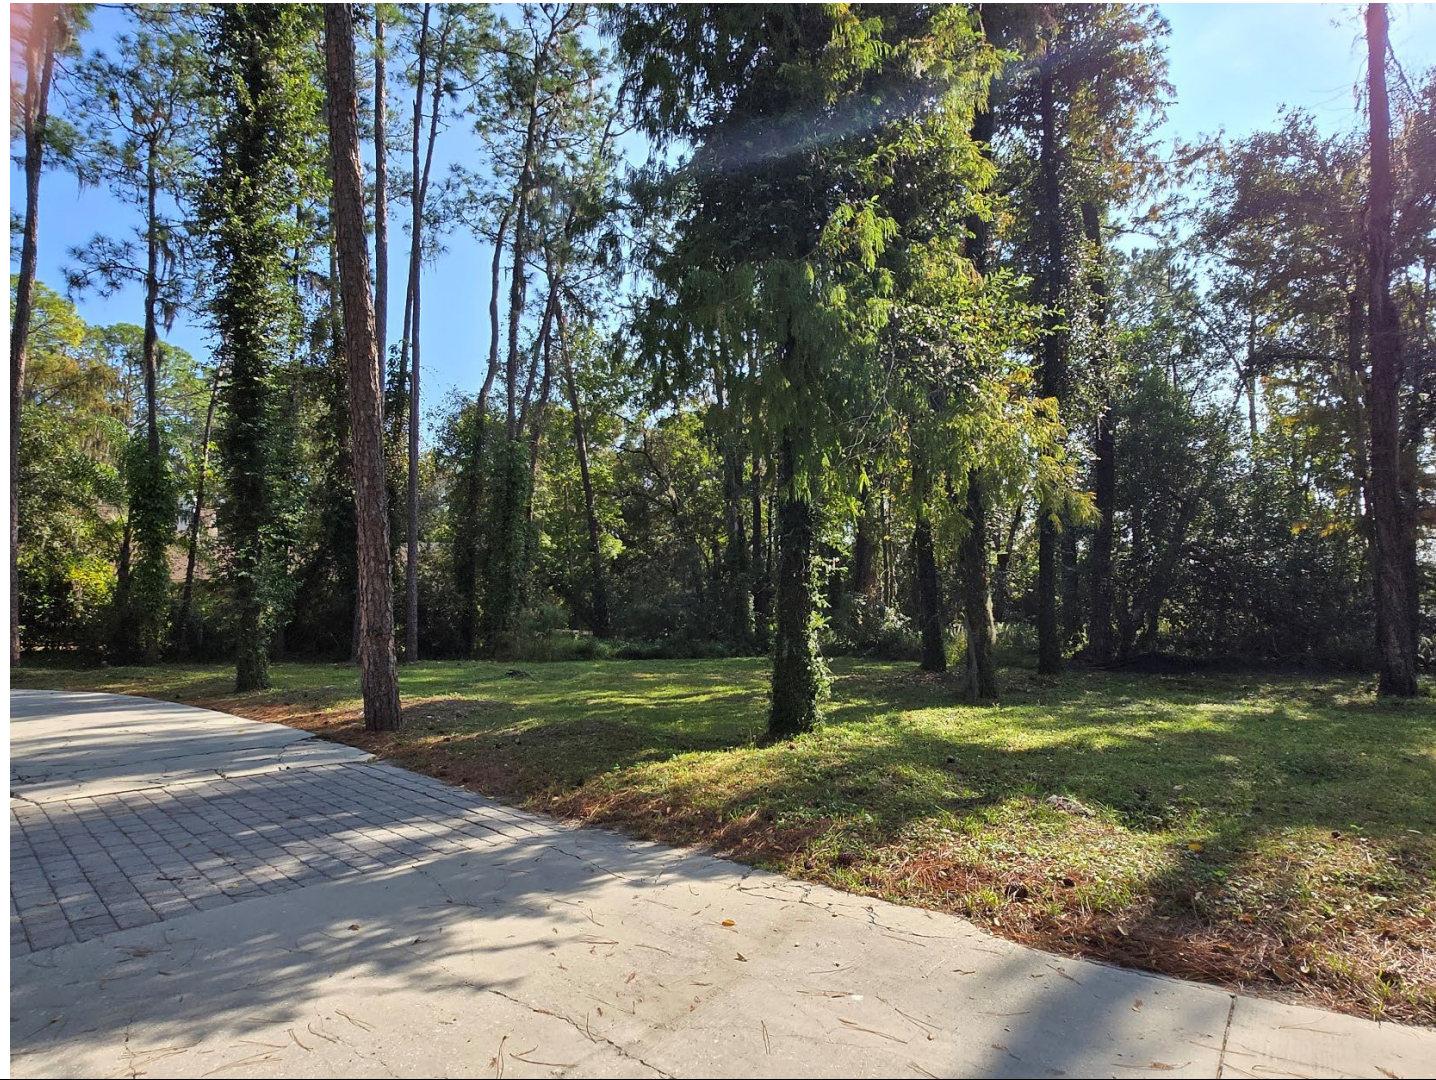
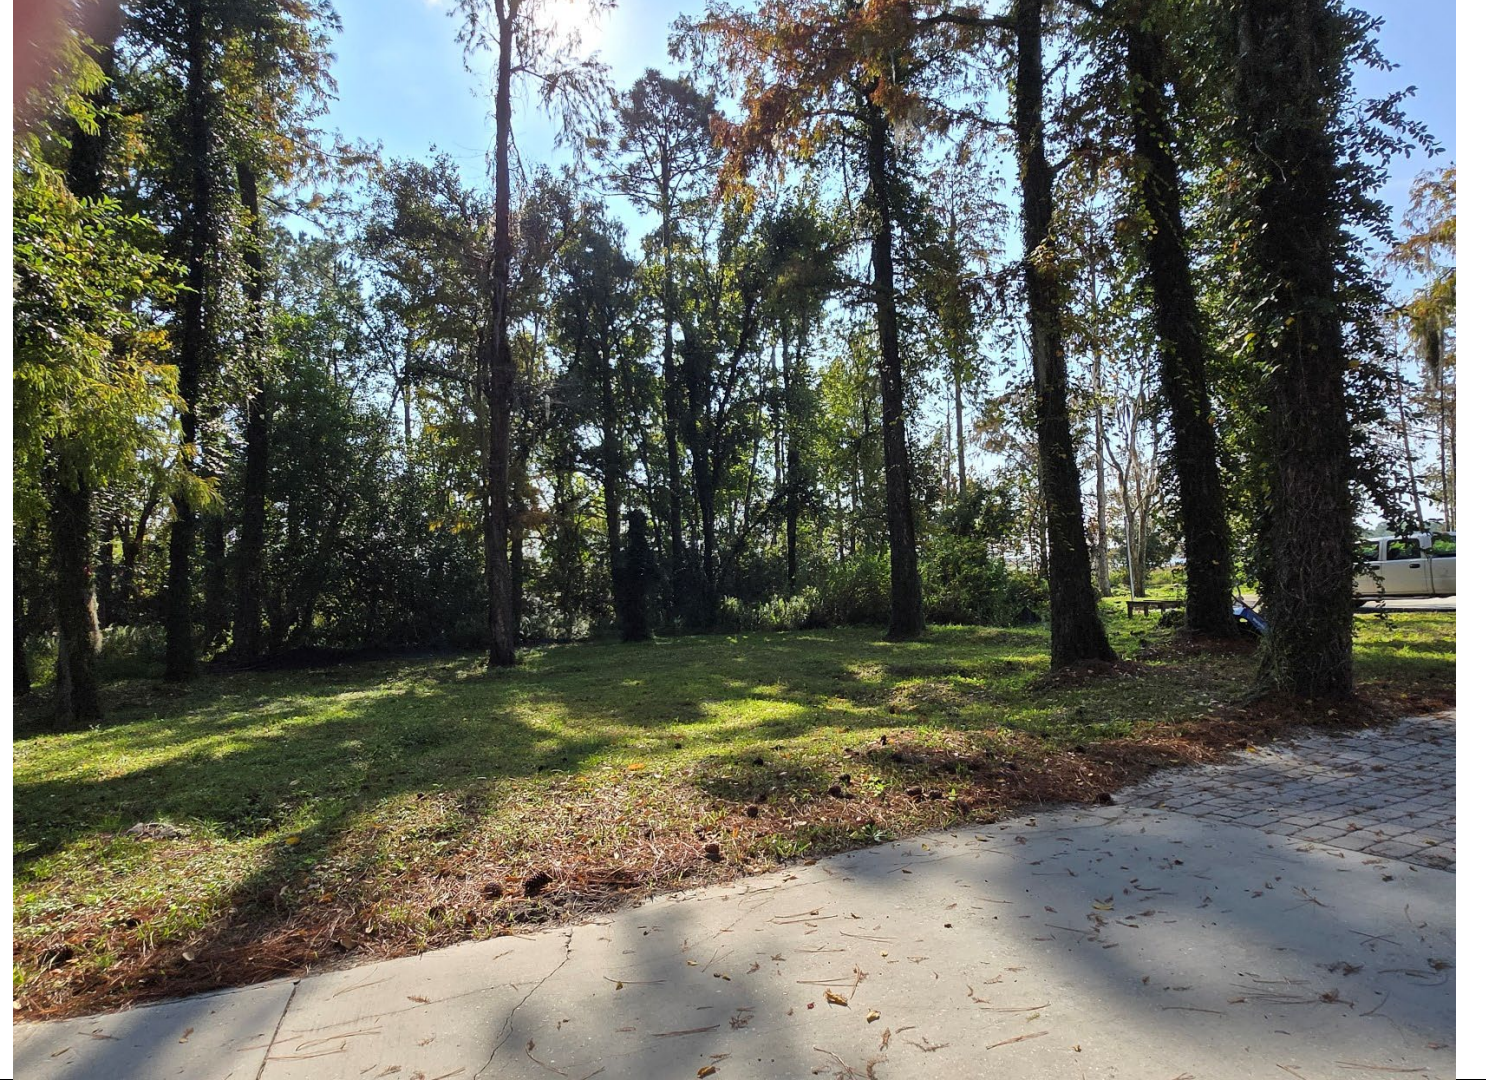
R2 – Views looking east/southeast to southwest from driveway; fill to be removed; supplemental planting of trees, shrubs, ferns. Creeping fig on trees to be treated as would be climbing fern by cutting lower section and treating base with herbicide

R2 - 0.335 ac, W2b fill to be removed and supplemental planting of trees and shrubs under existing canopy of slash pine with bald cypress.

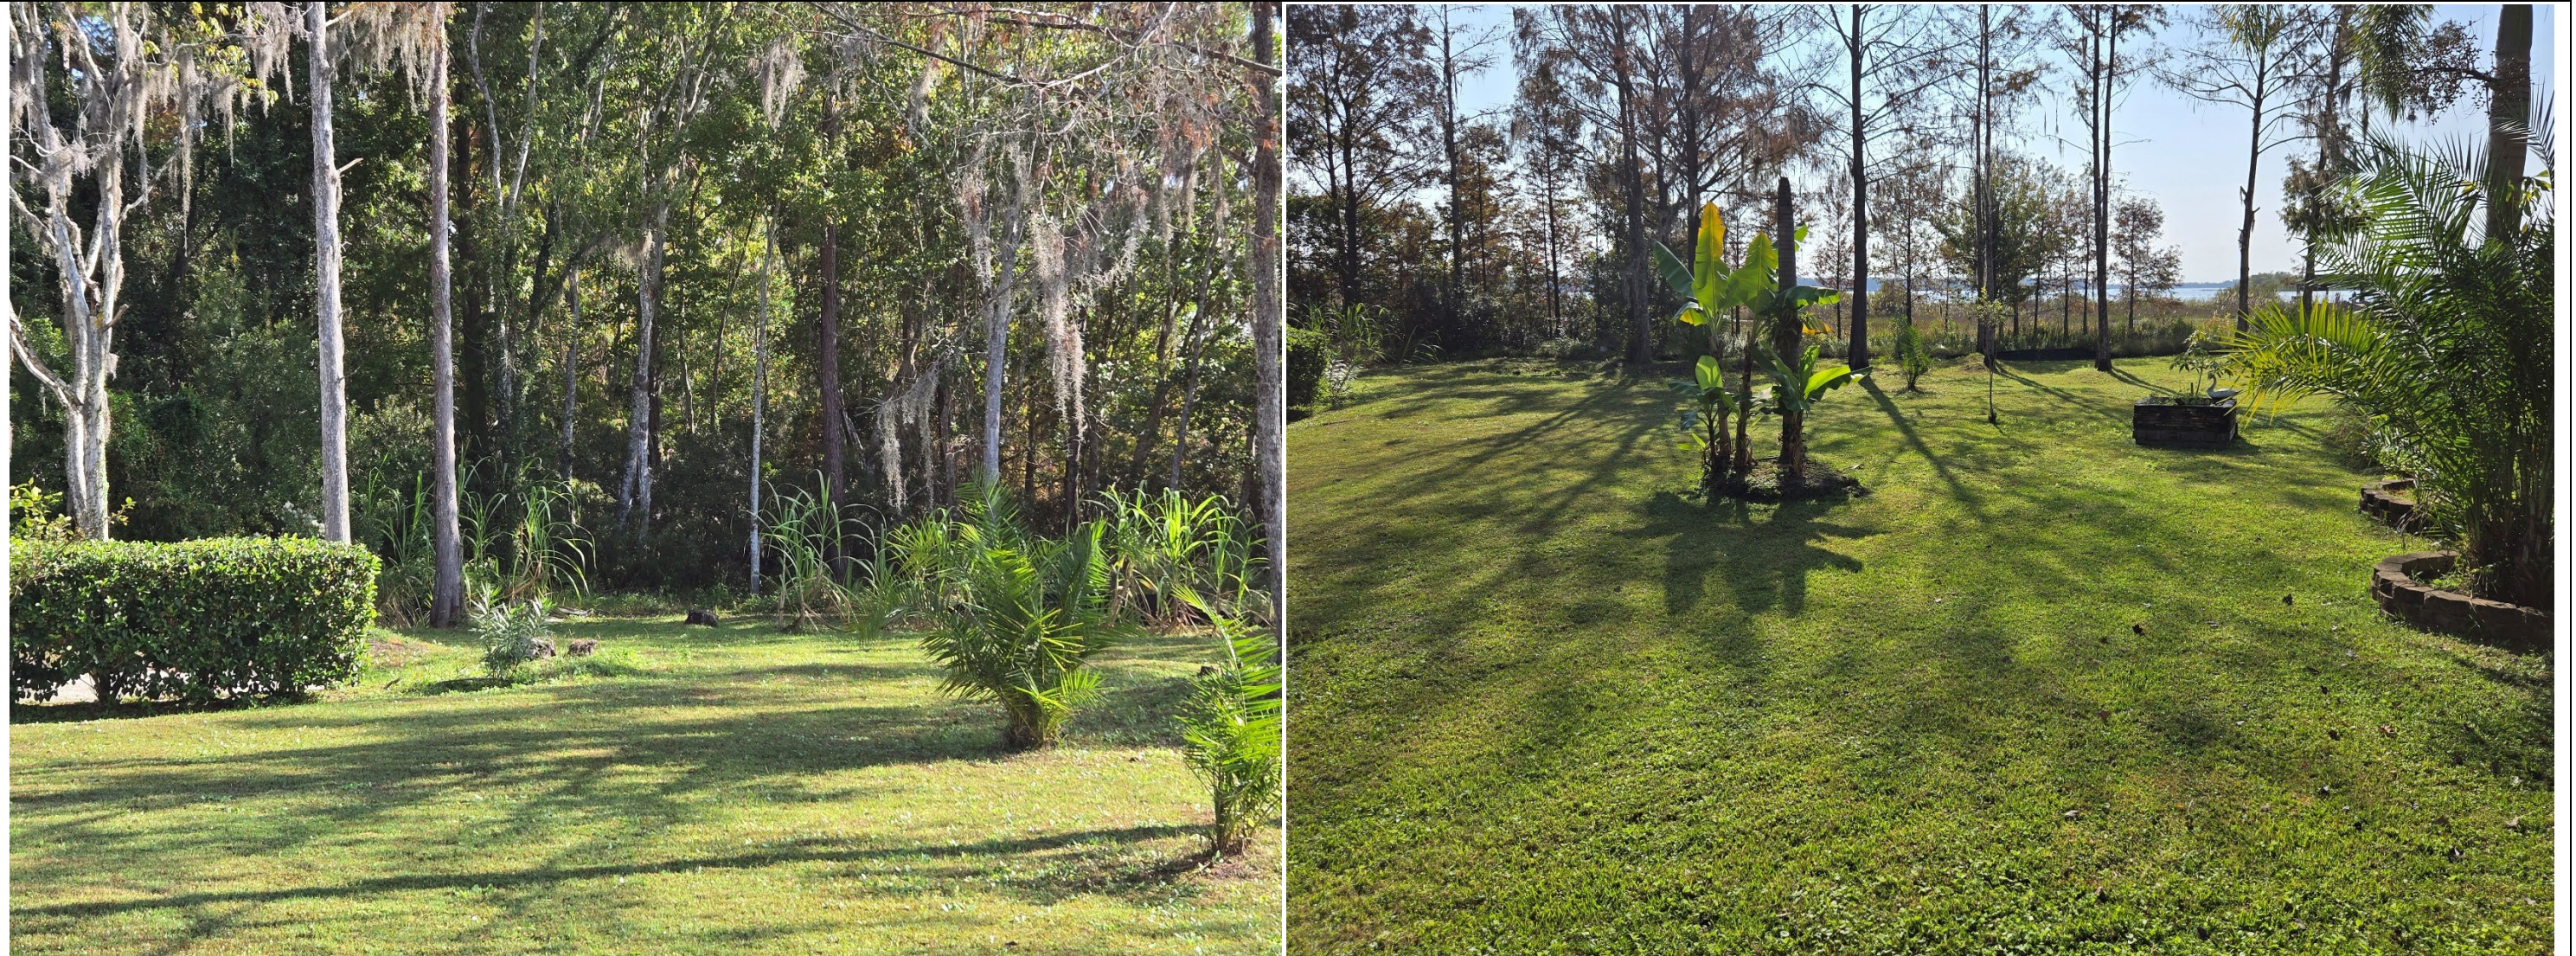
R 3 Views looking east then south toward lake and boardwalk. Fill, concrete pad, small structures and non-native landscape plants to be removed. Native canopy trees to remain; supplemental planting with native trees, shrubs, with natural herbaceous recruitment

R3 - 0.681 ac, W1a fill to be removed and historic 615 to be replanted with wetland trees and shrubs; herbaceous to recruit from adjacent wetland

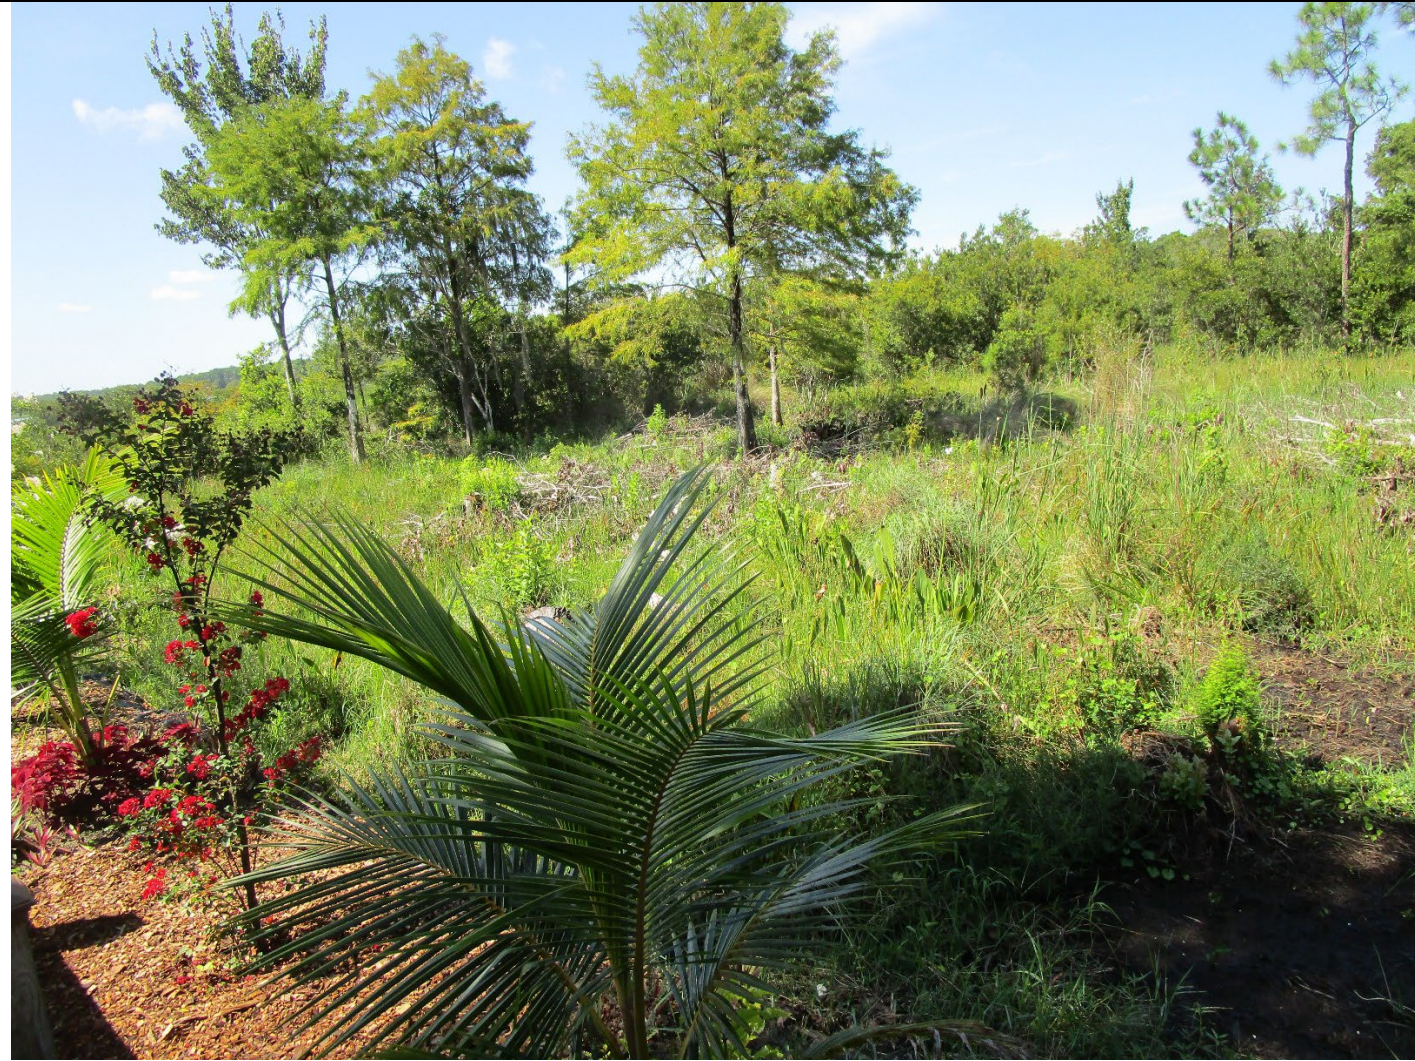
R4 in foreground and edge of dock on left edge; August 2022; in 2025 non-native plants have been removed. Fill to be removed.

R4 - 0.0059 ac, W1b fill to be removed along boardwalk and 615 vegetation to recruit from adjacent unfilled wetland.

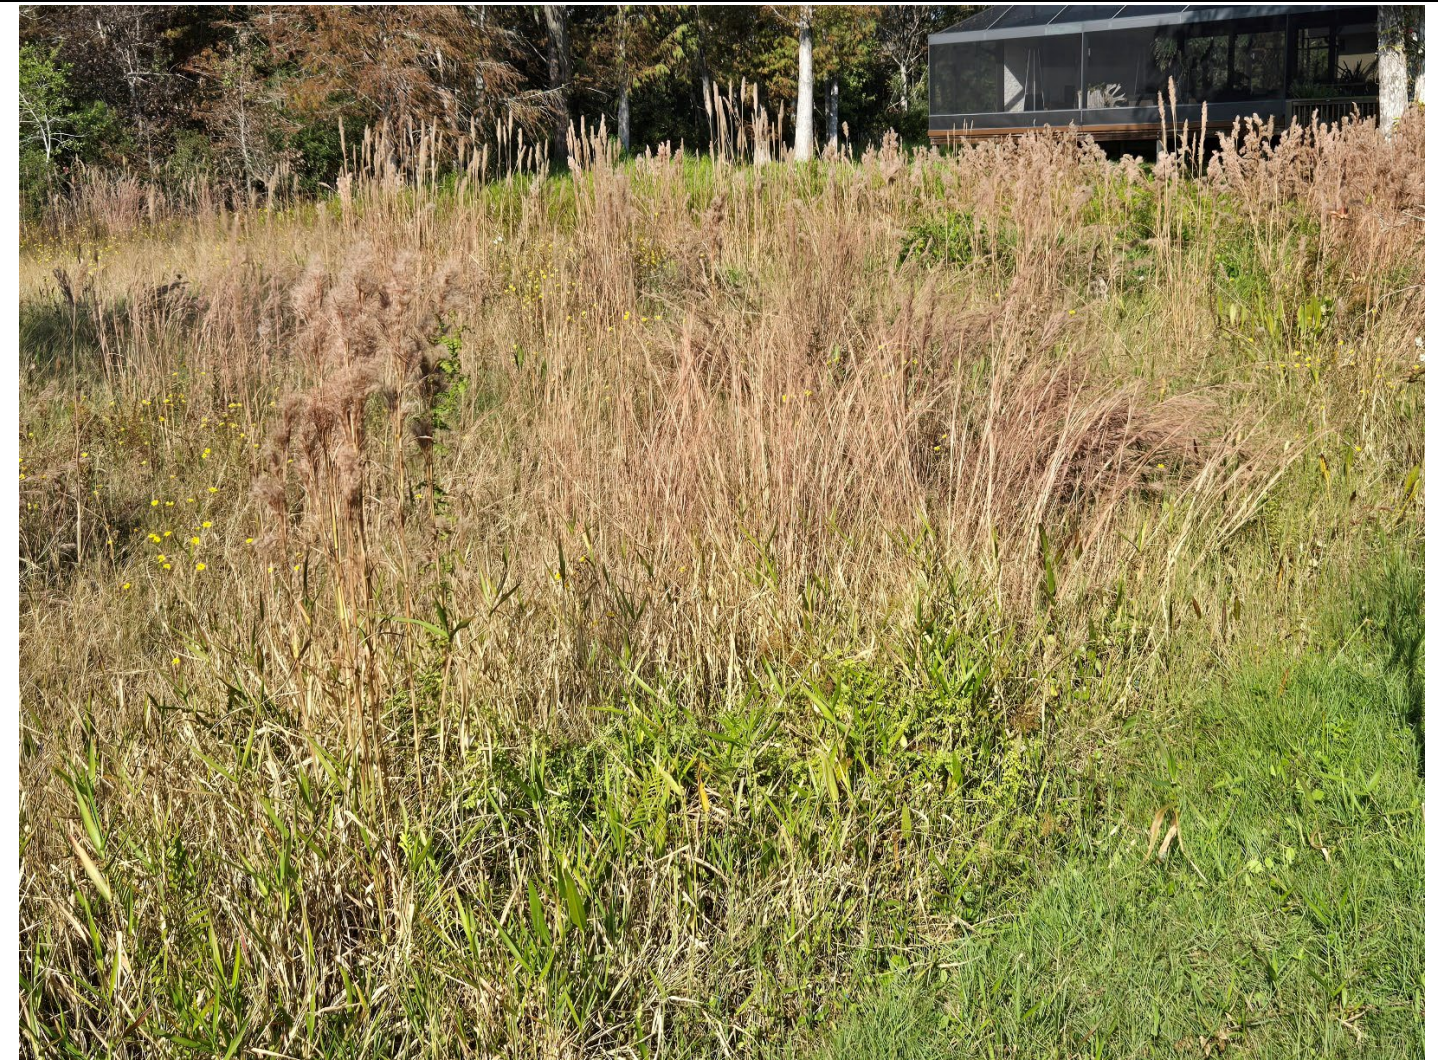
R5 photo taken November 2025; naturally regrowing; no planting. Edge in right foreground is R4 along boardwalk

R5 - 0.149 ac, W1b. Invasive species including small areas of cogon grass along edge, umbrella sedge clump, few scattered climbing fern to be mechanically removed (the sedge) or treated with appropriate herbicide concurrent with cogon grass treatment in R6. 615 vegetation to recruit from adjacent unfilled wetland.

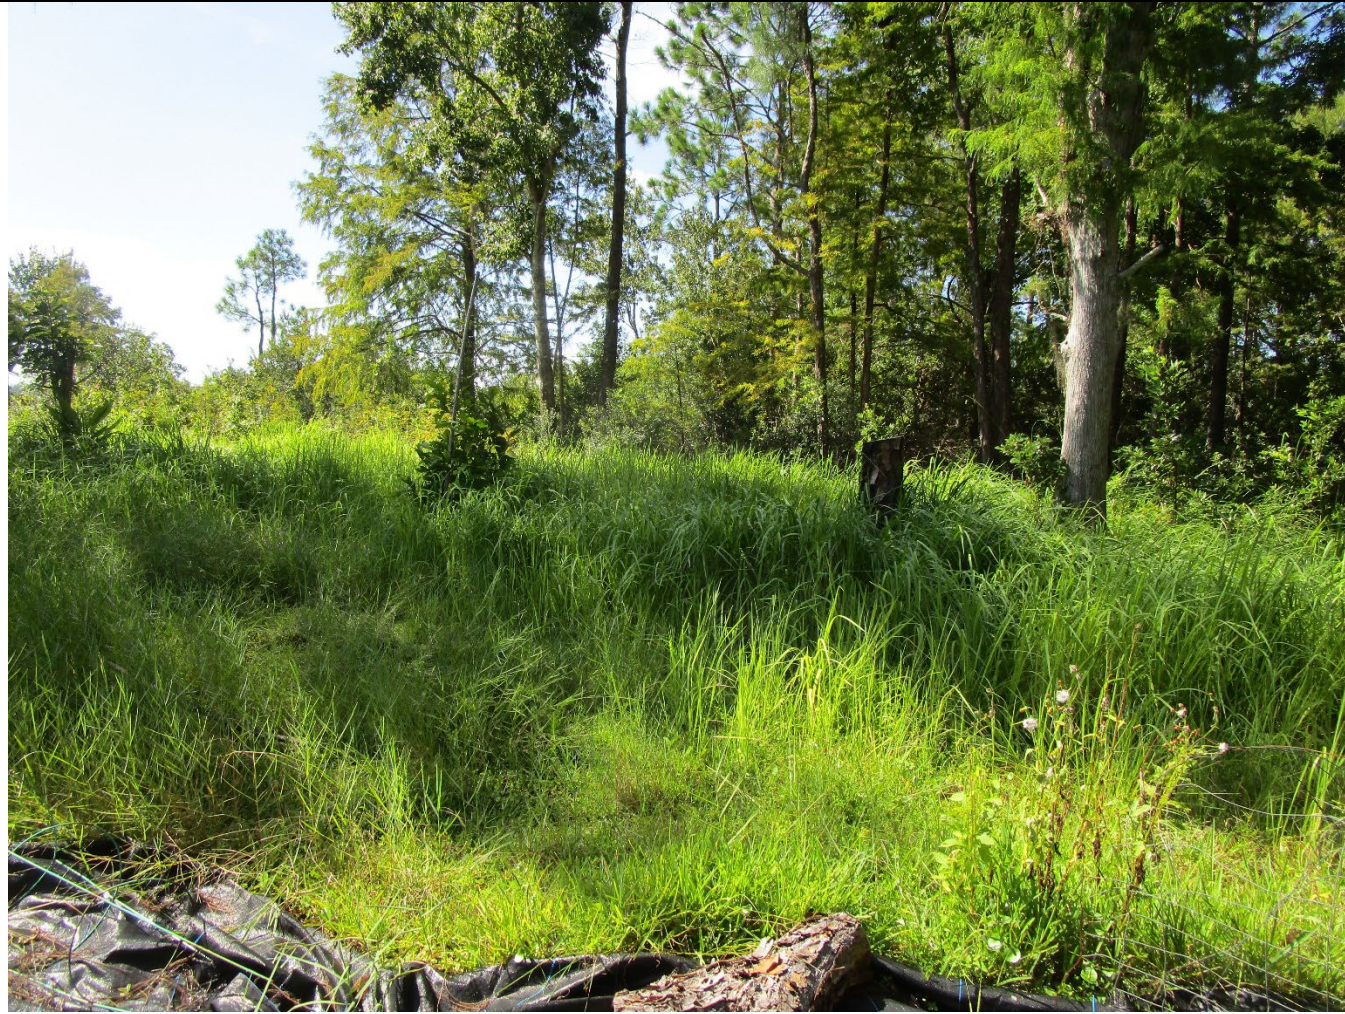
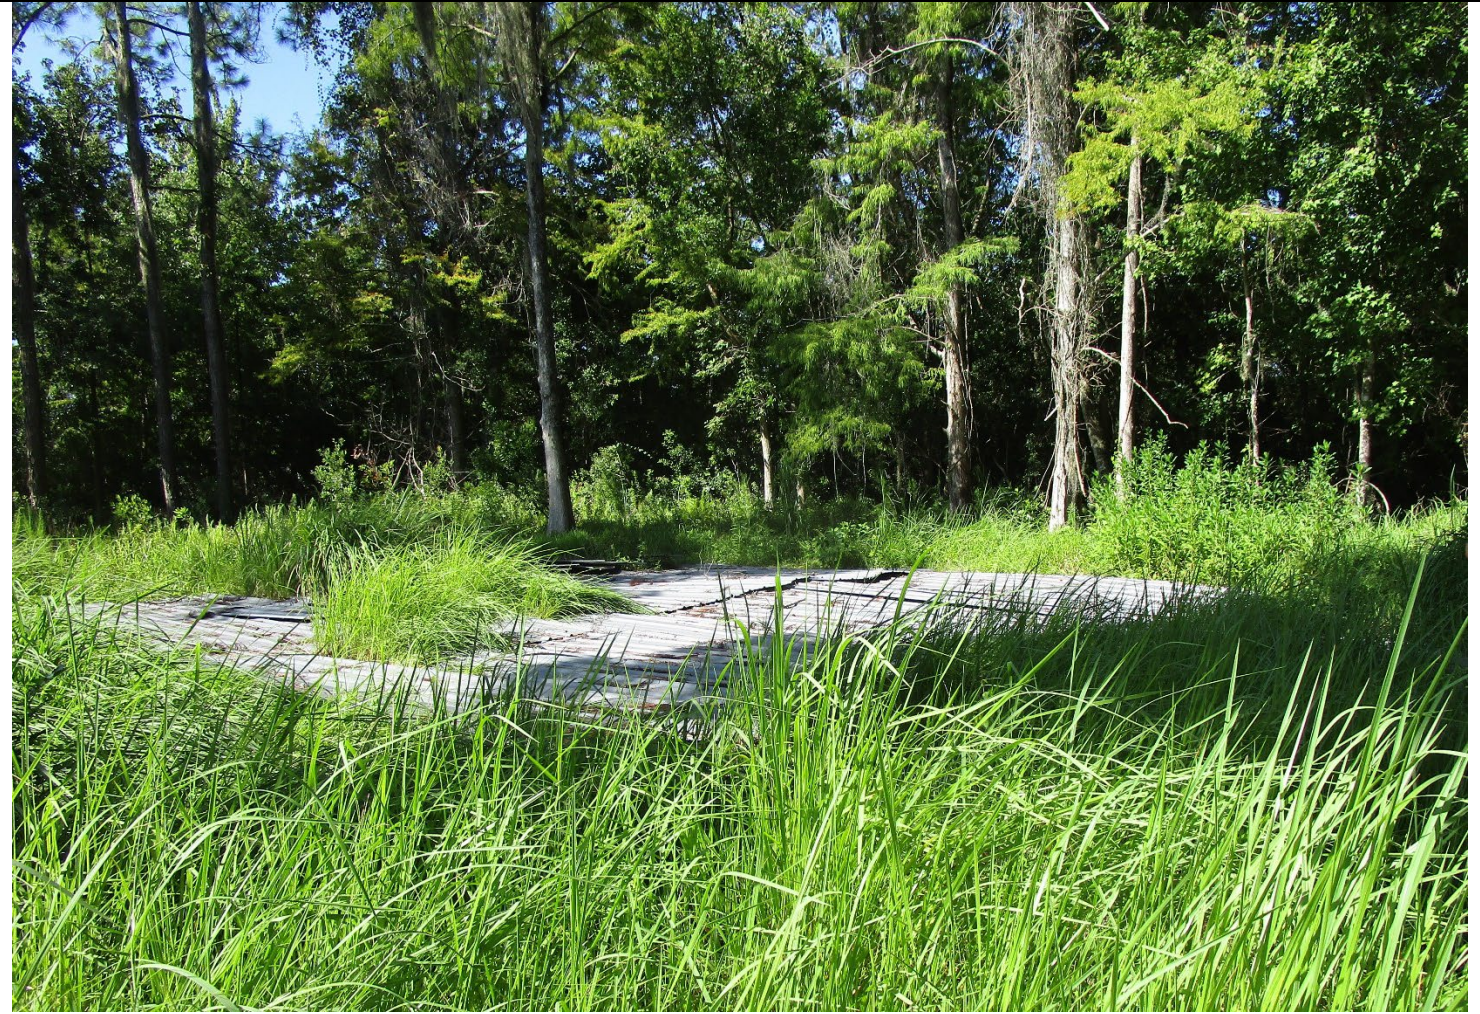
R6 View looking southwest toward lake and west toward intact forested wetland. Cogon grass area west of house. Property owner hired contractor to treat cogon and treatment began on 12/8/2025 (photos from 2023. Area has been mowed near house and will be allowed to regrow as necessary through cogon grass treatment. Area to be replanted with supplemental trees and shrubs once cogon is reduced to manageable cover (to be determined).

R6 - 0.334 ac, W1b. Phase 1 Herbicide Immediate: Invasive cogon grass to be treated (herbicide/mechanical reduction; repeat over time) 615 vegetation to recruit from adjacent unfilled wetland. After cogon is under control with periodic treatments, additional canopy and shrubs to be planted in approximately half the area (0.167 ac)
