CSER
McCulloch Road Roadway
Conceptual Analysis Study, from
N. Orion Blvd. to N. Tanner Road
Orange County, Florida
NADIC Project No.:
PR.GEO-RD20007.1

Re: Contamination Screening Evaluation Report
McCulloch Road Roadway Conceptual Analysis Study
(North Orion Boulevard to North Tanner Road)
Orange County, Florida
Orange County Project No.: Y20-827-CH
NADIC Proposal No. PQ.GEO-RD21007.1

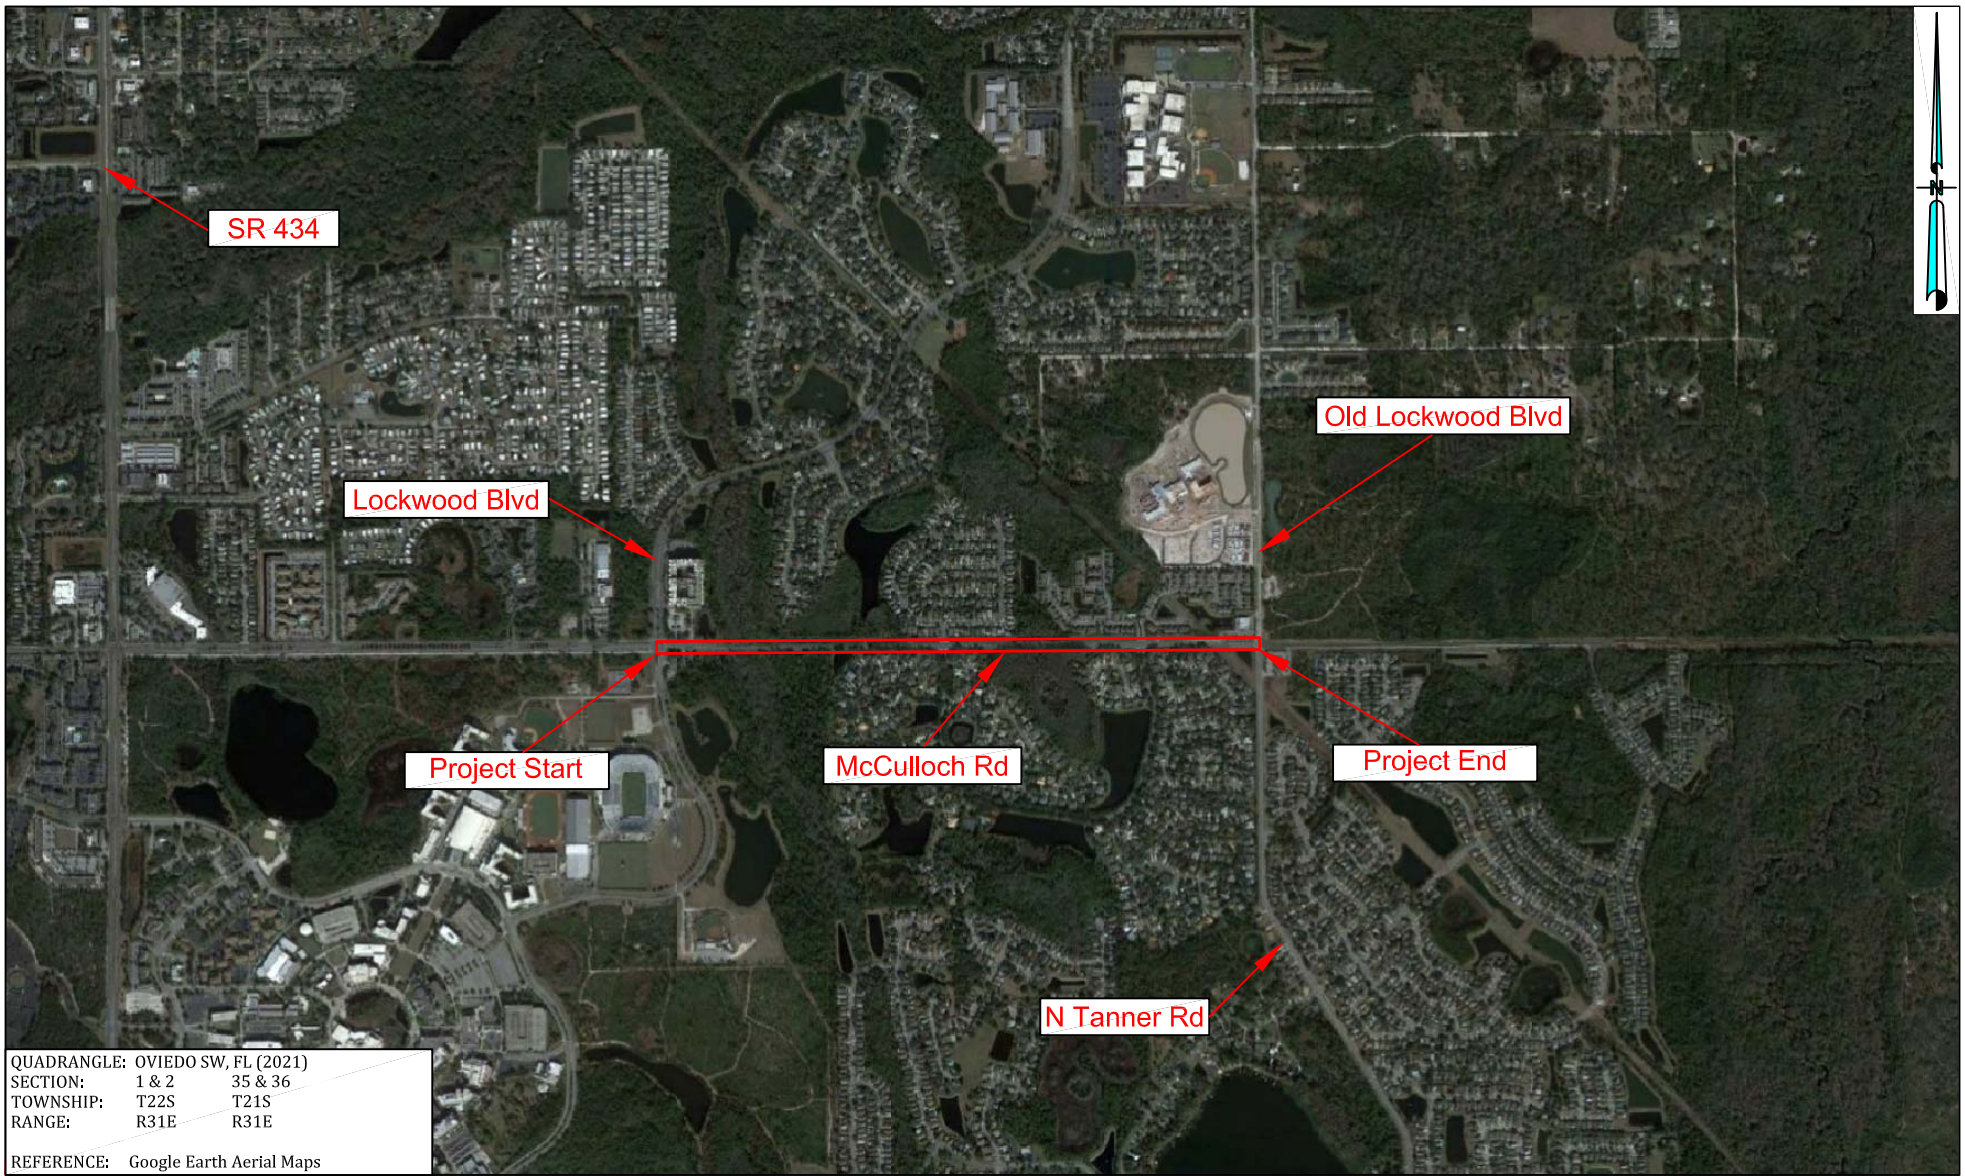
FIGURE 1
 VICINITY MAP
 PROJECT NAME:
**MCCULLOCH ROAD
 ROADWAY CONCEPTUAL
 ANALYSIS (RCA)**

The study corridor along McCulloch Road begins at North Orion Boulevard and proceeds east approximately 1.3 miles to North Tanner Road. The vicinity map showing the approximate location of the proposed roadway improvements is shown on **Figure 1** in **Appendix A**. The site of the proposed improvements is generally located in Sections 1, 2, 35 and 36, Township 22 South, Range 31 East, in Oviedo SW, Florida.

QUADRANGLE: OVIEDO SW, FL (2021)
 SECTION: 1 & 2 35 & 36
 TOWNSHIP: T22S T21S
 RANGE: R31E R31E
 REFERENCE: Google Earth Aerial Maps

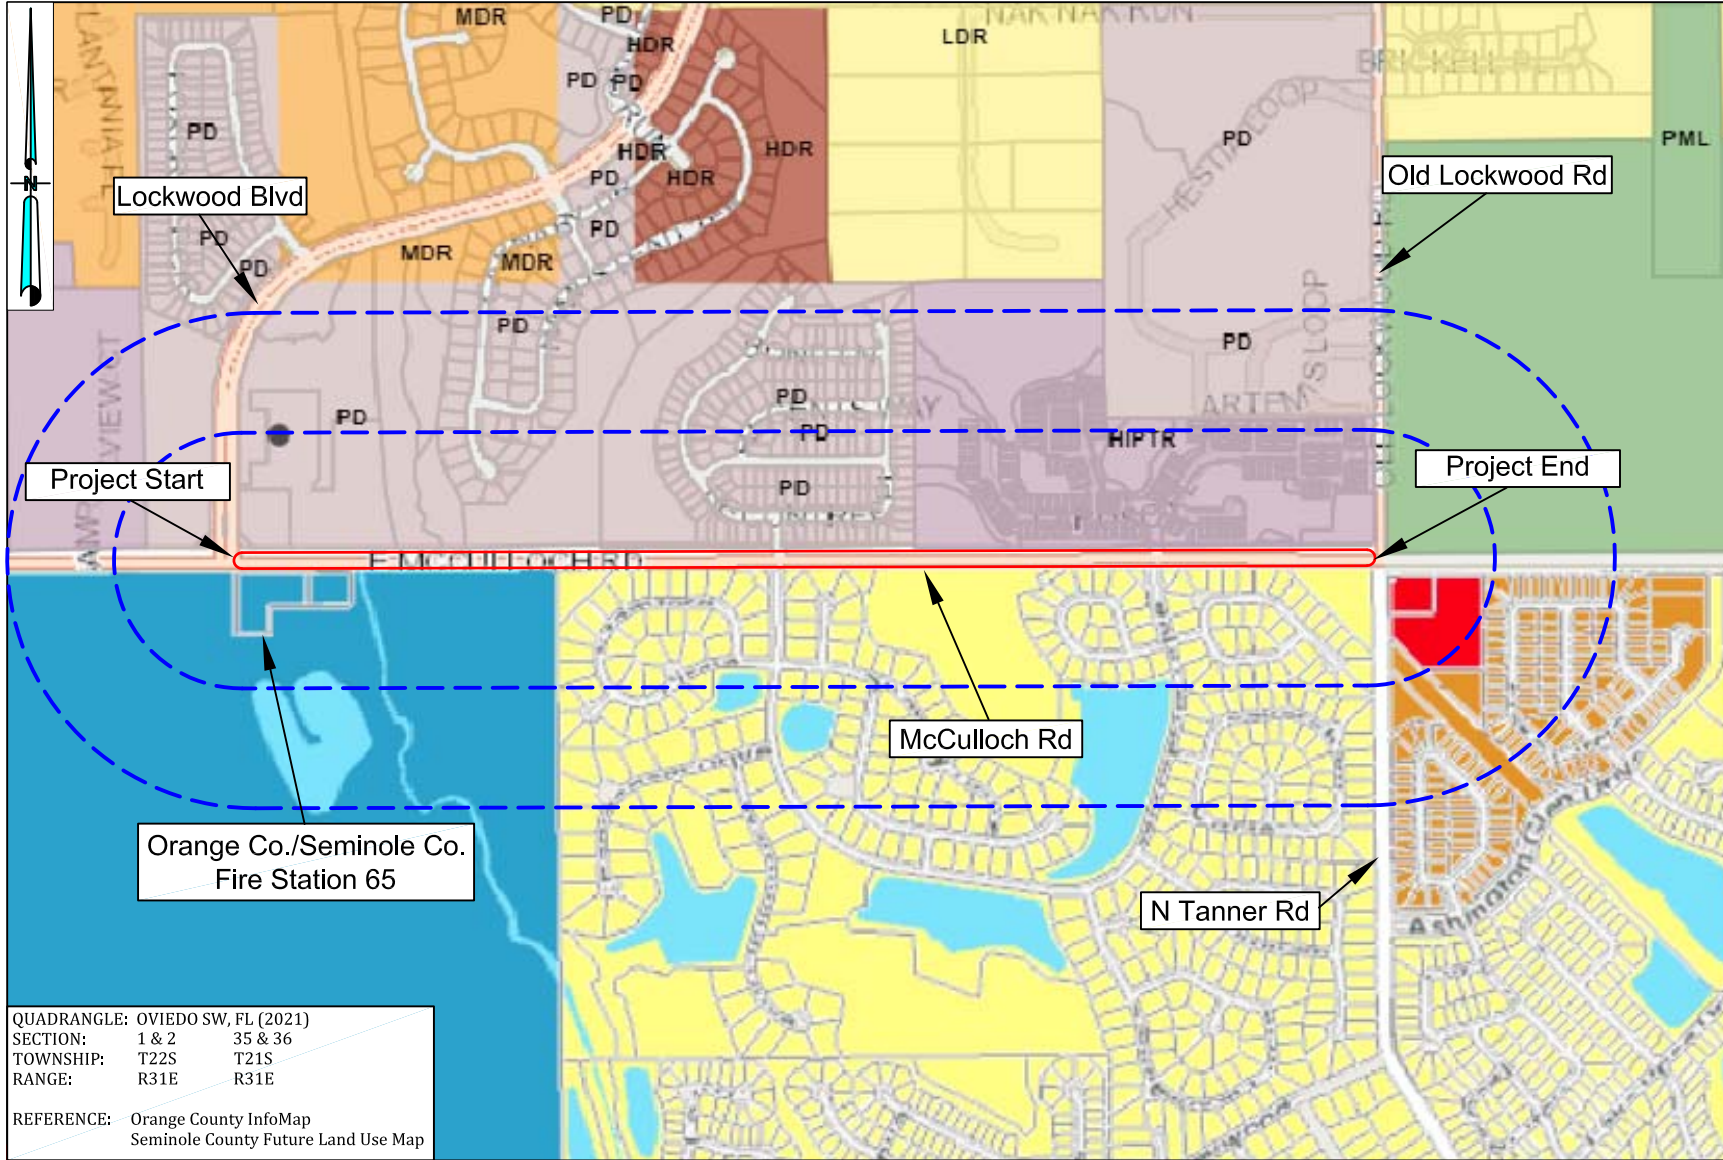
FIGURE 2
 LAND USE MAP

- High Density Residential
- Higher Intensity Planned Development Transitional
- Low Density Residential Development
- Medium Density Residential Development
- Planned Development
- Preservation/Managed Lands
- Low Density Residential
- Low-Medium Density
- Commercial
- Institutional
- Water Body
- Approximate Project Location
- Buffer Outline

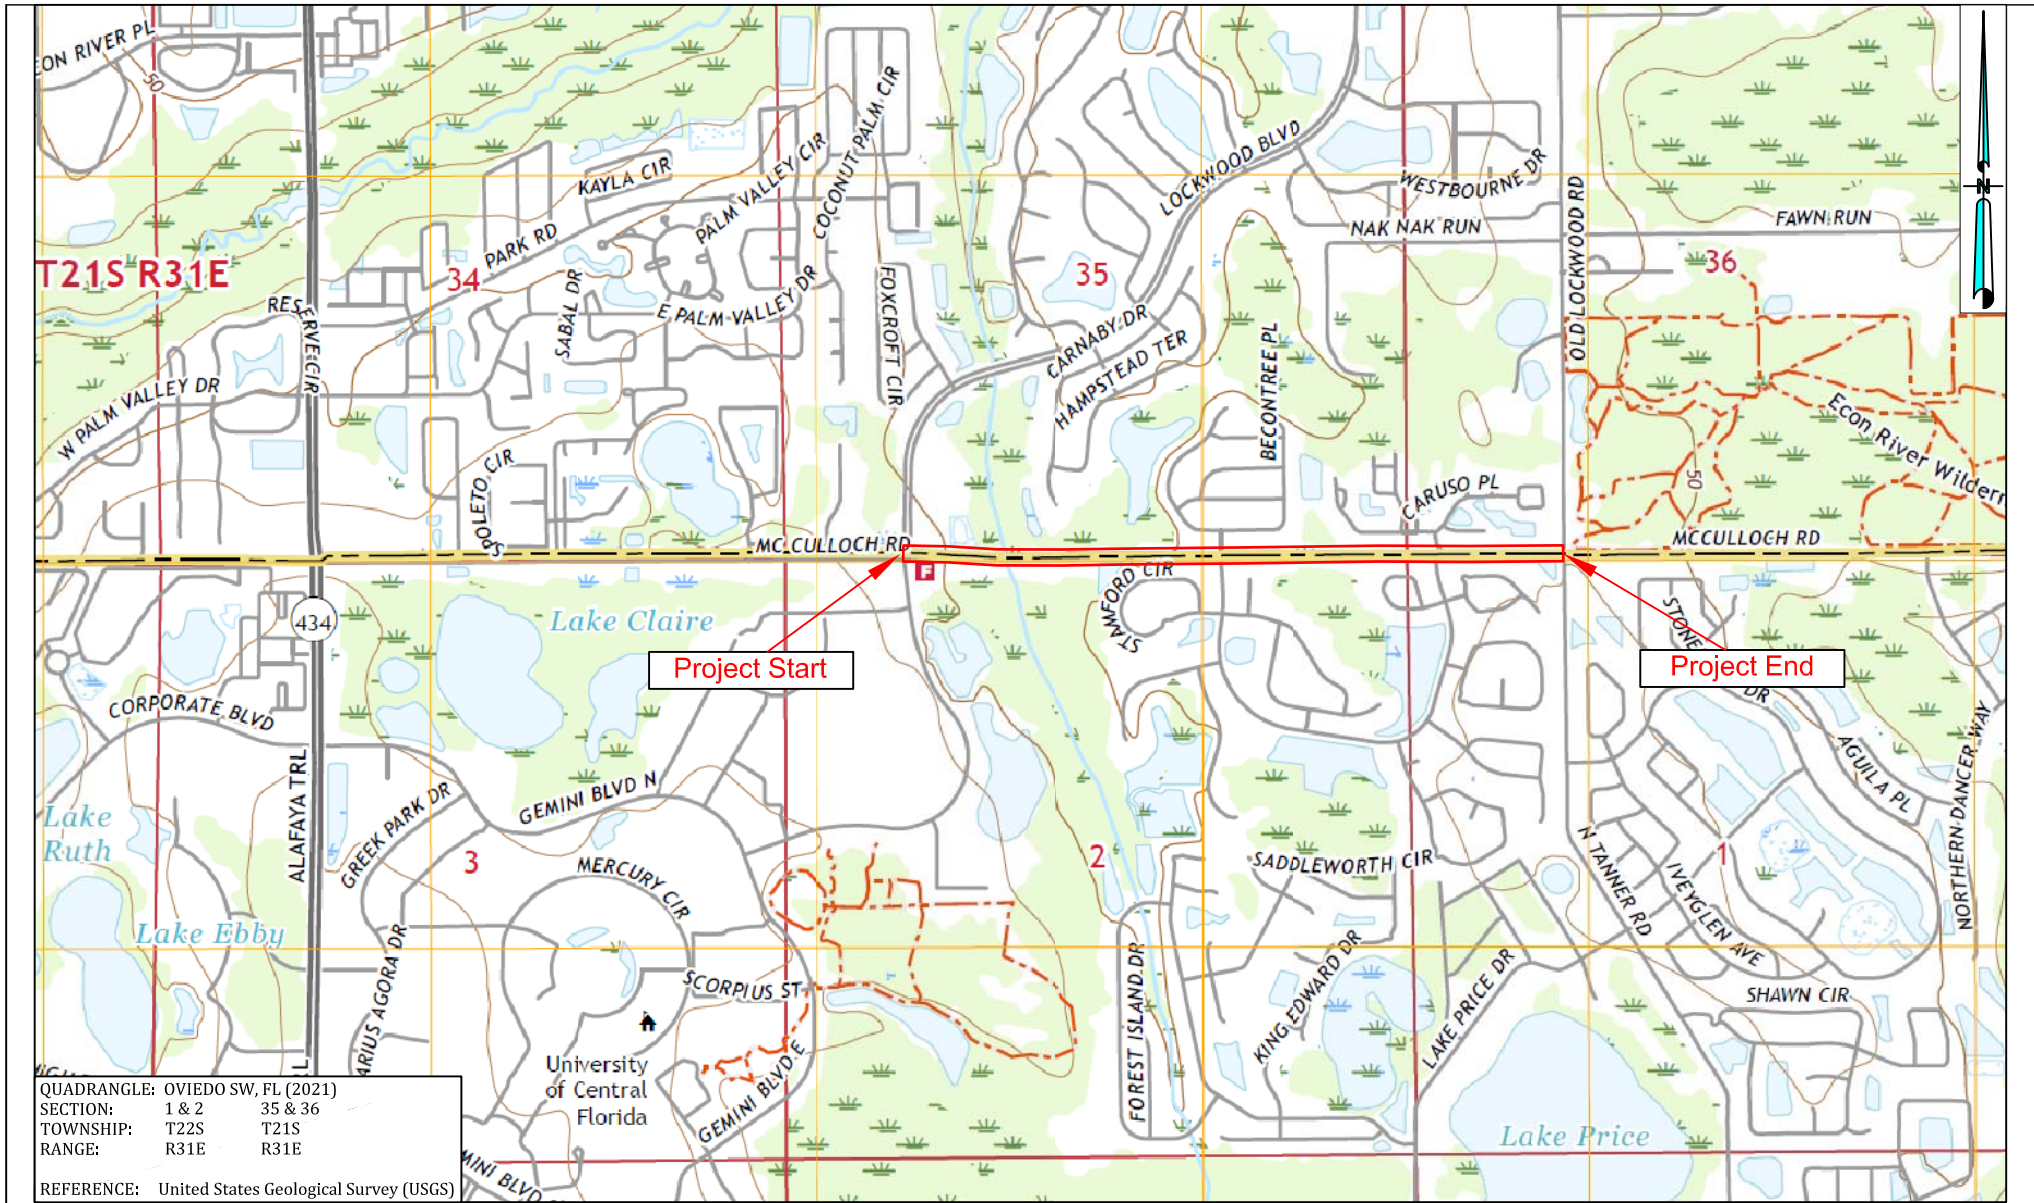
FIGURE 3
TOPOGRAPHIC MAP
PROJECT NAME:
MCCULLOCH ROAD ROADWAY CONCEPTUAL ANALYSIS (RCA)

QUADRANGLE: OVIEDO SW, FL (2021)
 SECTION: 1 & 2 35 & 36
 TOWNSHIP: T22S T21S
 RANGE: R31E R31E
 REFERENCE: United States Geological Survey (USGS)

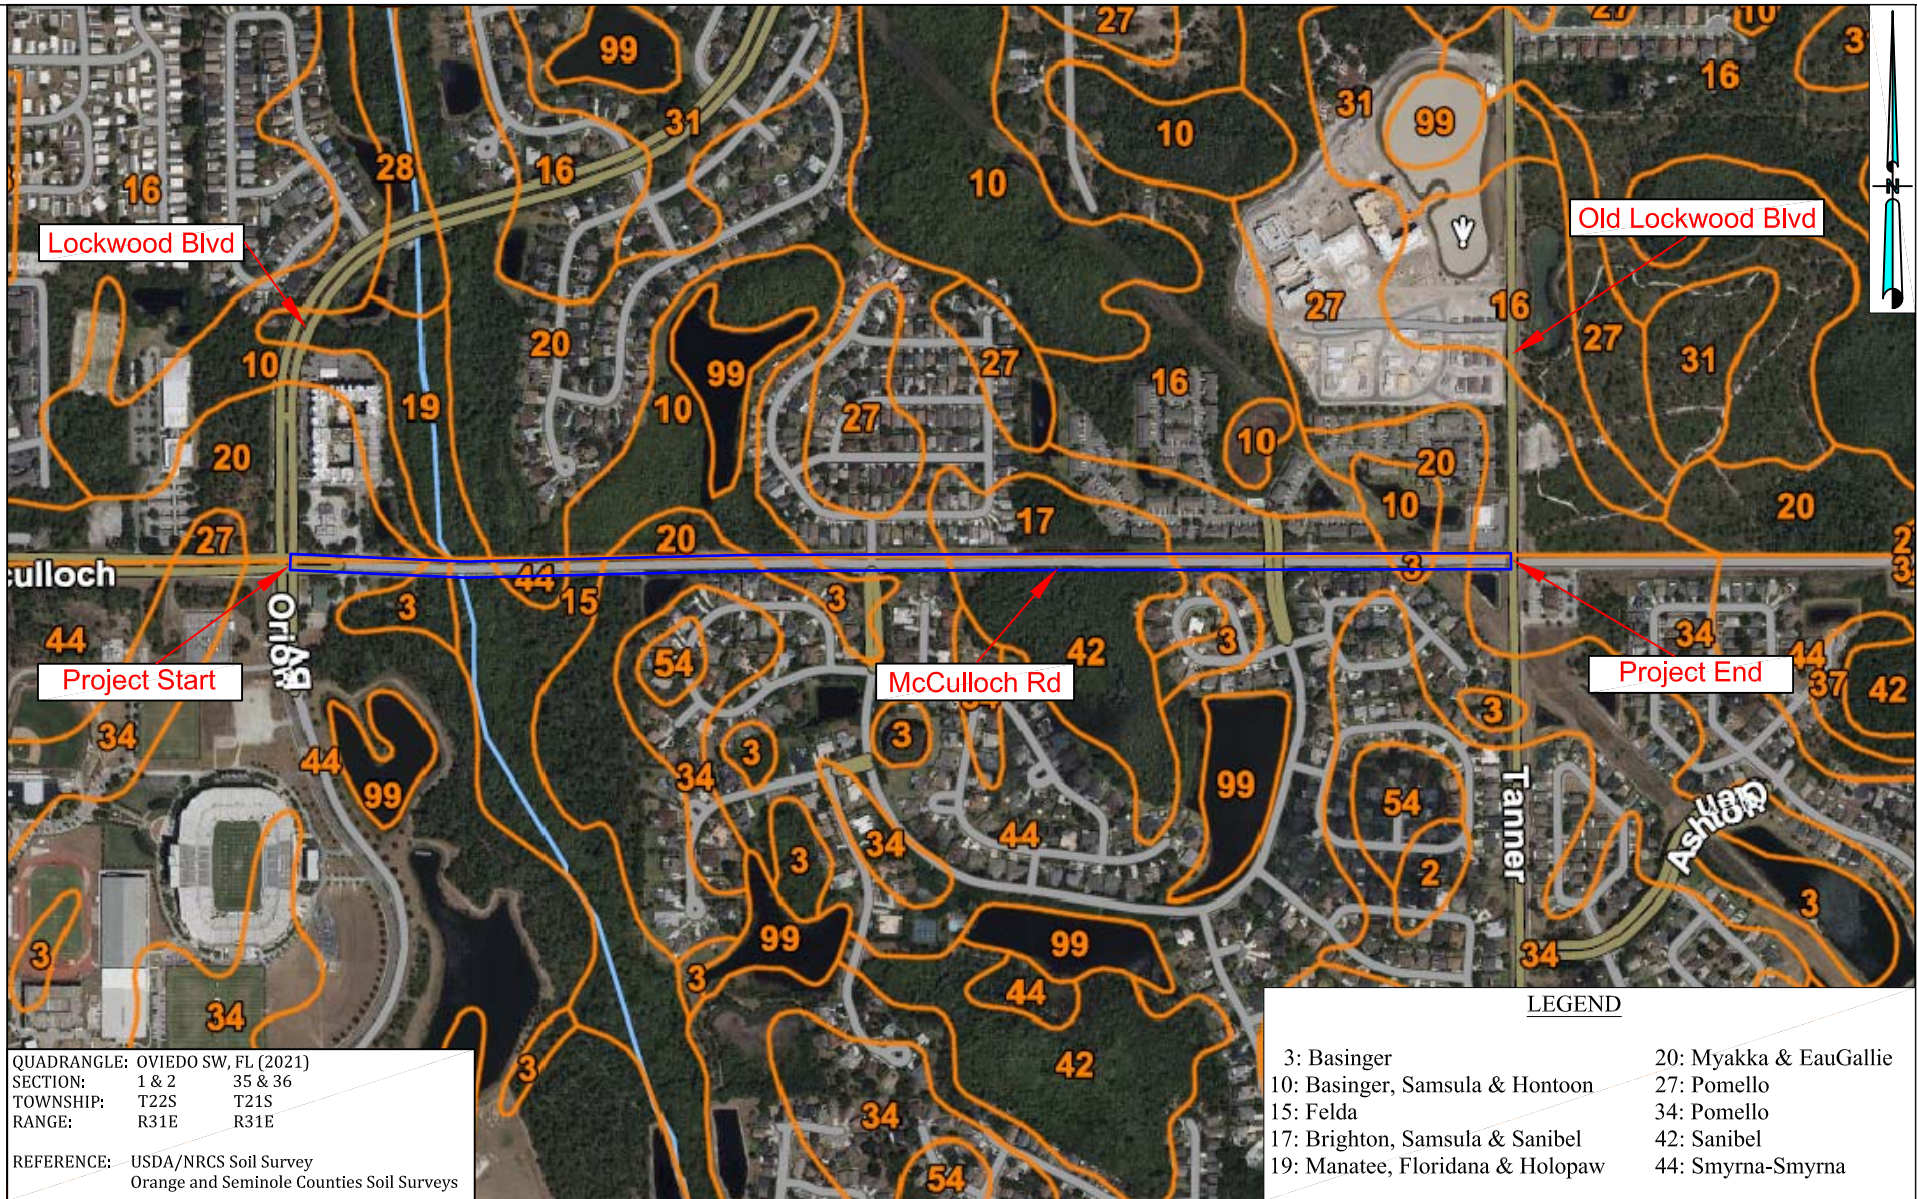
FIGURE 4
SOIL SURVEY MAP
PROJECT NAME:
MCCULLOCH ROAD ROADWAY CONCEPTUAL ANALYSIS (RCA)

LEGEND	
3: Basinger	20: Myakka & EauGallie
10: Basinger, Samsula & Hontoon	27: Pomello
15: Felda	34: Pomello
17: Brighton, Samsula & Sanibel	42: Sanibel
19: Manatee, Florida & Holopaw	44: Smyrna-Smyrna

The Orange and Seminole Counties Soil Survey published by the United States Department of Agriculture (USDA), Natural Resources Conservation Service (NRCS) is a comprehensive publishes source of information regarding near-surface soil and surficial groundwater depth. The NRCS Orange and Seminole Counties Soil Survey were reviewed for information regarding near-surface soil conditions within the study corridor.

Information from the NCRS Soil Survey is very general and may be outdated due to recent developments in the project site vicinity. Therefore, it may not reflect the actual soil and groundwater conditions, particularly if development has modified the natural soil conditions or surface and near surface drainage.

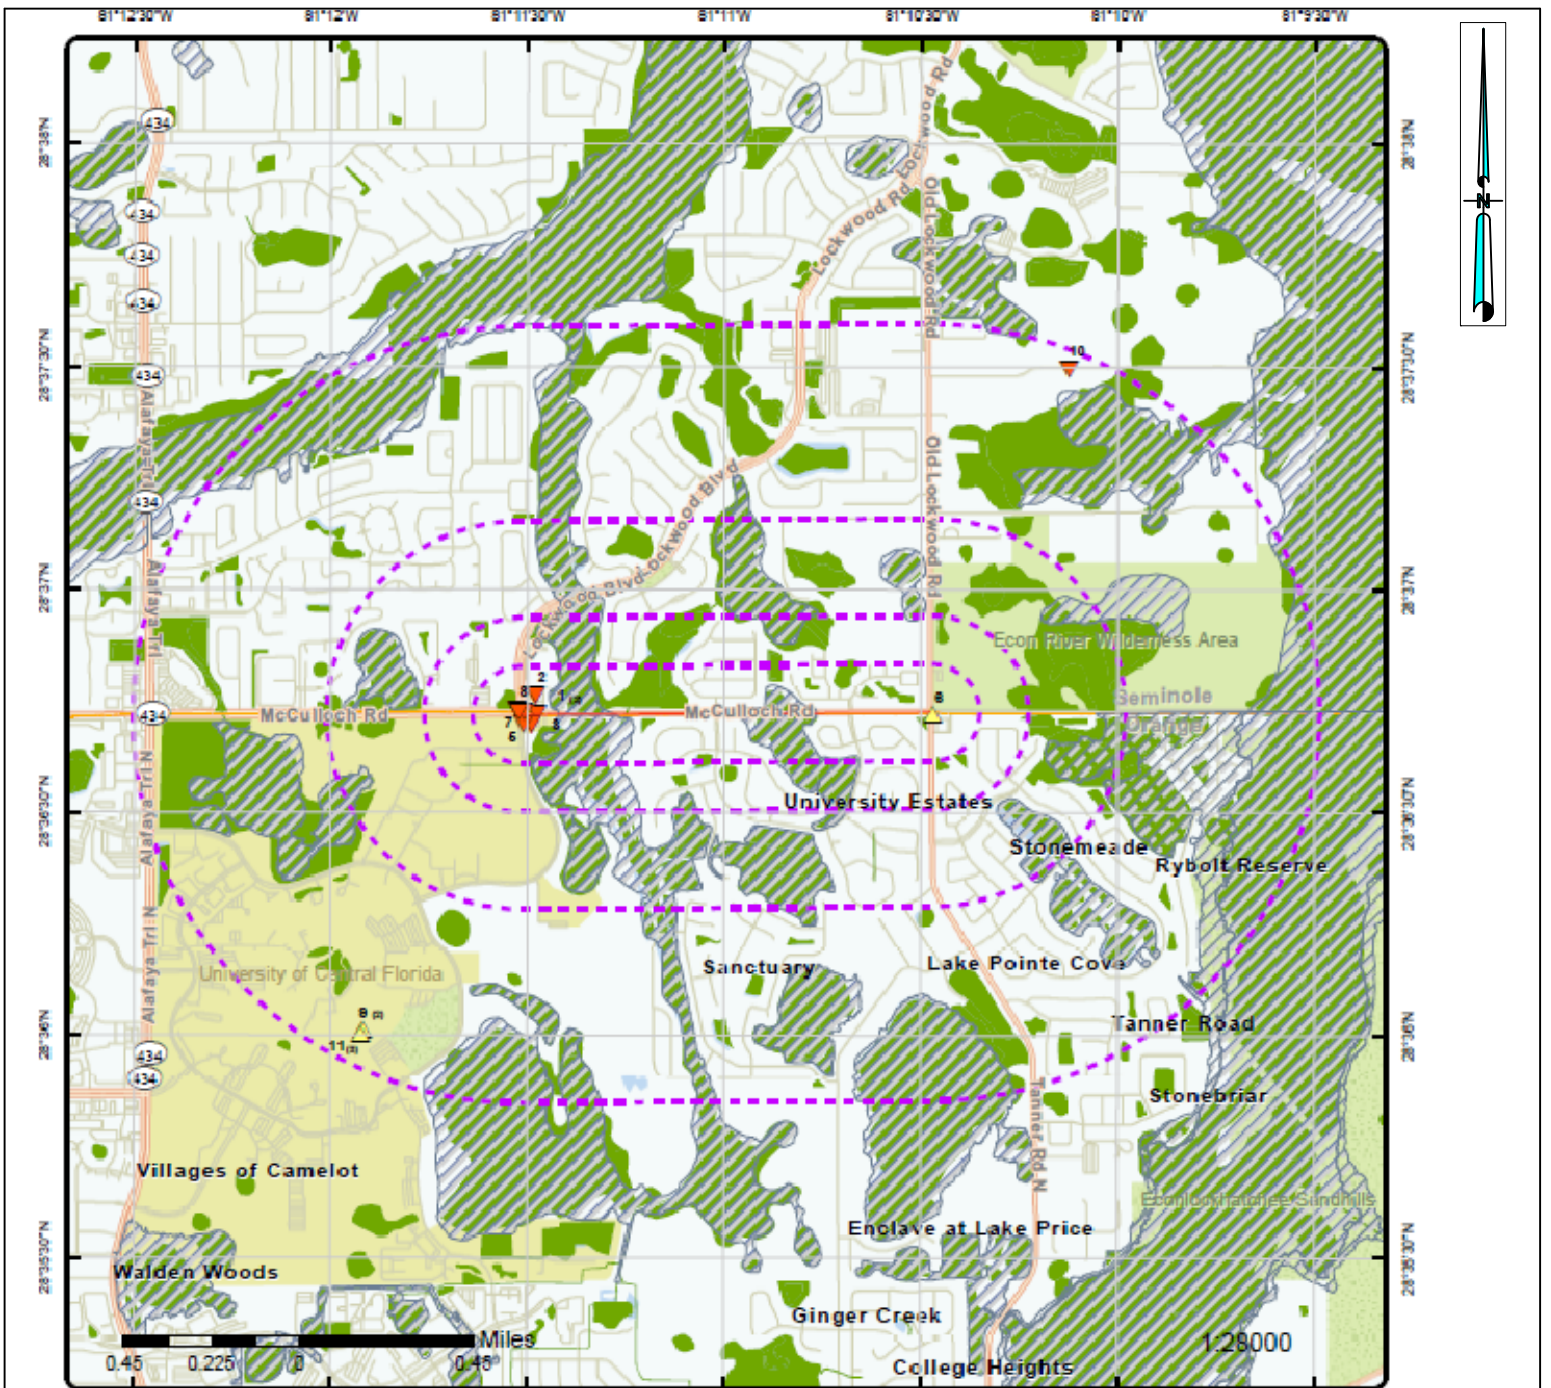
FIGURE 5
 POTENTIAL CONTAMINATION SITE MAP
 PROJECT NAME:
 MCCULLOCH ROAD ROADWAY CONCEPTUAL ANALYSIS (RCA)

Five (5) potentially contaminated sites were identified within the study corridor and were assigned a **No** and **Low**. None of the sites identified was assigned a rating of **Medium** or **High**. **Table 4** lists the sites identified in the study corridor and presents a summary of associated public records reviews and site reconnaissance observations. **Figure 5** in **Appendix A** illustrates the location of the Potential Contaminated Sites with the study corridor. Documents obtained from the public record search for various sites are included in **Appendix H**

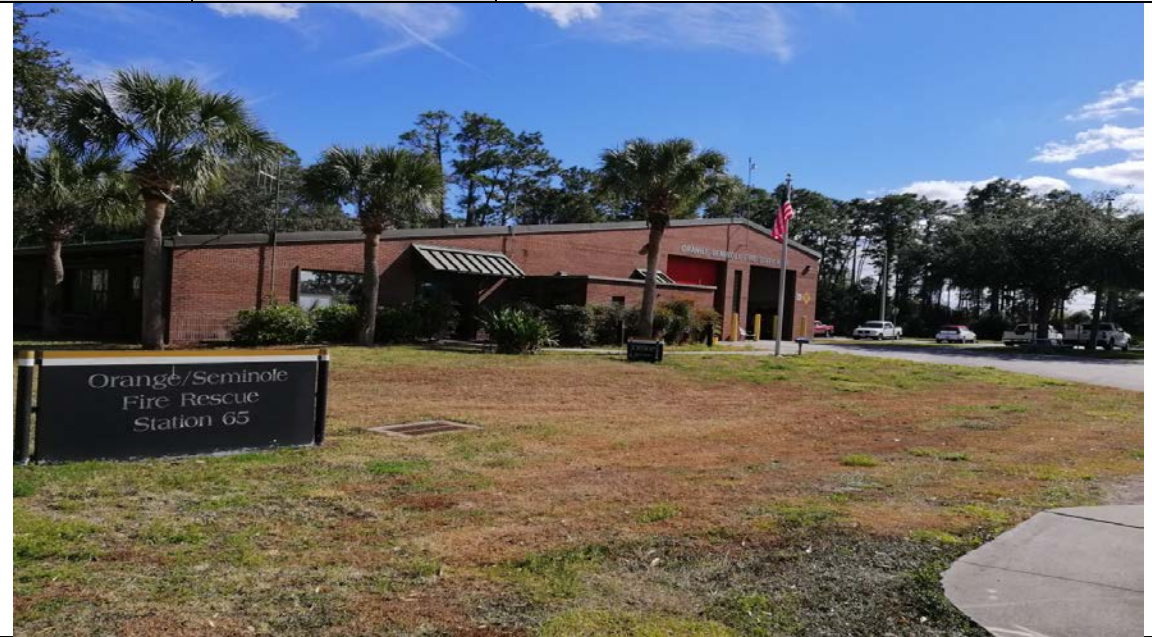
Photo: 2	Date: 02/01/2022	Description: Orange/Seminole Fire Rescue Station # 65 at Southeast Quadrangle of McCulloch Road and Orion Blvd Intersection
----------	------------------	---

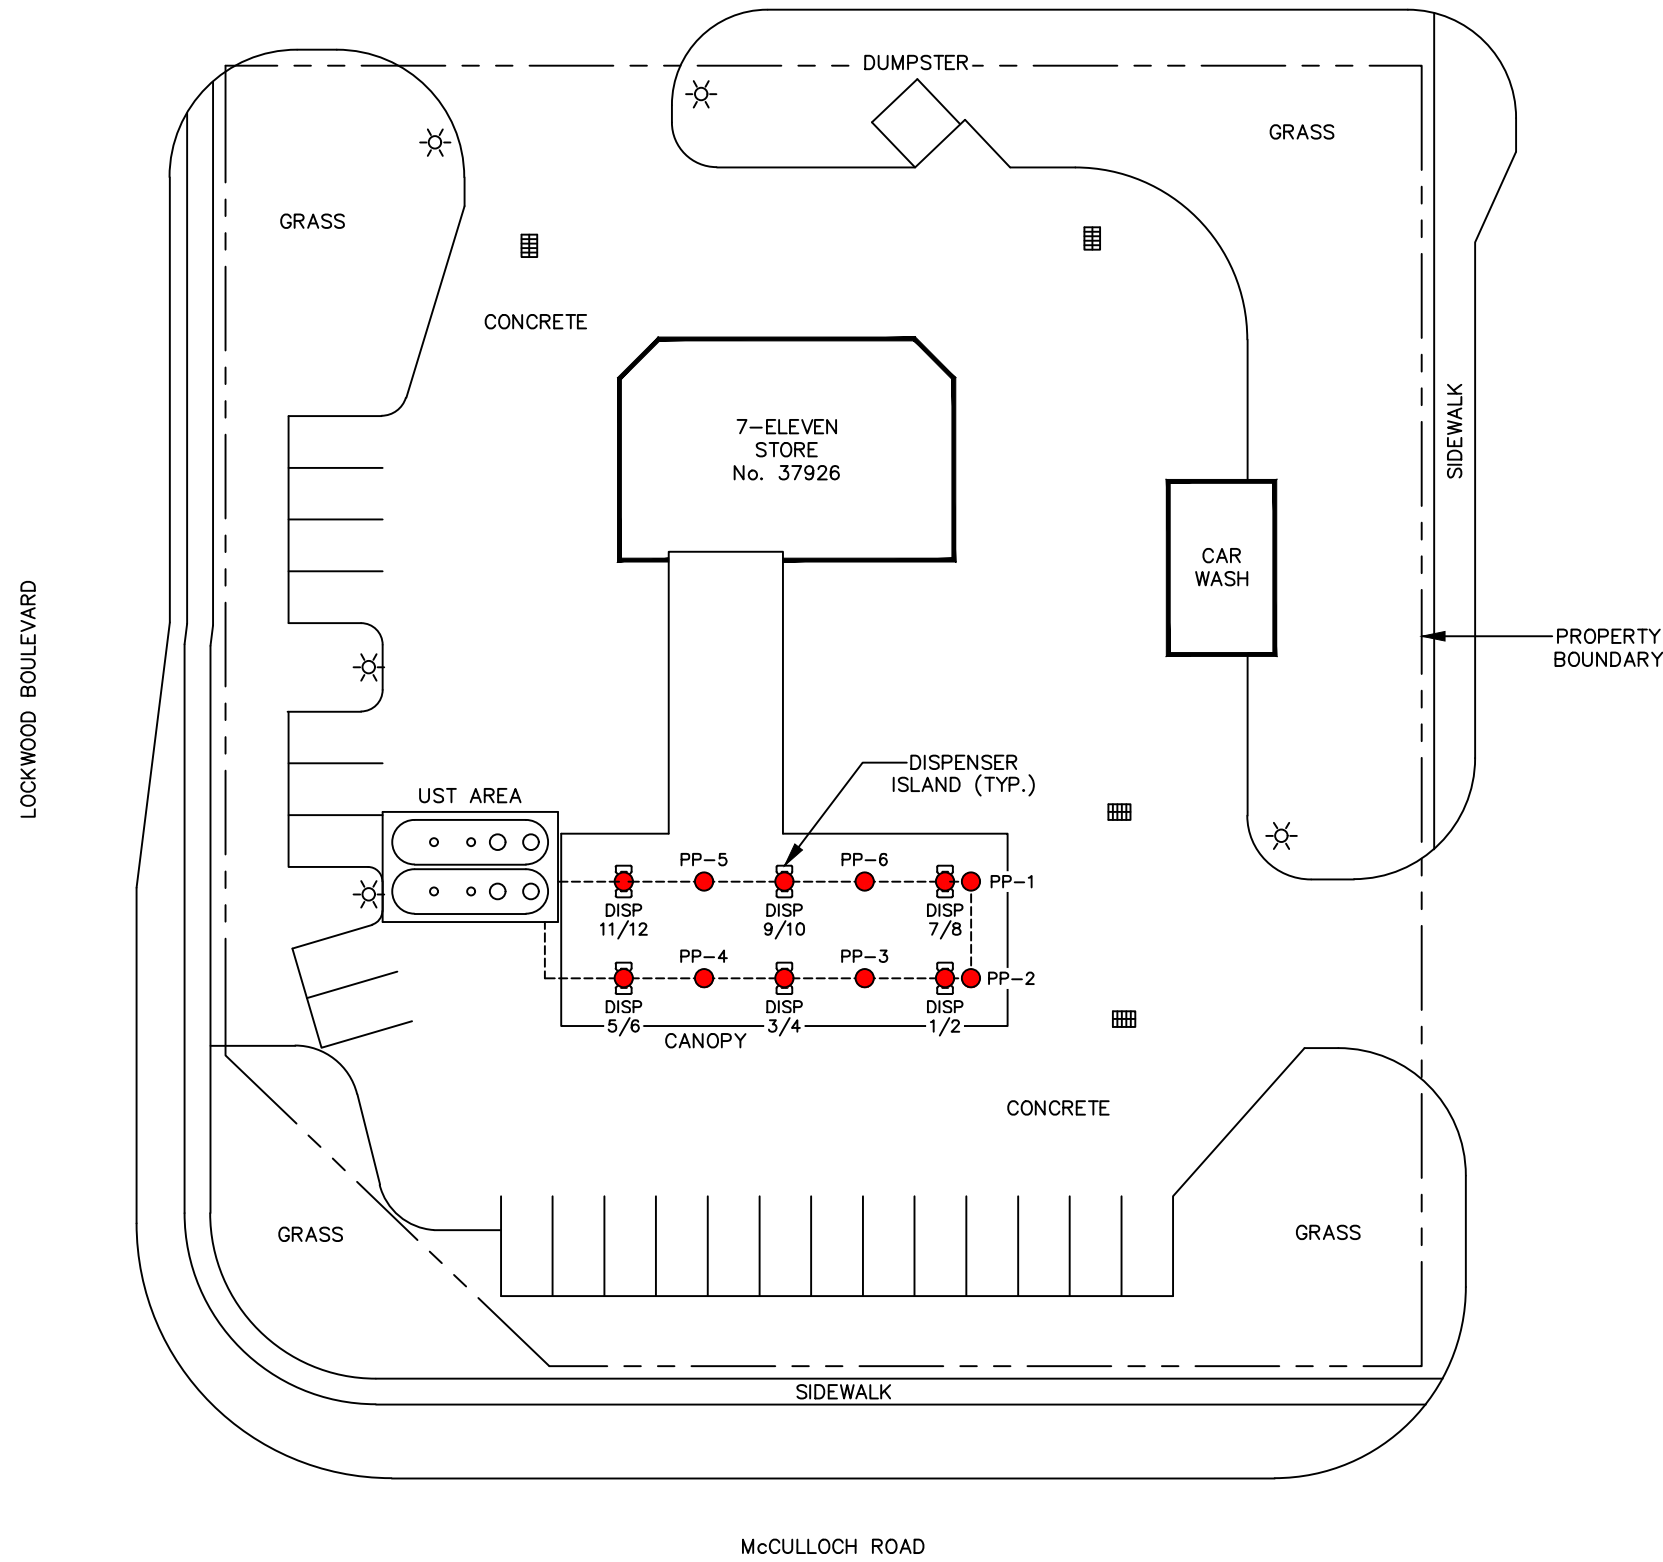
OFFICE: TAMPA	DATE: 10-10-18	ACAD FILE: 4499B1
SITE MAP		
CLIENT: 7-ELEVEN, INC.	PM: BB	
LOCATION: 7-ELEVEN STORE No. 37926 1640 E. McCULLOCH ROAD OVIEDO, SEMINOLE COUNTY, FLORIDA FDEP FACILITY ID No. 59/9805292		
DESIGNED: BB	DRAWN: SDJF	PROJECT NO.: 631254499
		FIGURE: 1

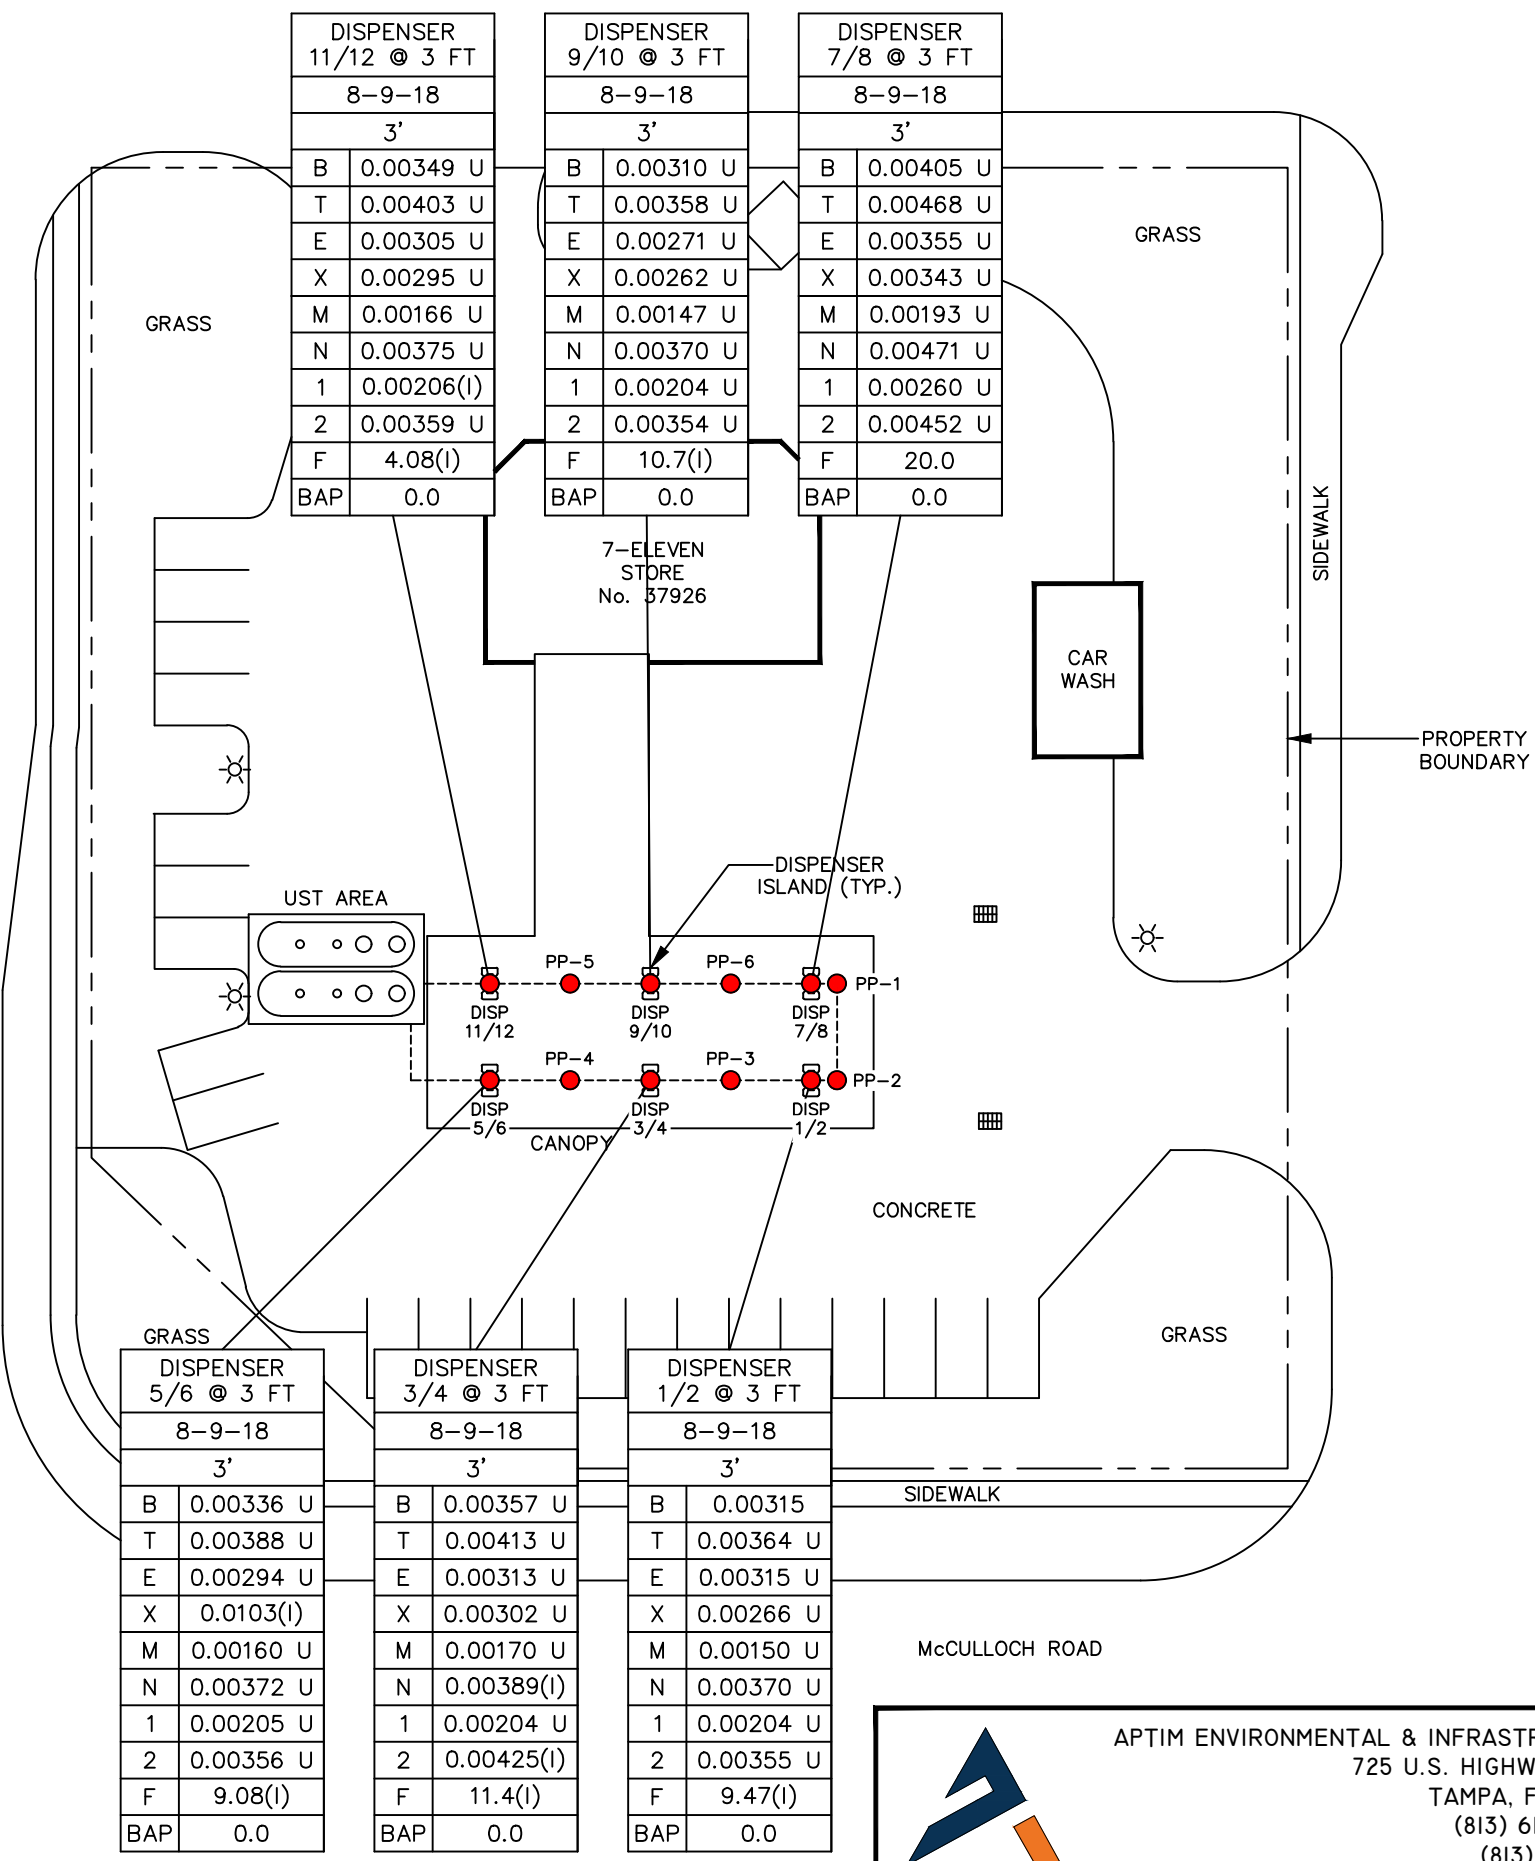
●		SAMPLE LOCATION
DISPENSER 1/2 @ 3 FT		SAMPLE IDENTIFICATION
8-9-18		DATE OF SAMPLE
3'		DEPTH OF SAMPLE (FEET)
B	0.00315	BENZENE CONCENTRATION (mg/kg)
T	0.00364	TOLUENE CONCENTRATION (mg/kg)
E	0.00276	ETHYLBENZENE CONCENTRATION (mg/kg)
X	0.00266	TOTAL XYLENES CONCENTRATION (mg/kg)
M	0.00150	MTBE CONCENTRATION (mg/kg)
N	0.00370	NAPHTHALENE CONCENTRATION (mg/kg)
1	0.00204	1-METHYLNAPHTHALENE CONC. (mg/kg)
2	0.00355	2-METHYLNAPHTHALENE CONC. (mg/kg)
F	9.47(l)	TRPH CONCENTRATION (mg/kg)
BAP	0.0	BENZO(A)PYRENE EQUIV. CONC. (mg/kg)

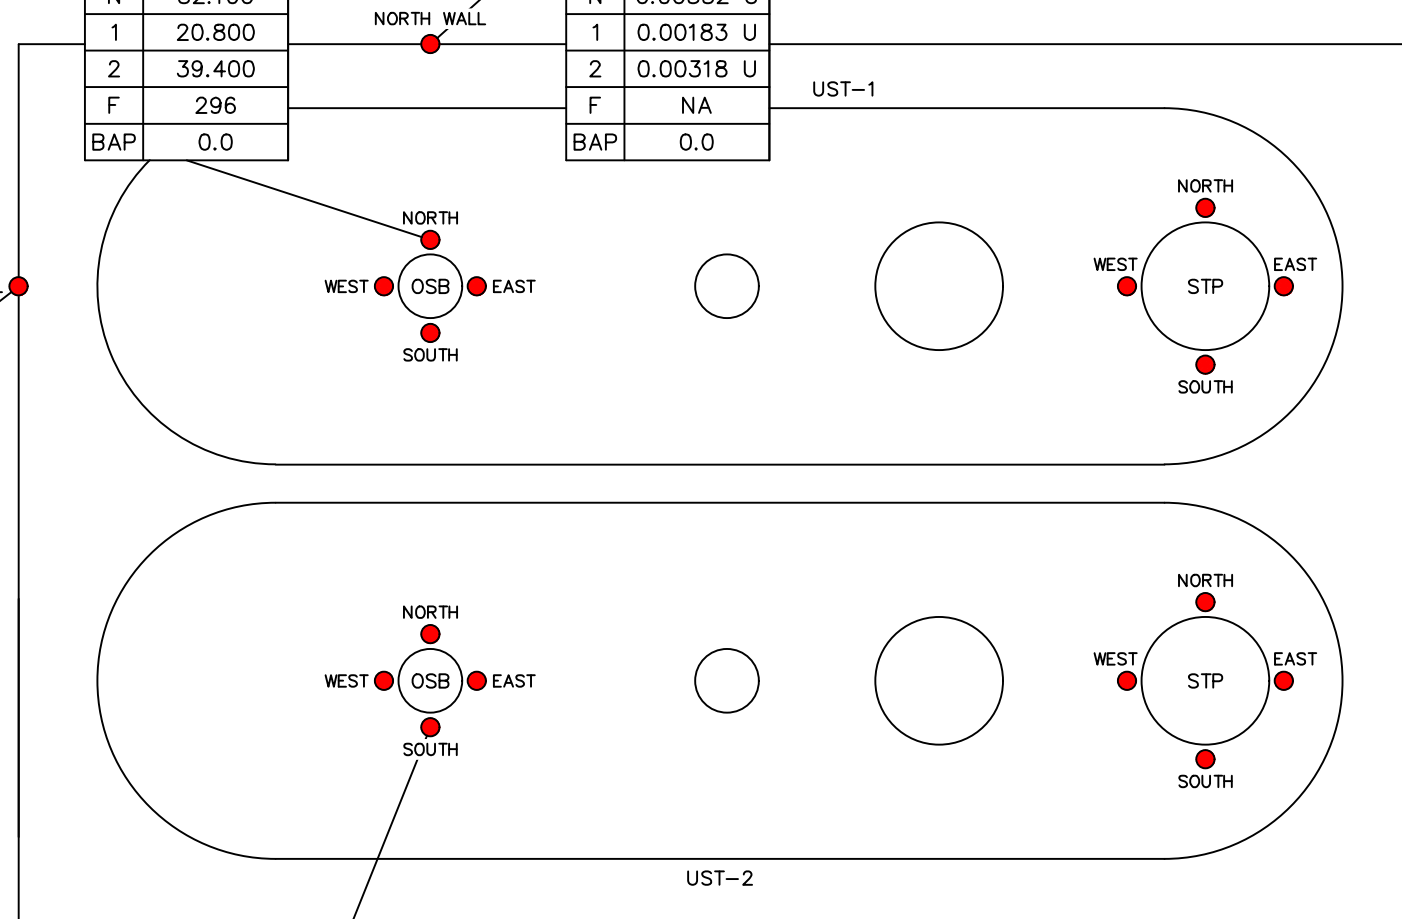
OSB-2 SOUTH@2.5FT	
8-20-18	
2.5'	
B	0.00319 U
T	0.00369 U
E	0.00280 U
X	0.00270 U
M	0.00152 U
N	0.00359 U
1	0.0117
2	0.0222
F	3.20 U
BAP	0.0

OFFICE: TAMPA	DATE: 10-10-18	ACAD FILE: 4499B6
SOIL ANALYTICAL MAP - OVERSPILL BUCKET AUGUST 10 AND 20, 2018		
CLIENT: 7-ELEVEN, INC.	PM: BB	
LOCATION: 7-ELEVEN STORE No. 37926 1640 E. McCULLOCH ROAD OVIDO, SEMINOLE COUNTY, FLORIDA FDEP FACILITY ID No. 59/9805292		
DESIGNED: BB	DRAWN: SDJF	PROJECT NO.: 631254499
		FIGURE: 6

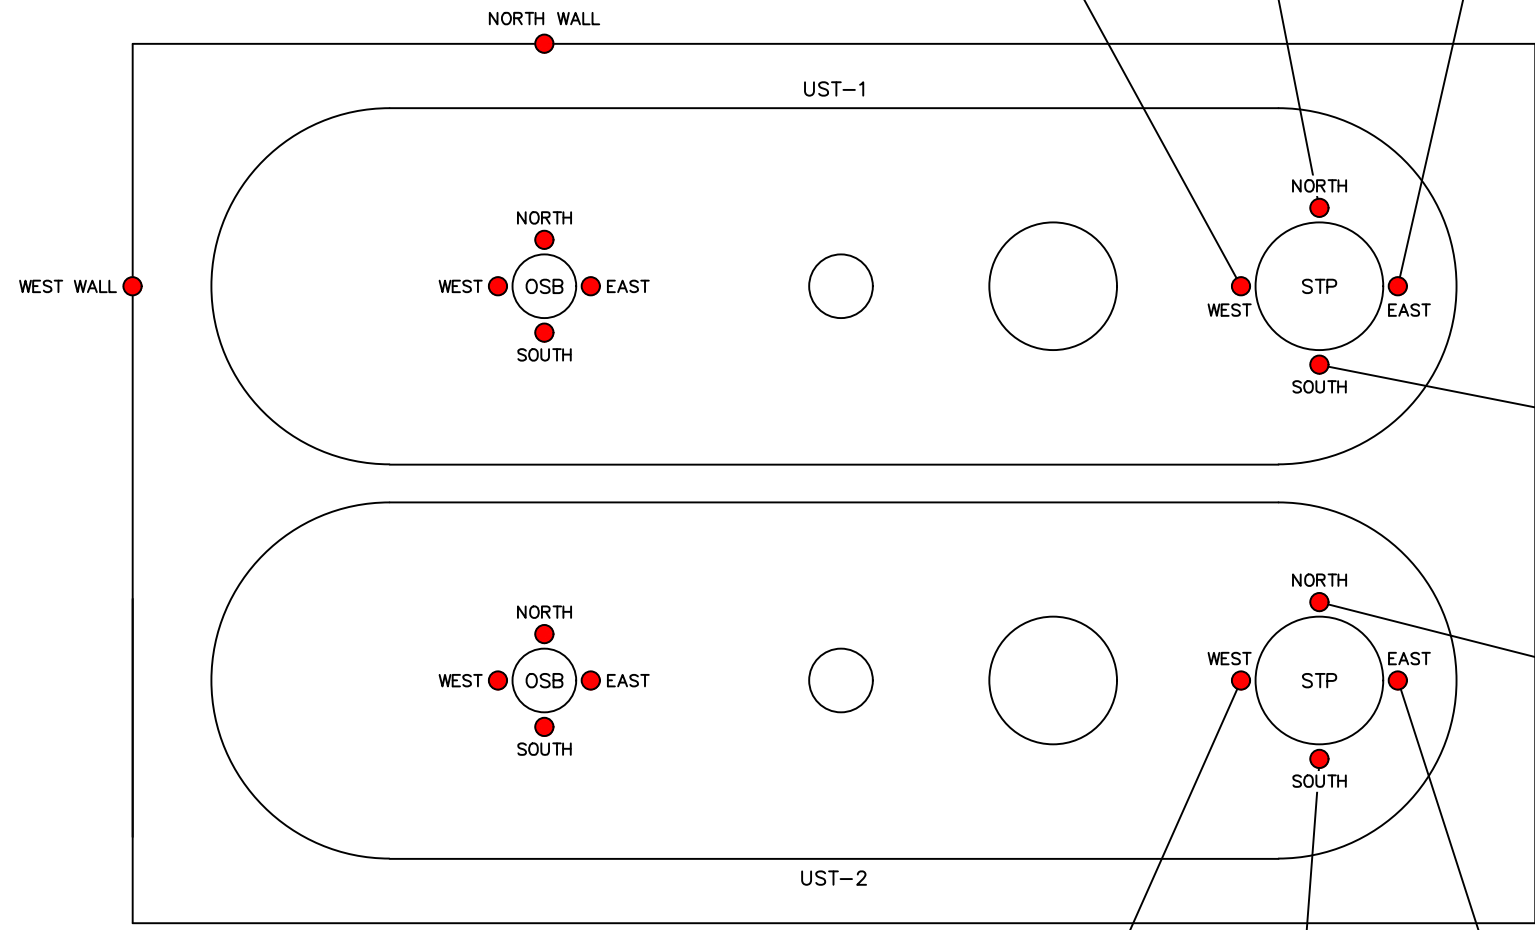
UST-1 NORTH		SAMPLE IDENTIFICATION
8-10-18		DATE OF SAMPLE
0-1'	24.0	DEPTH OF SAMPLE (FT)/ NET OVA READING (ppm)

UST-1 SOUTH	
8-10-18	
0-1'	15.0
1-2'	24.0
2-3'	10.0

UST-2 NORTH	
8-10-18	
0-1'	7.0
1-2'	14.0
2-3'	10.0

OFFICE: TAMPA	DATE: 10-10-18	ACAD FILE: 4499B8
OVA/PID READINGS MAP - SUBMERSIBLE TURBINE PUMP AUGUST 10, 2018		
CLIENT: 7-ELEVEN, INC.	PM: BB	
LOCATION: 7-ELEVEN STORE No. 37926 1640 E. McCULLOCH ROAD OVIEDO, SEMINOLE COUNTY, FLORIDA FDEP FACILITY ID No. 59/9805292		
DESIGNED: BB	DRAWN: SDJF	PROJECT NO.: 631254499
		FIGURE: 8
