CSER
McCulloch Road Roadway
Conceptual Analysis Study, from
N. Orion Blvd. to N. Tanner Road
Orange County, Florida
NADIC Project No.:
PR.GEO-RD20007.1

Re: Contamination Screening Evaluation Report
McCulloch Road Roadway Conceptual Analysis Study
(North Orion Boulevard to North Tanner Road)
Orange County, Florida
Orange County Project No.: Y20-827-CH
NADIC Proposal No. PQ.GEO-RD21007.1

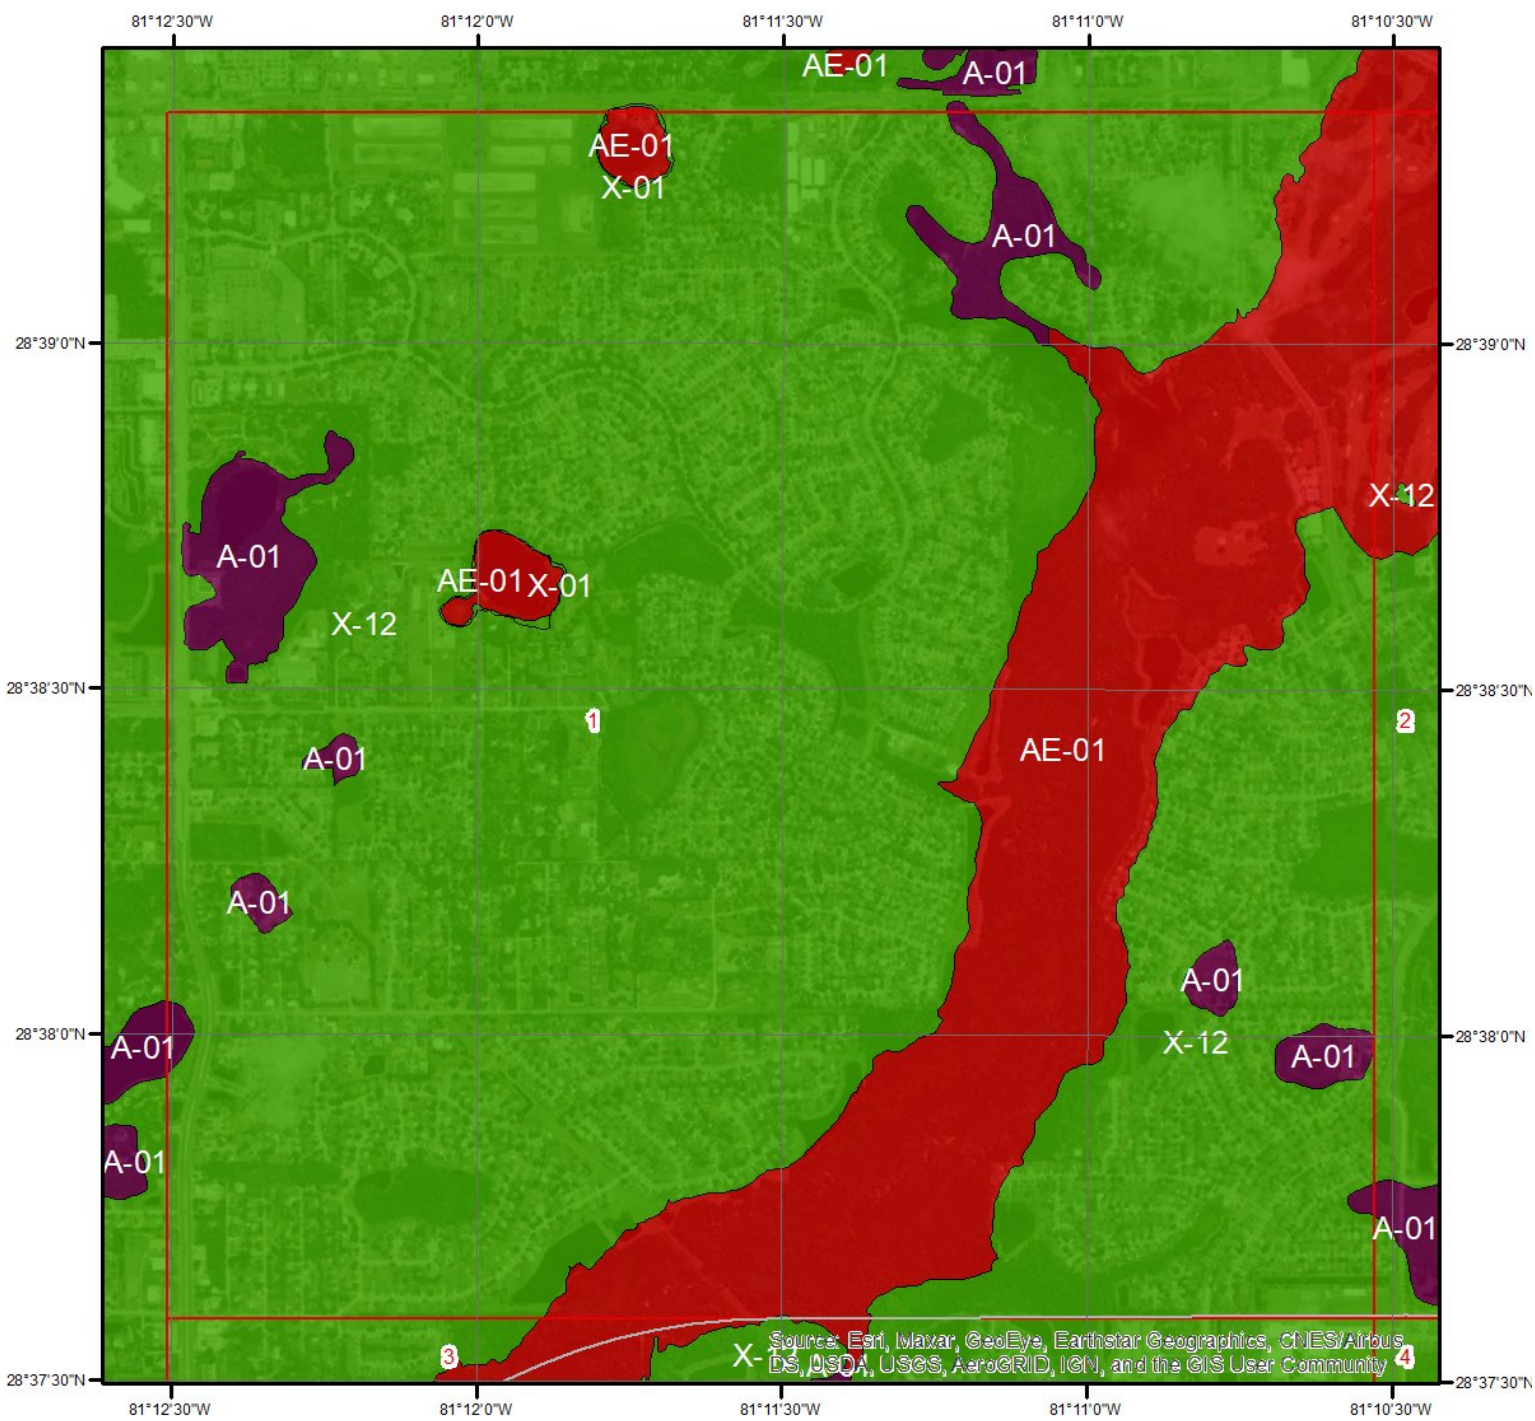
Flood Hazard Zones - Page 1

This map shows FEMA flood hazard zones. FIRM panels are shown to the right, and blank indicates no data is available.

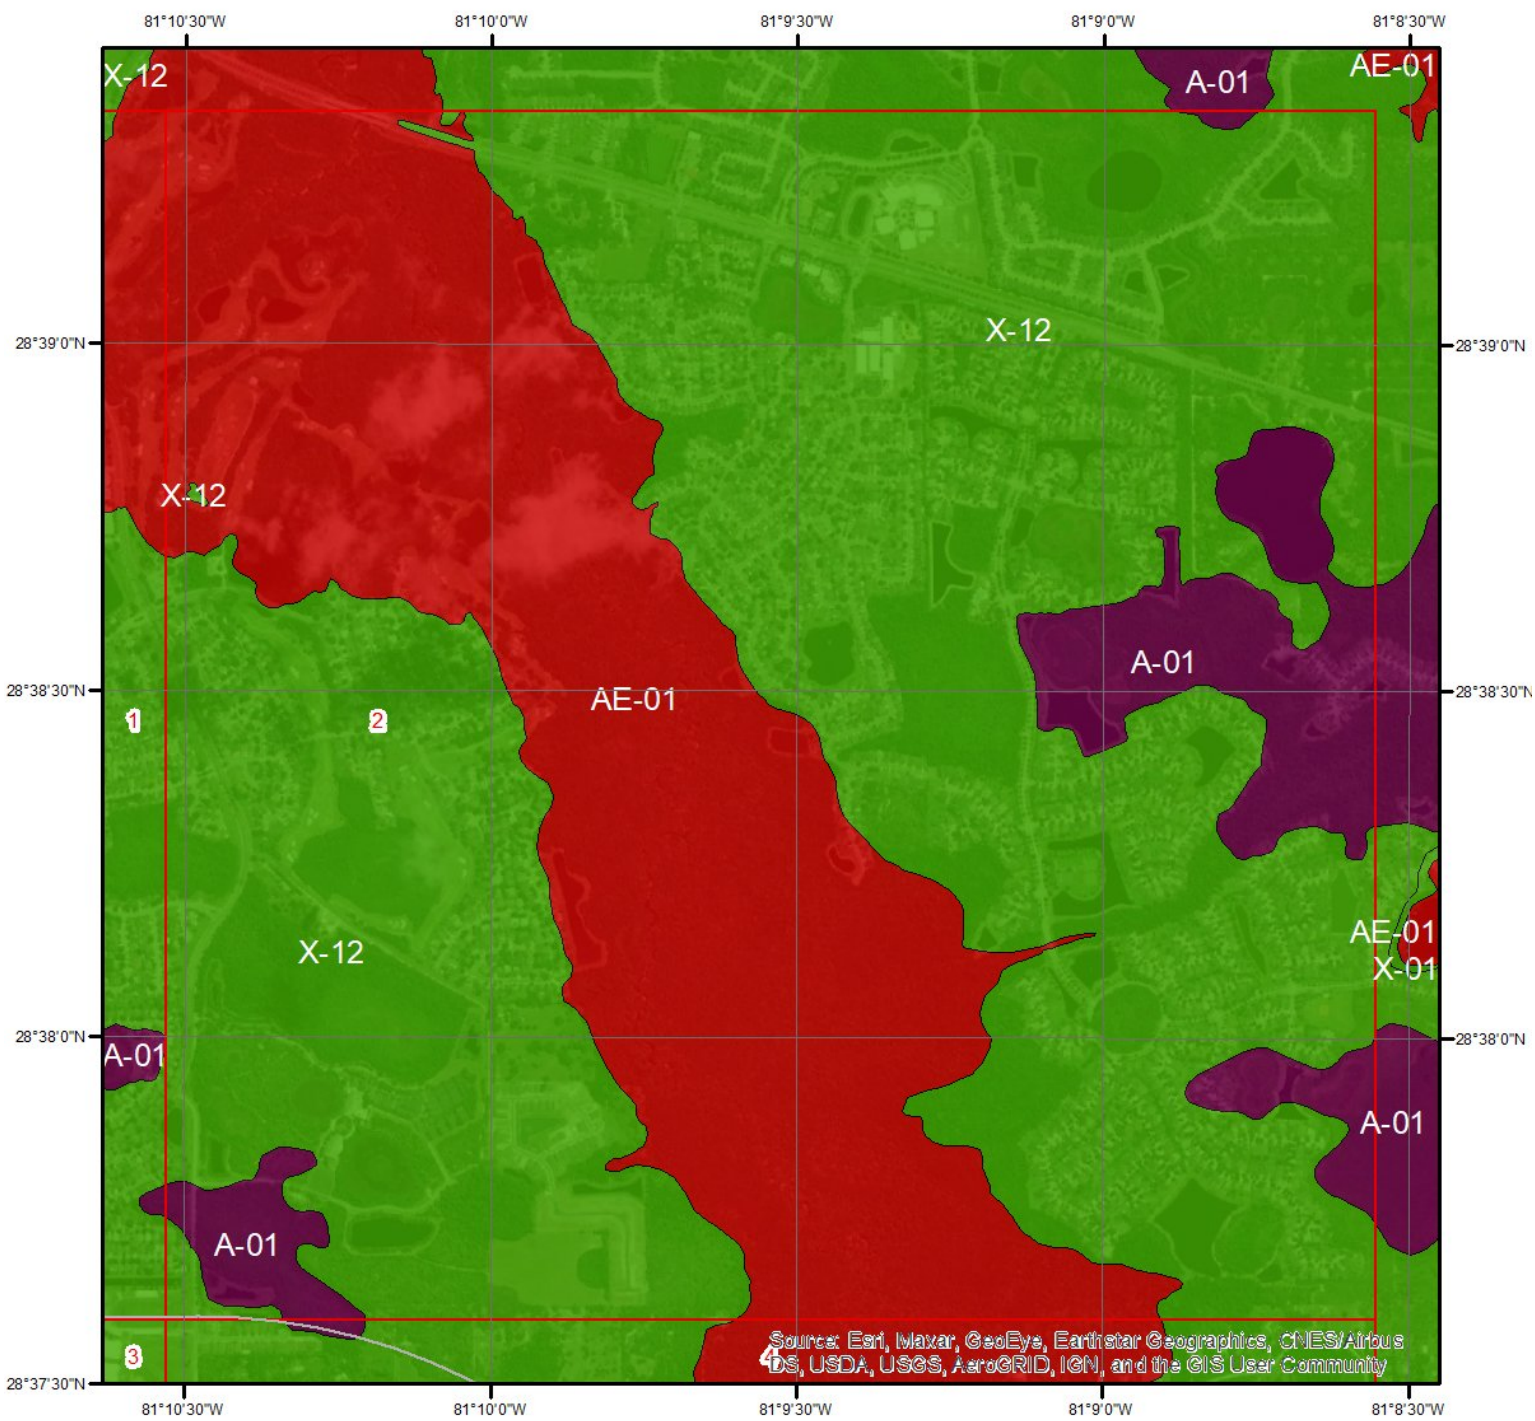
Flood Hazard Zones - Page 2

This map shows FEMA flood hazard zones. FIRM panels are shown to the right, and blank indicates no data is available.

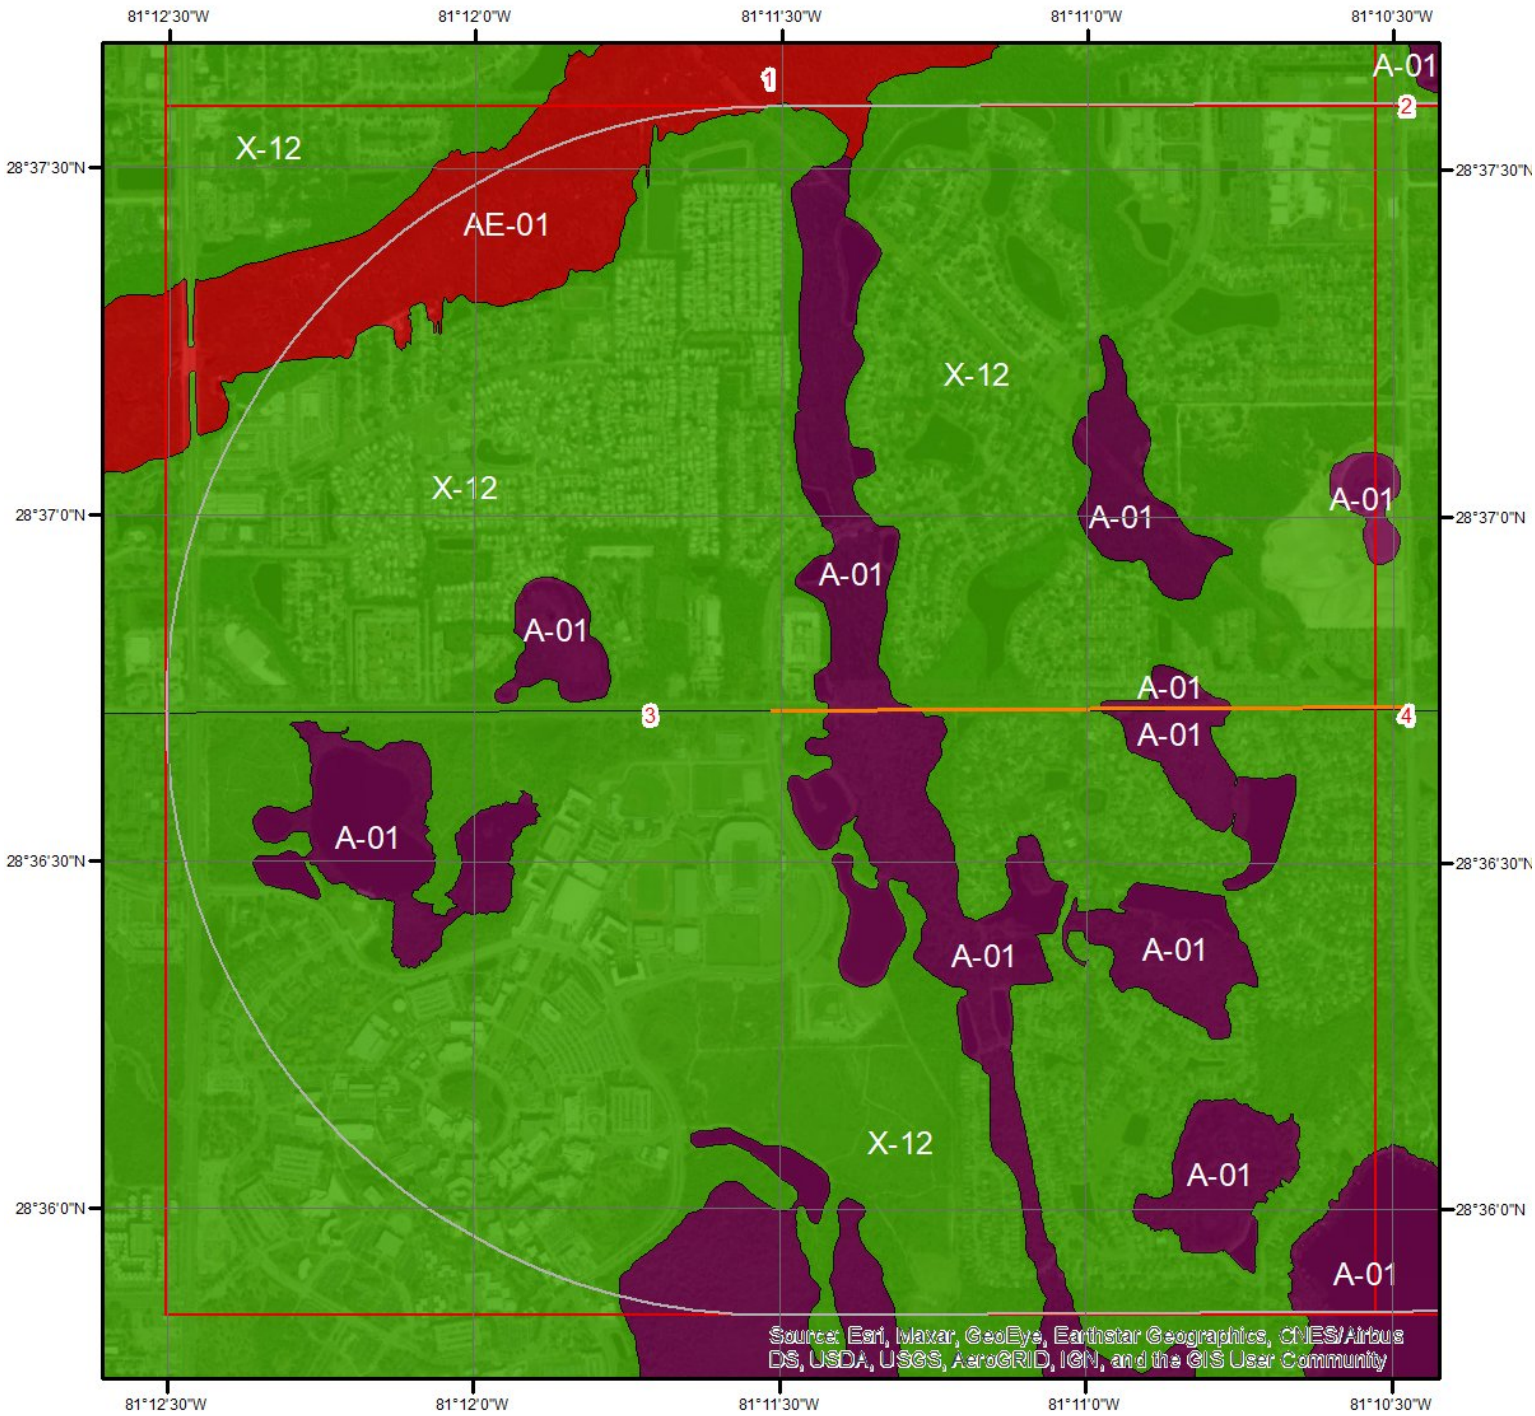
Flood Hazard Zones - Page 3

This map shows FEMA flood hazard zones. FIRM panels are shown to the right, and blank indicates no data is available.
