SUBJECT: March 7, 2023 – Public Hearing
Chuluota Road Roadway Conceptual Analysis Study

Roadway Conceptual Analysis for Chuluota Road (CR 419) From SR 50 to Lake Pickett Road

Chuluota Road (CR 419) FROM SR 50 TO LAKE PICKETT ROAD

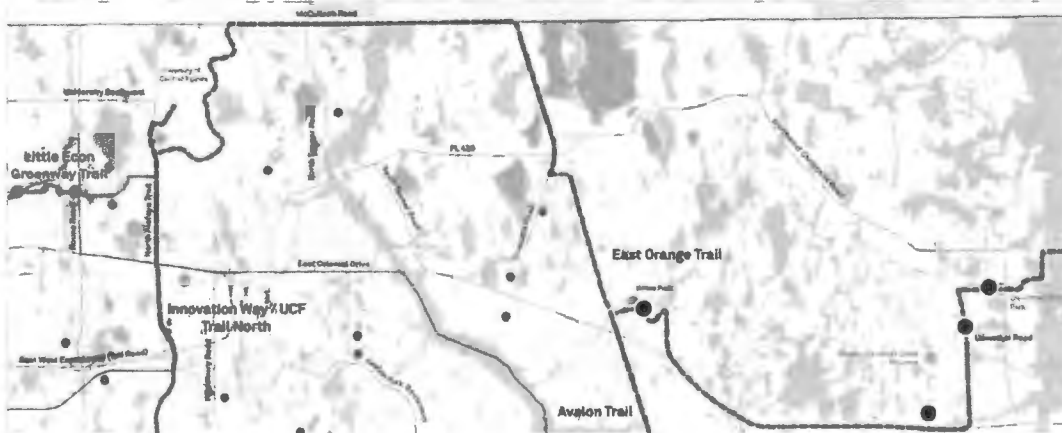
The County’s Transportation Element Future Conditions Number of Lanes 2030 Map indicates Chuluota Road is to be improved to a four-lane section. Other planned transportation improvements in the vicinity of Chuluota Road include:

- Lake Pickett Road - Widening to four lanes (note, these improvements are under further consideration by the County)
- SR 50 – Widening to six lanes by FDOT
- East Orange Trail (see below) – This trail is planned to coincide with northern portions of the Chuluota Road improvements and be constructed in the Chuluota Road right-of-way for that portion.

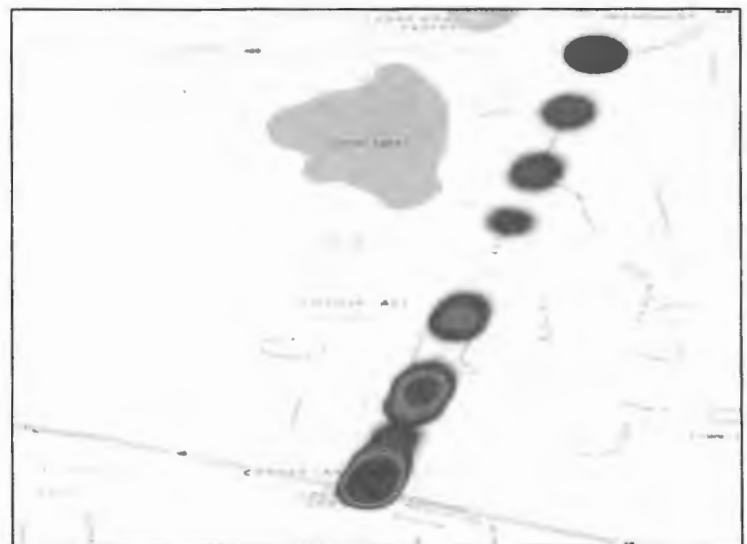
**Figure 2-5
Concentration of Crashes Along Chuluota Road**

- Chuluota Road at SR 50/Colonial Drive – 60 crashes
- Chuluota Road at Cypress Lake Glen Boulevard (South)/Schoolview Way Intersections – 24 crashes
- Chuluota Road at CR 420/Lake Pickett Road – 13 crashes

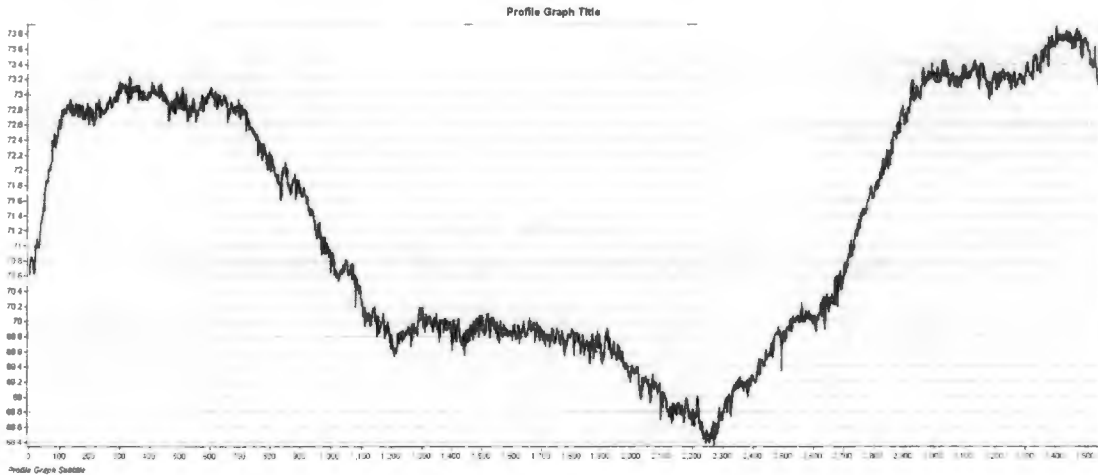
**Figure 3-2 Existing Roadway Profile
from LiDAR
SR 50 to Lake Pickett Road**

The existing ground profile of Chuluota Road is reflected below on Figure 2-2 which indicates a starting elevation of approximately 70 feet at SR 50. The existing profile then rises to an elevation of approximately 73 feet just south of Schoolview Way. The roadway then steadily drops between Cypress Lake Glen Boulevard to the north of Corner Lake Drive before reaching an elevation of approximately 69 feet. The Chuluota Road grade then rises to an elevation of approximately 73.5 feet at Lake Pickett Road. It is noted that the information presented in the section is based on Orange County LiDAR information which utilizes the NAVD88 datum.

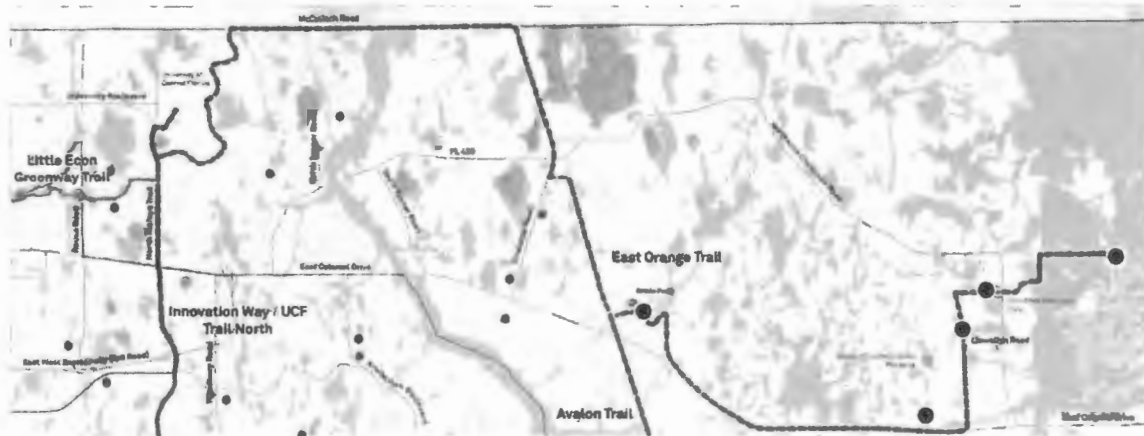
The County's Transportation Element Future Conditions Number of Lanes 2030 Map indicates Chuluota Road is to be improved to a four-lane section. Other planned transportation improvements in the vicinity of Chuluota Road include:

- Lake Pickett Road - Widening to four lanes (These improvements are under further consideration by the County)
- SR 50 – Widening to six lanes by FDOT
- East Orange Trail (see below) – Future new trail which will coincide with northern portions of the Chuluota Road improvements

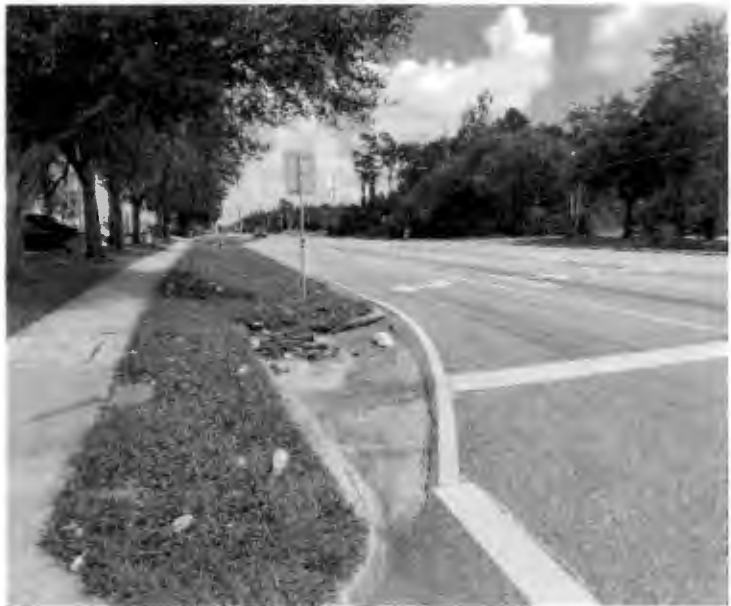
Stormwater runoff is conveyed by a ditch into an existing FDOT storm drain system draining west along SR 50. There is no existing stormwater attenuation or water quality treatment.

Existing inlet drains west into FDOT SR 50 ROW

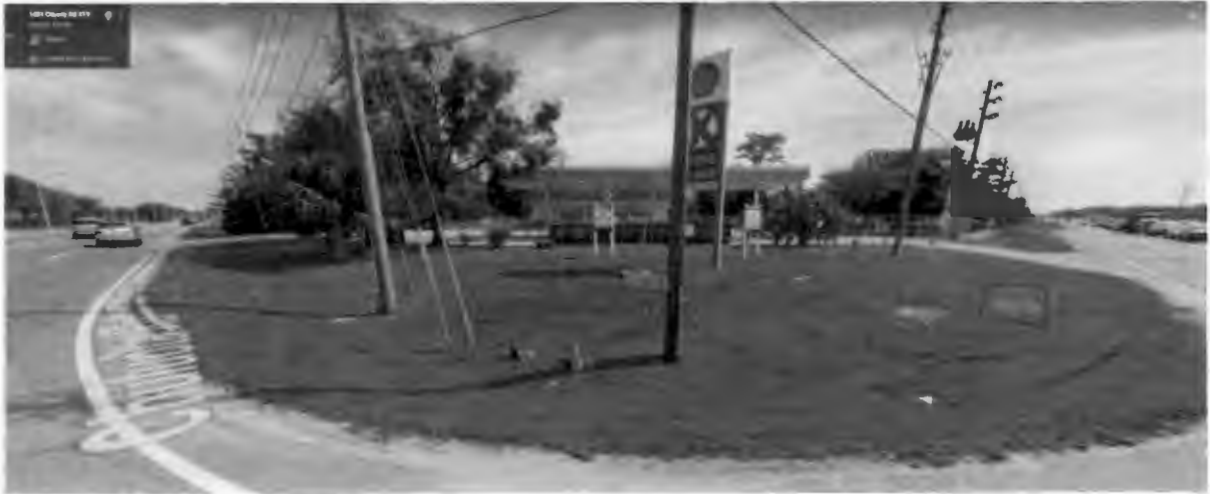
Stormwater runoff sheet flows into the existing FDOT storm drain system draining east along Colonial Blvd. There is no existing stormwater attenuation or water quality treatment.

Existing inlet on east side of Chuluota Road drains into FDOT SR 50 ROW

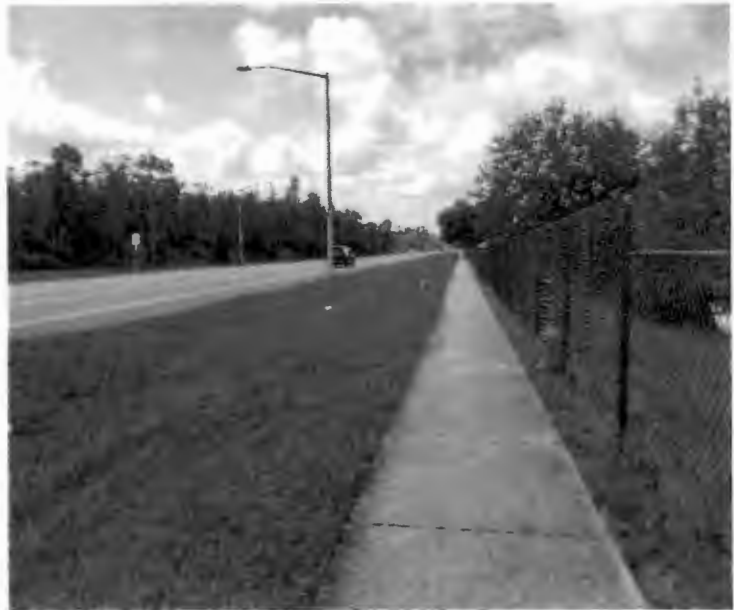
Roadside ditch facing south

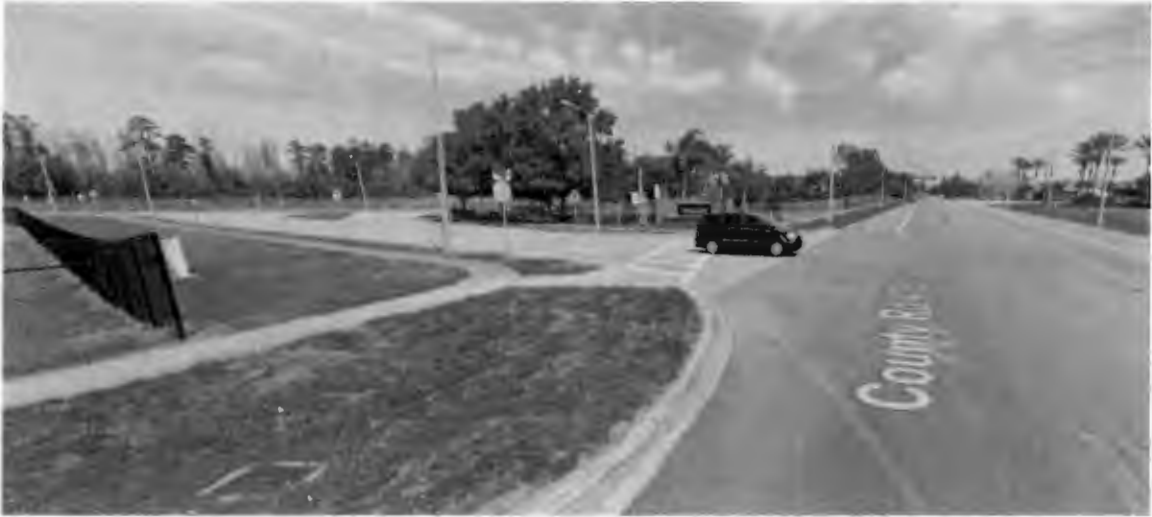
County LiDAR indicates that Basin 2A ranges in elevation from 70 feet to 73 feet (mean 72.0 feet). Stormwater runoff sheet flows into a ditch which is conveyed via a ditch bottom inlet and storm drain into the existing pond north of intersection of Schoolview Way and Chuluota Road (ERP#27857).

Chuluota Road and Schoolview Way showing ditch bottom inlet which drains to existing pond

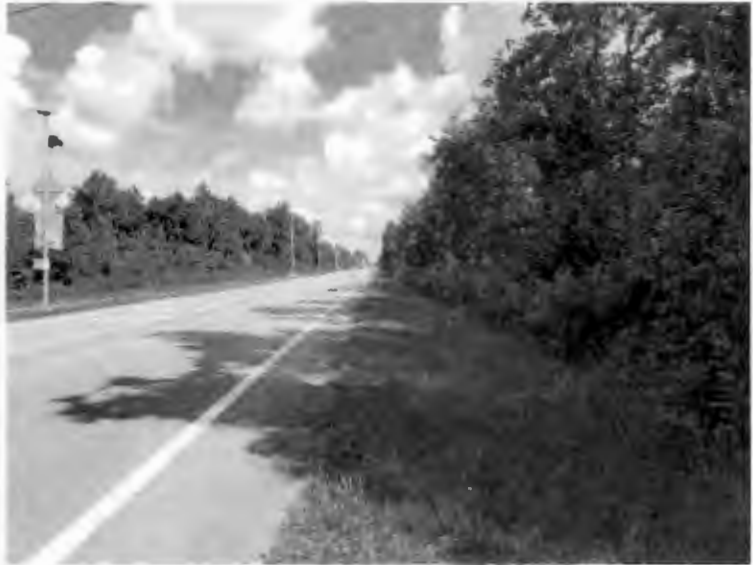
County LiDAR indicates that Basin 2B ranges in elevation from 66.7 feet to 73.5 feet (mean 70.7 feet). Stormwater runoff sheet flows into adjacent roadside ditches that flow towards an existing cross drain (CD-1). The existing cross drain flows toward the wetland system to the west of Chuluota Road. A side drain under Corner Lake Drive conveys this runoff to wetlands west of Chuluota Road in Basin 3.

Roadside ditch facing north

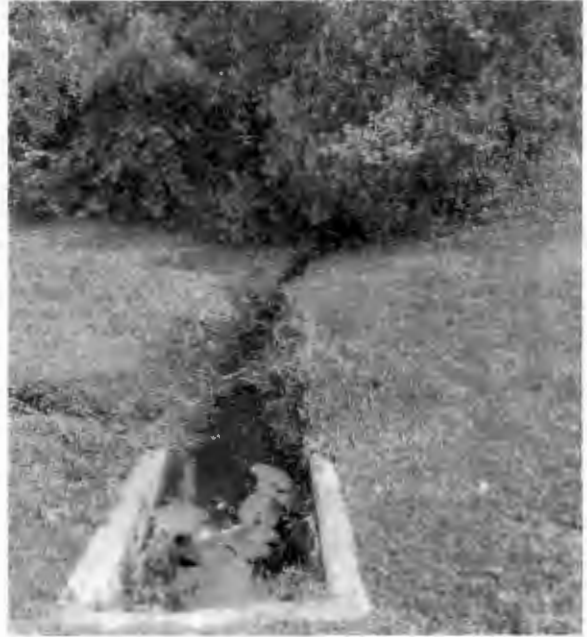
The existing cross drain drains to a relict wetland canal west of Chuluota Road which ultimately discharges to Corner Lake.

Existing side drain under Corner Lake Drive which conveys runoff from Basin 2B to Basin 3

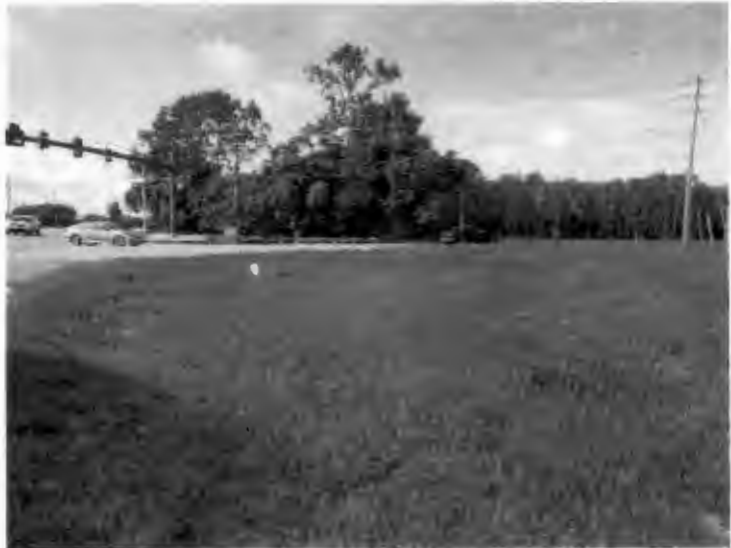
Existing dry pond northeast of Lake Pickett Road and Chuluota Road

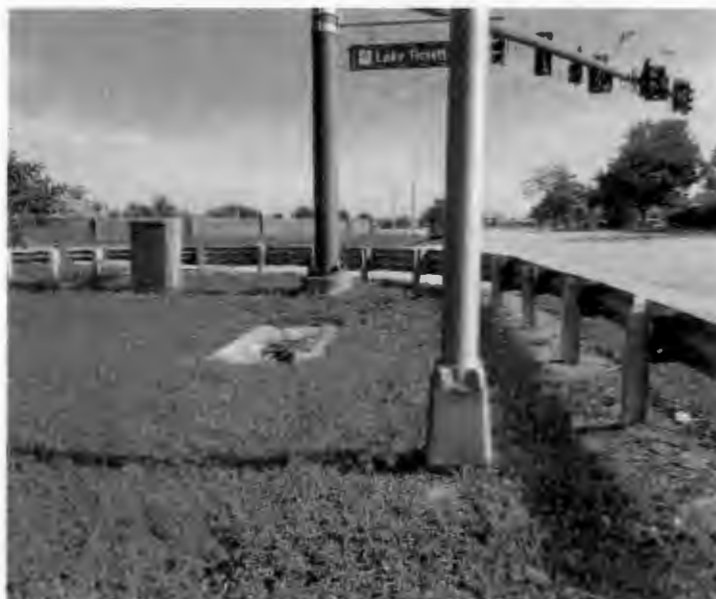
Ditch bottom inlet at southwest intersection of Lake Pickett Road and Chuluota Road, facing north

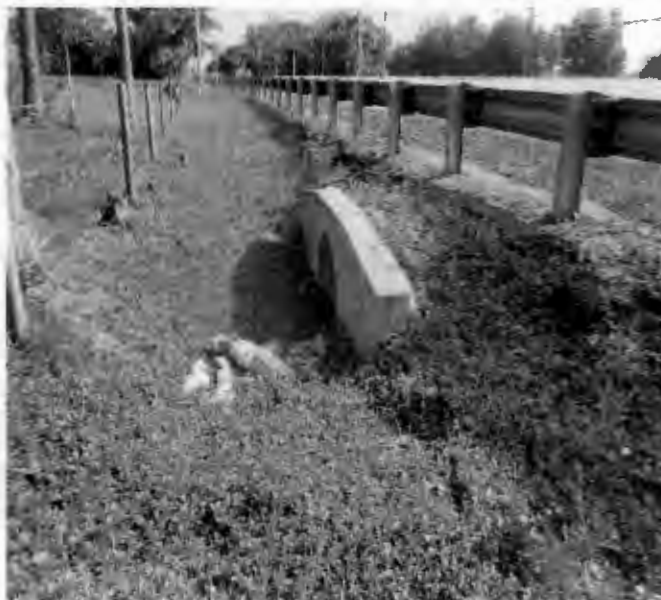
Cross drain which conveys runoff from basin 4-300 to storm drain on east side of Chuluota Road, facing north and east.

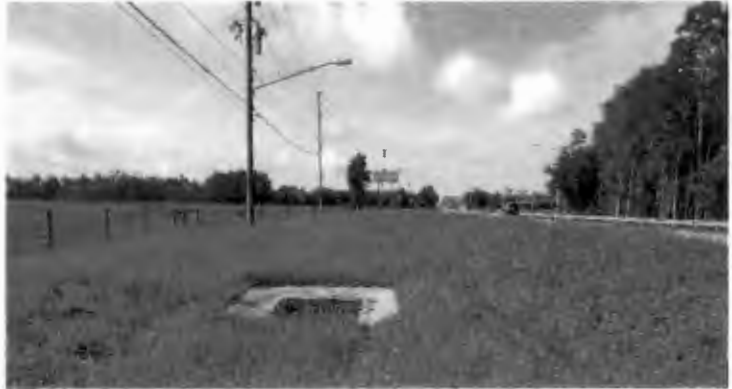
Runoff is conveyed via sheet flow to a roadside ditch which drains to a cross drain under Chuluota Road. That cross drain conveys runoff to a storm drain on the east side of Chuluota Road (in Basin 4-400). Runoff is ultimately conveyed to the existing storm drain system along Lake Pickett Road to wet detention ponds associated with the Mandalay Subdivision (ERP#101908-1, -2, and -4).

Ditch bottom inlet which conveys sheet flow from Chuluota Road to existing storm drain, facing south
