SUBJECT: March 7, 2023 – Public Hearing  
Chuluota Road Roadway Conceptual Analysis Study

The Orange County Transportation Planning Division has completed the Chuluota Road Roadway Conceptual Analysis (RCA) study.

# Roadway Conceptual Analysis for Chuluota Road (CR 419) From SR 50 to Lake Pickett Road

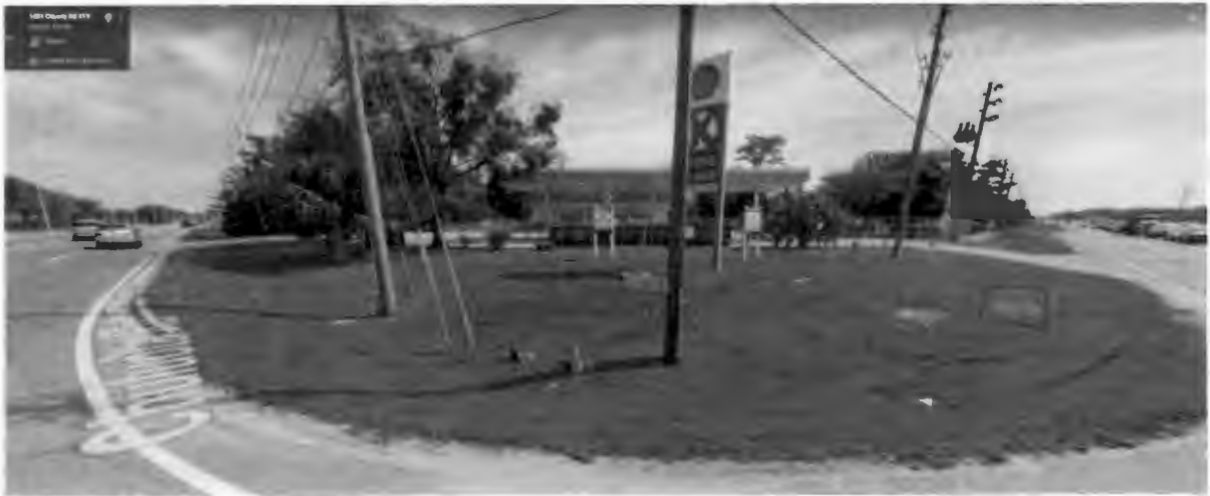
Stormwater runoff sheet flows into the existing FDOT storm drain system draining east along Colonial Blvd. There is no existing stormwater attenuation or water quality treatment.

*Existing inlet on east side of Chuluota Road drains into FDOT SR 50 ROW*

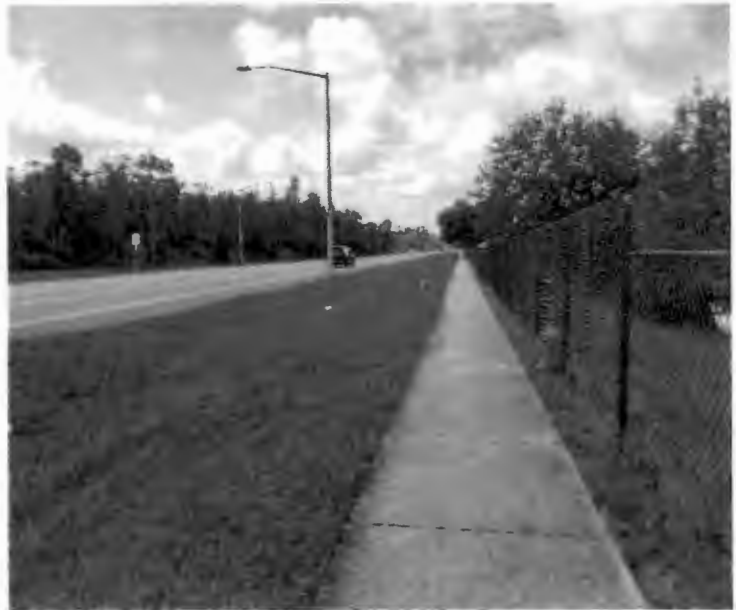
County LiDAR indicates that Basin 2A ranges in elevation from 70 feet to 73 feet (mean 72.0 feet). Stormwater runoff sheet flows into a ditch which is conveyed via a ditch bottom inlet and storm drain into the existing pond north of intersection of Schoolview Way and Chuluota Road (ERP#27857).

*Roadside ditch facing south*

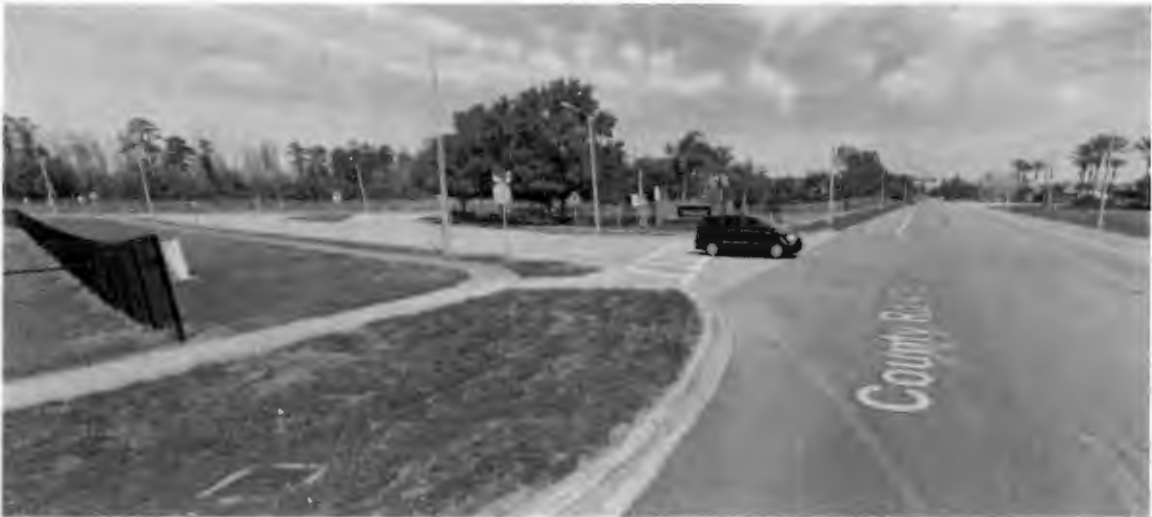
*Chuluota Road and Schoolview Way showing ditch bottom inlet which drains to existing pond*

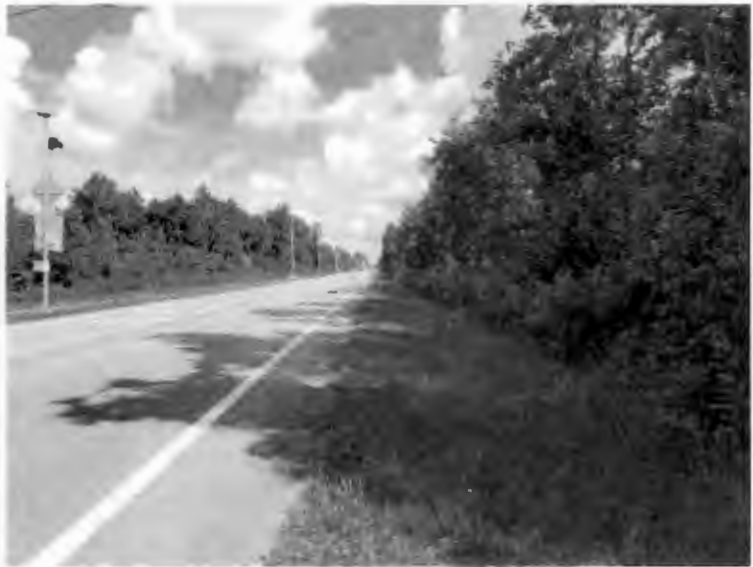
County LiDAR indicates that Basin 2B ranges in elevation from 66.7 feet to 73.5 feet (mean 70.7 feet). Stormwater runoff sheet flows into adjacent roadside ditches that flow towards an existing cross drain (CD-1). The existing cross drain flows toward the wetland system to the west of Chuluota Road. A side drain under Corner Lake Drive conveys this runoff to wetlands west of Chuluota Road in Basin 3.

*Roadside ditch facing north*

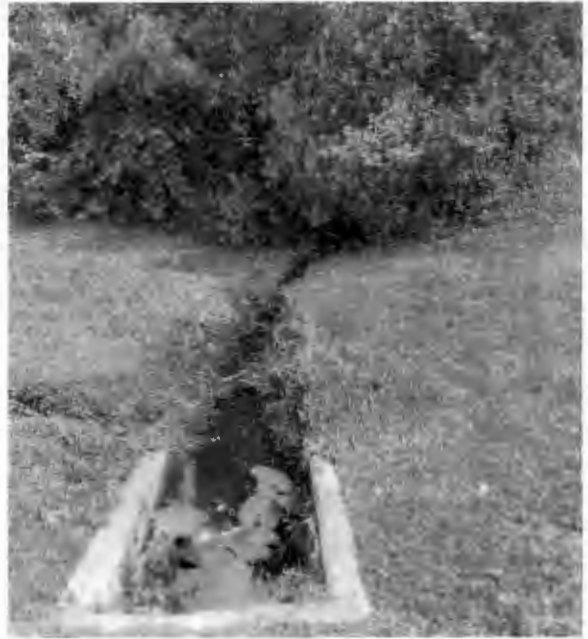
The existing cross drain drains to a relict wetland canal west of Chuluota Road which ultimately discharges to Corner Lake.

*Existing side drain under Corner Lake Drive which conveys runoff from Basin 2B to Basin 3*

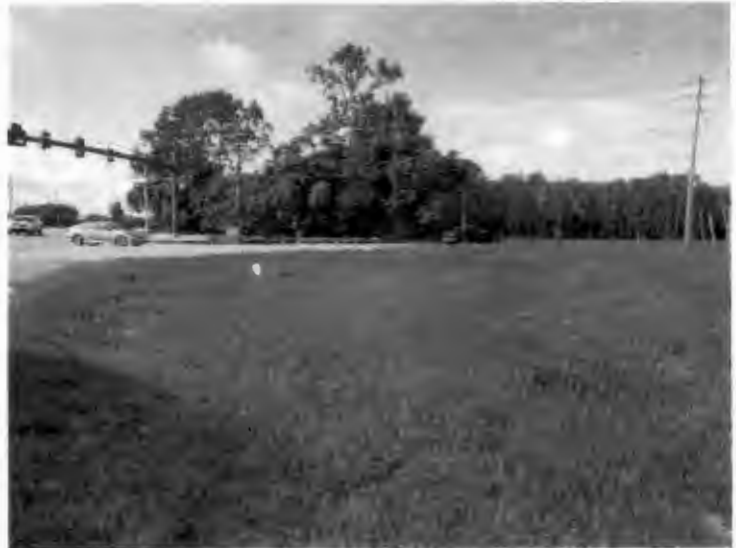
*Existing dry pond northeast of Lake Pickett Road and Chuluota Road*

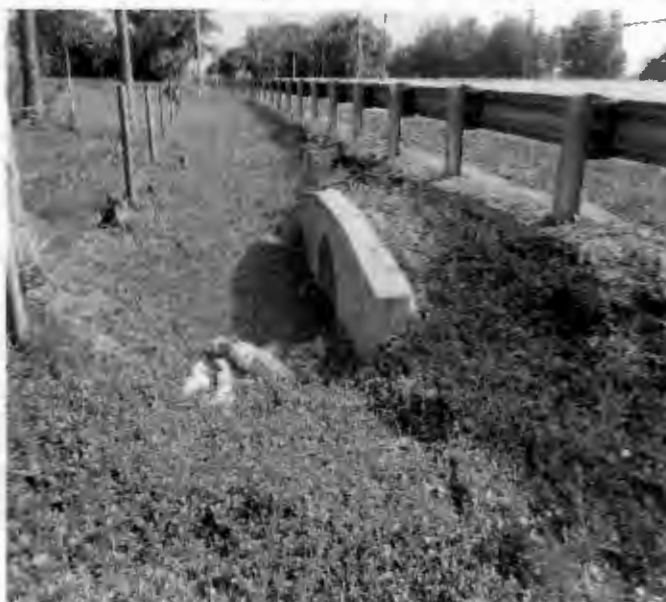
*Cross drain which conveys runoff from basin 4-300 to storm drain on east side of Chuluota Road, facing north and east.*

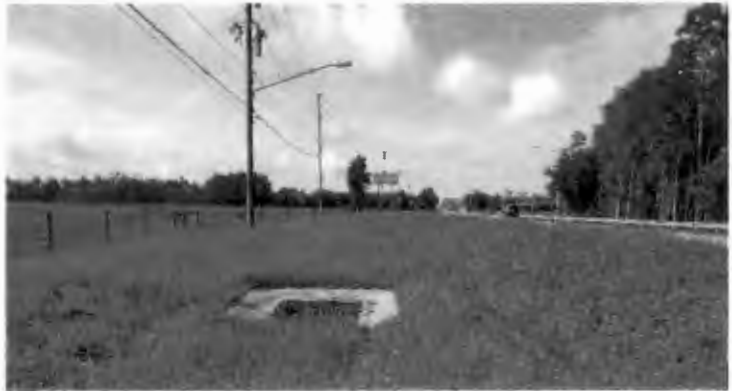
Runoff is conveyed via sheet flow to a roadside ditch which drains to a cross drain under Chuluota Road. That cross drain conveys runoff to a storm drain on the east side of Chuluota Road (in Basin 4-400). Runoff is ultimately conveyed to the existing storm drain system along Lake Pickett Road to wet detention ponds associated with the Mandalay Subdivision (ERP#101908-1, -2, and -4).

*Ditch bottom inlet which conveys sheet flow from Chuluota Road to existing storm drain, facing south*
